Facilities Master Planning

Beaver Dam School District

Beaver Dam, WI

Existing Facilities Survey

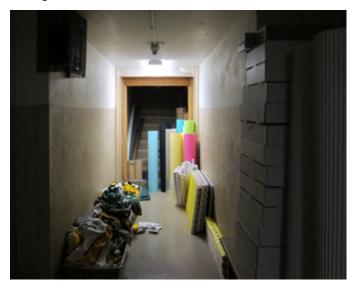
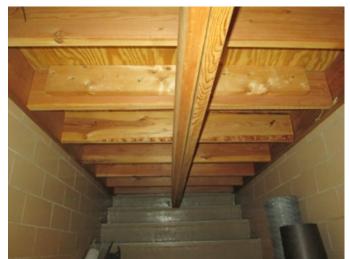
The boiler room and football team locker rooms are located in the lower level. This area is generally located below the chorus and band areas. Two open stair wells serve this area, neither of which exits directly to the exterior. A third stair has been covered and turned into a storage room.

This area is not ADA accessible. The level is commonly referred to as 'The Pit' and contains 'Tradition Tunnel". It also contains mechanical rooms, custodial rooms, storage, boys team locker rooms, team showers and a team conference room. The floors are painted concrete or ceramic tile for the shower area. The floors are in fair condition. The restroom adjacent to the locker room is in poor condition. The restroom ceiling is severely water damaged, the partitions are rusty and the doors are delaminated.

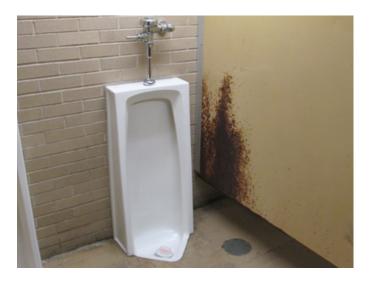
The team conference room reportedly has no ventilation. The ceiling within the locker area has exposed piping running through it with peeling paint. Headroom clearance within the locker room areas is limited. These locker rooms should be considered for complete remodeling including addition of an elevator or they should be abandoned and rebuilt in a different location.

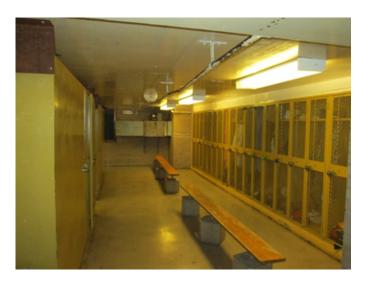
The lockers are in fair condition. The shower ceiling needs to be patched and painted.

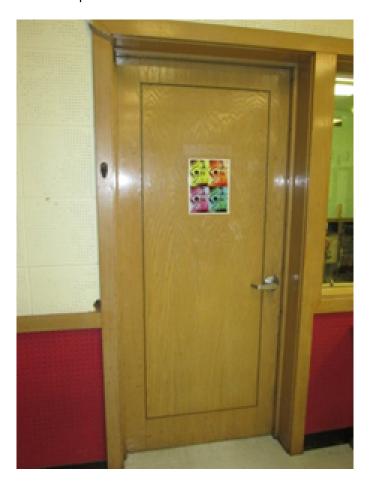
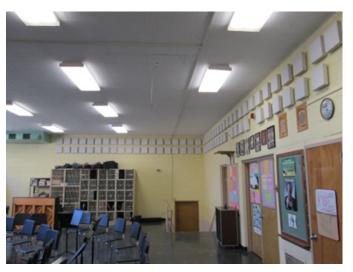
Directly above the Lower Level is the Band, Choir and Music area. The orchestra and band rooms are generally worn and in need of renovation. These spaces have been made accessible by the addition of a lift and a ramp but spatial organization is poor and should be considered for general overhaul. Rooms in this area have either VCT or vinyl asbestos composition tile which are generally in good condition. The ceilings are 1'x1' acoustical tile which is in fair condition. The walls of the band room and practice rooms also have portions covered with the acoustical tile. The orchestra room has painted block walls with small acoustical panels on the walls.

- 16. Remodel the band, choir and music area.
- 17. Repair damaged wall in speech room.
- 18. Renovate auditorium lobby and replace lighting.
- 19. Repair or replace the casework and countertops within the Tech Ed classroom that are damaged.

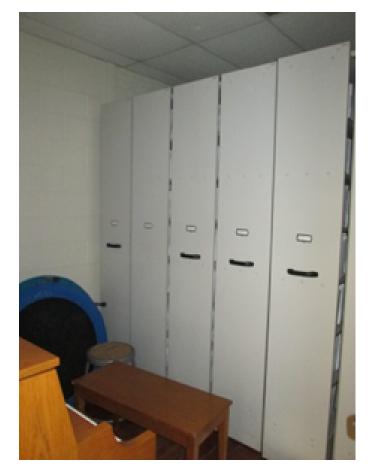
The chorus room is the old stage for the south gym. The chorus room has a wood floor and a 2×4 lay-in acoustical ceiling which are in good condition. The music room has VCT flooring and a 2×2 lay-in acoustical ceiling, both of which are in good condition. One of the practice rooms contains space saving music storage.

There is a lift and ramp in this area to allow for ADA accessibly to the music rooms. Acoustical doors are wood with wood frames and are outdated. There is also wood paneling on the walls.

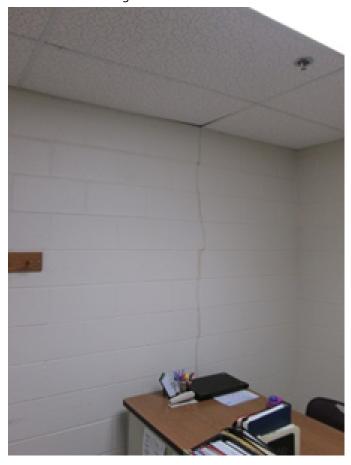
In the speech office there are issues in the masonry wall with vertical cracking at the wall.

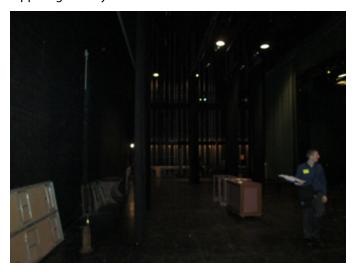
The auditorium has carpeted aisles which are in fair condition. The seating is in good condition. The sealed concrete under the seating is in good condition. Finishes appear generally dated but are otherwise serviceable.

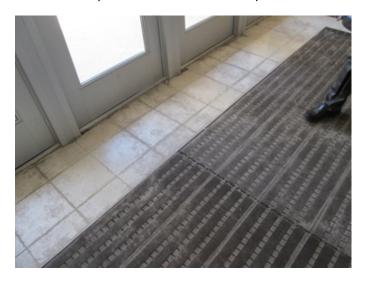
The exterior entrance at the auditorium lobby has VCT floor that is in poor condition and needs replacement.

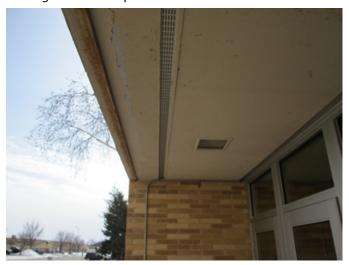
Also, the soffit outside this vestibule is peeling paint and rusting and needs repairs.

- 6. Investigate and repair the building façade cracks and water stains.
- 7. Repair the loose fascia and soffit.
- 8. Replace six (6) steel entry doors.

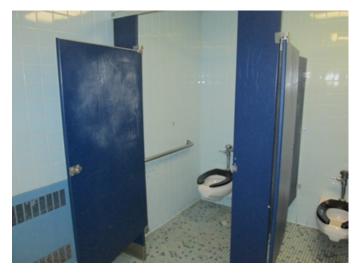
The Tech Ed area's main hallway ceiling is an aged 2 x4 layin acoustical ceiling which should be replaced. The toilet rooms adjacent to this hallway are aged, but the tile is in fair condition, the toilet partitions, however, are in poor condition. These toilet rooms need to be renovated.

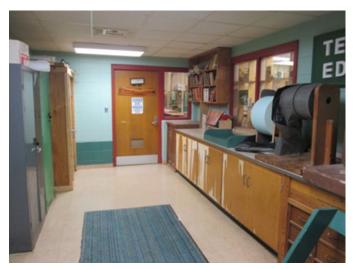
There is some casework located at in this area that is in poor condition and should be replaced.

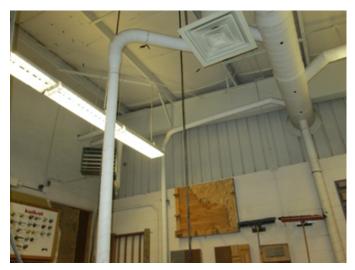
All of the exterior swing doors/frames in the Tech Ed areas are rusty and should be repaired and repainted. The graphic arts classroom has 2x2 lay-in acoustical ceiling tile, some of which is water damaged and should be replaced. The areas are in generally good repair. The woods, power and auto mechanics and metal shop all have exposed structural ceilings. Some of the ceiling insulation panels have damage, are peeling and should be repaired.

- 20. Repair insulated ceiling panels in Tech Ed area.
- 21. Renovate/ Enlarge the girls locker room to Title 9 compliant.
- 22. Review the IMC to reconfigure or enlarge in conjunction with the career center.

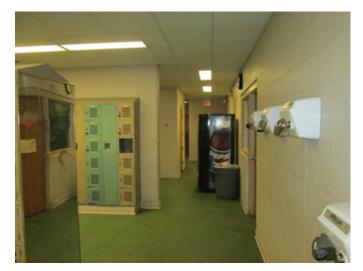
The north gym has a wood floor which is in good condition. The adjacent locker rooms have poured floors, which are in good condition. The ceilings are vinyl wrapped gypsum board lay-in and are in good/fair condition, approximately 30% of the ceiling panels are damaged and should be replaced within the boys locker room. Within the boys team locker area approximately 20% of the lockers are damaged and should be replaced.

- 27. Provide ADA access to mezzanine at south gym.
- 28. Within the locker rooms, repair the damaged ceilings and damaged lockers.
- 29. Replace the damaged art room casework.

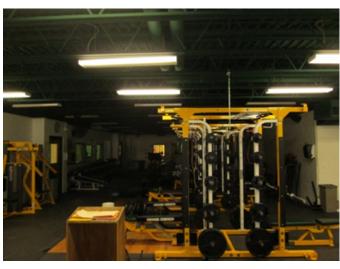
There is a fitness/weight room adjacent to the north gym which has rubber flooring and an open ceiling. Both the room and the equipment are in good condition. There is an aerobics room south of the north gym which also has a rubber floor and has a 2x4 lay-in acoustical ceiling, both of which are in good condition.

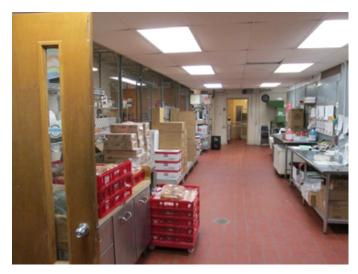
The kitchen area is adjacent to the loading area across the hall. The high school kitchen prepares meals for the entire district. The kitchen and storage area are undersized for the size of the high school. Access is difficult for deliveries.

The ceiling in the storage area is a 2 x 4 lay-in acoustical ceiling which is in poor condition. This ceiling should be washable, it is not. Some of the freezer/refrigerator panels are rusting and should be repaired. There are wall sections missing due to remodeling that should be repaired. The flooring throughout the storage and kitchen areas is quarry tile which is in good condition. There is inadequate storage. The entire loading / unloading / storage / kitchen / serving / dish washing area should be redesigned and remodeled to the correct size and configuration to meet the building and district food service expectations.

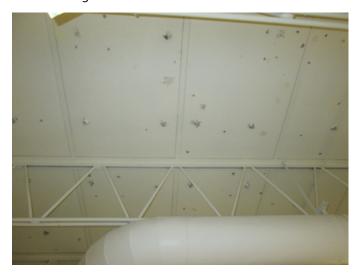
The art rooms have painted concrete floors some of which are worn and should be re-painted. The ceilings are exposed structure, 1'x1' acoustical tile or a 2 x 4 lay-in acoustical ceiling some of which should be replaced due to water damage.

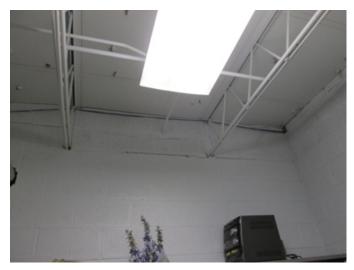
Most of the casework is damaged and should be replaced. There is also damage that needs to be repaired where the exposed structure meets the masonry wall.

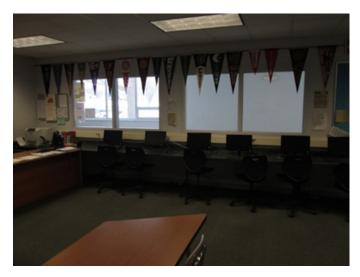
The career center and alternative education area are located on the far west of the building. The area is carpeted which is in good condition. The ceiling is a 2×2 lay-in acoustic ceiling. These classrooms appear to be oversized and underutilized but are otherwise in generally good condition.

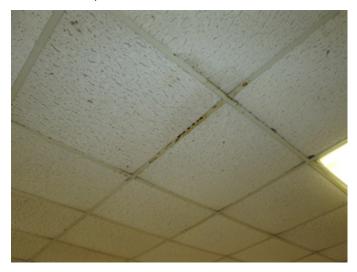
In general the interior door frames and doors are in fair/poor condition and should be repainted/refinished. Also, in most areas, ceiling tiles are stained and some of the grid needs to be replaced.

- 32. Replace old and/or damaged ceiling tile and grid throughout the building (multiple locations).
- 33. Remove remaining vinyl asbestos floor tile and replace with vinyl composition tile.

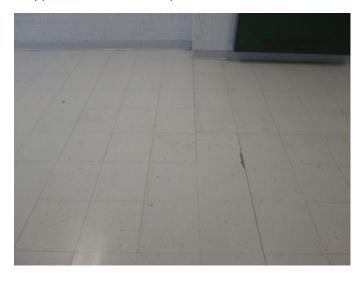
In corridors, there are a lot of instances of VCT tile being chipped and needs to be repaired.
