facility survey

Beaver Dam Unified School District

Beaver Dam, WI PRA Project #114442

December 2011

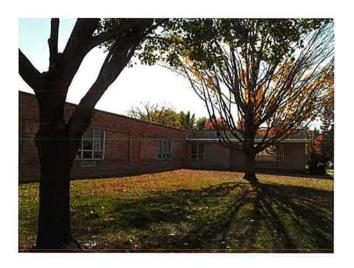
The façade is in generally good condition, but there is a cracked precast concrete window head on the west side of the building.

- 1. Replace the single glazed window systems with double glazed systems.
- 2. Patch the broken precast concrete window head trim.
- 3. Replace the oldest sections of the roof.

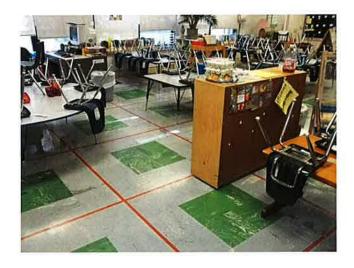
Some of the original vinyl asbestos tile which is in good condition is visually distracting, such as the tile located in several kindergarten rooms.

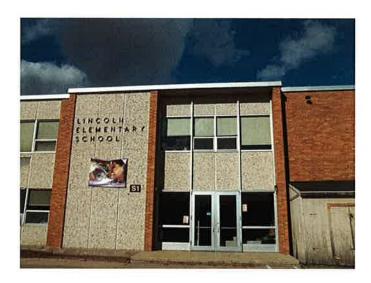
The windows are single glazed and should be replaced. The overhead light fixture on the north side of the building has exposed wire connections that should be repaired.

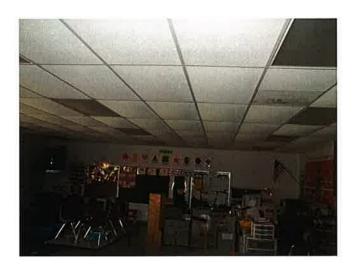
The classrooms generally have 2x4 acoustical lay-in ceiling tile which is in fair condition due to the fact that they are 'bellied' due to moisture absorption and sagging, but there are areas of water stained ceiling tile that should be replaced. Some of the window stools are delaminating.

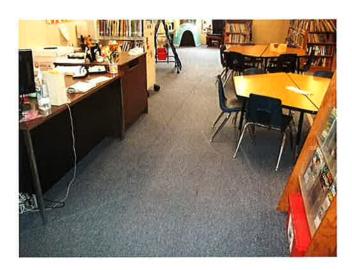
The library and computer lab have older carpet which should be replaced.

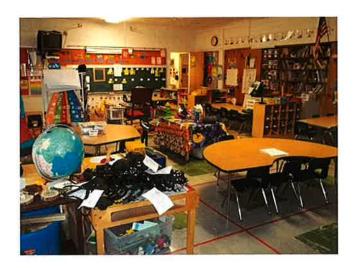
Some of the original vinyl asbestos tile which is in good condition is visually distracting, such as the tile located in several kindergarten rooms (visible in photo).

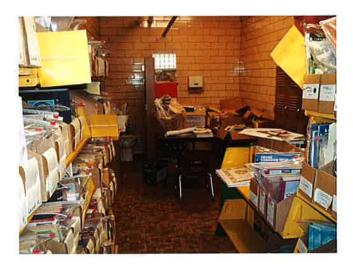
The old locker rooms are now used as storage. The doors/frames to the rooms are damaged/rusty. The hallway to the area is poorly lit.

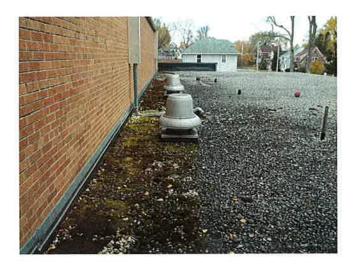
There is moss growing on a section of roof adjacent to the gym which should be removed.

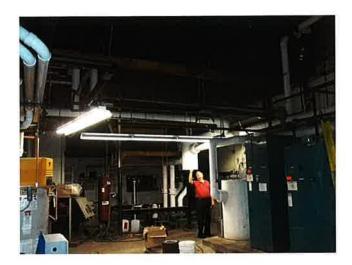
The main boiler and electrical service area is located below the first floor to the northwest of the building. The hallway/stairs leading to this area has damaged walls, damaged stairs and damaged ceilings, all of which should be repaired/replaced. The boiler area is subdivided into three basic rooms, the westernmost room serves no purpose and should be filled in to minimize ongoing maintenance and water infiltration.

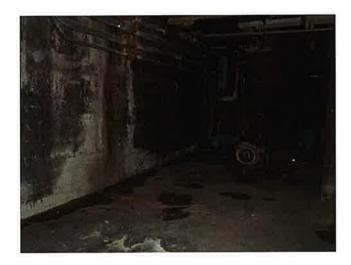
The eastern section of the boiler area houses electrical panels, electrical distribution and an elevator machine room. This area has extensive water infiltration issues. The top of this area is a parking lot. There is evidence of rusting rebar in the roof area and extensive damage to the active electrical conduit running through this area. This area should be further reviewed for struc-

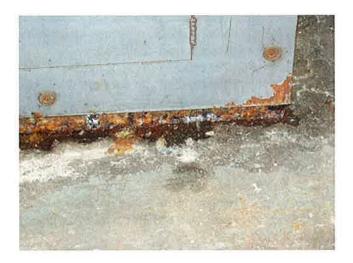
Electrical junction boxes and conduits in the adjacent room show significant rust due to water leakage in the space. This equipment needs to be replaced after the water infiltration problem is resolved. This condition has a high probability of creating an unscheduled outage that could leave a significant portion of the school without power for an extended period of time.

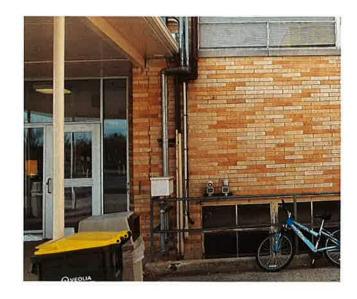
There is some loose fascia along the western façade that should be repaired. There is also a double-pane window section that has a failed seal which should be replaced. The interior courtyard, inclusive of the greenhouse contains single-glazed curtain wall which should be either infilled with a masonry wall and windows or replaced with a more energy efficient system. The greenhouse partial height wall shows extensive water staining and freeze/thaw damage. These walls should be replaced or repaired. The doors to the courtyard should receive new weatherstripping (BDUSD Update: repaired).
