2018 Facility Assessment Plan

Prepared by:

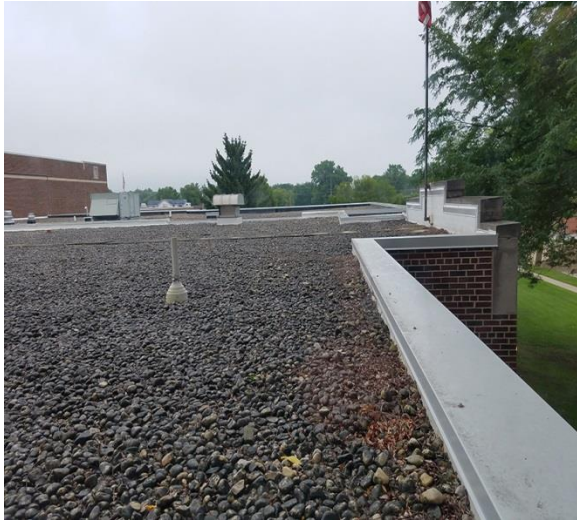
Existing Ballasted TPO Roof

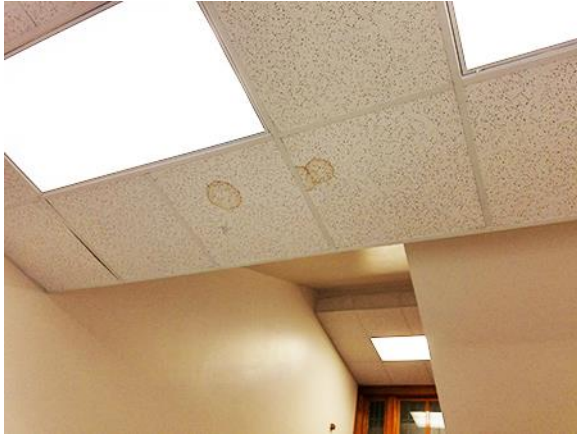
Ceiling Tile Staining at Stair S3

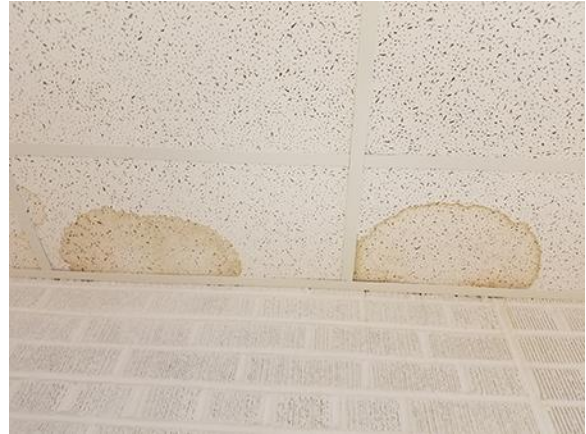
Ceiling Tile Staining at Library

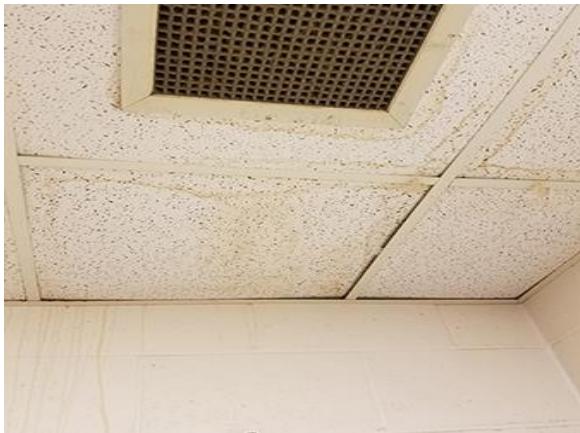
Ceiling Tile Staining at Storage Room

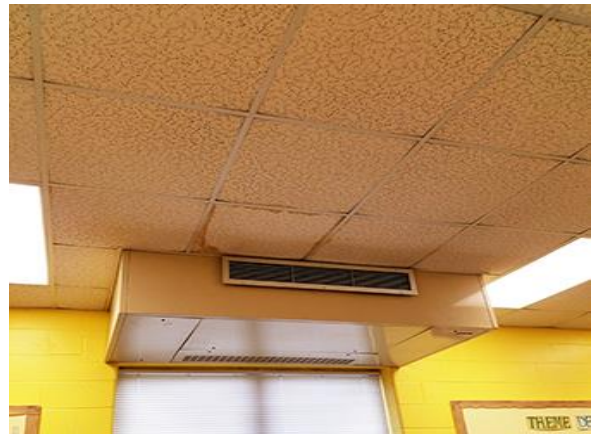
Ceiling Tile Degradation/Staining at Classroom 324

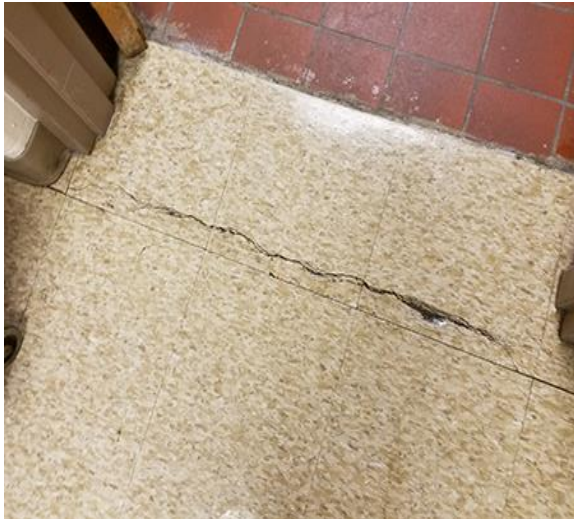
Damaged Vinyl Tile at Room Entry

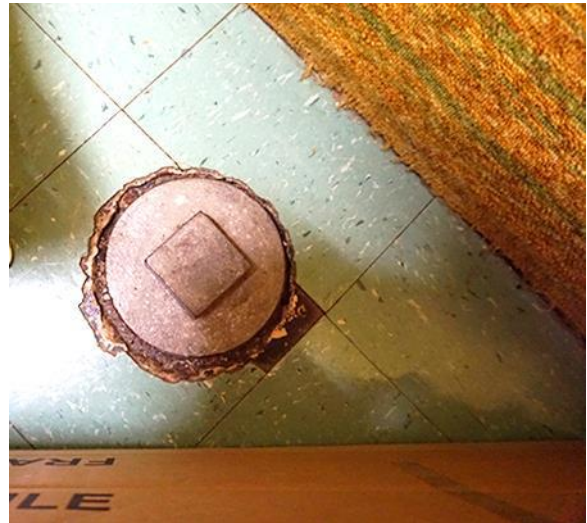
Vinyl Tile Deterioration at Penetration in Music Room

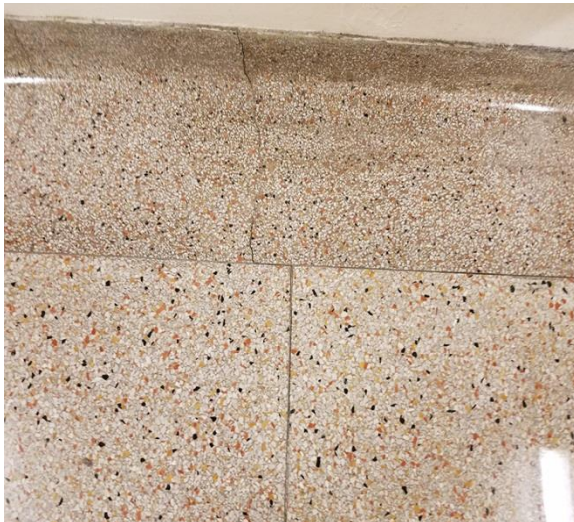
Cracked Terrazzo at Corridor

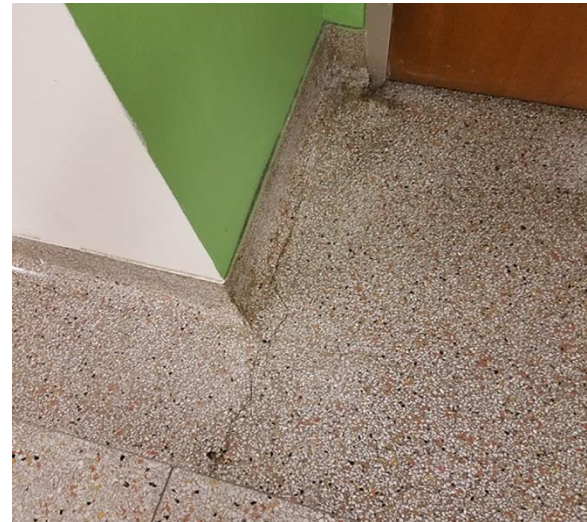
Cracked Terrazzo at Room Entry

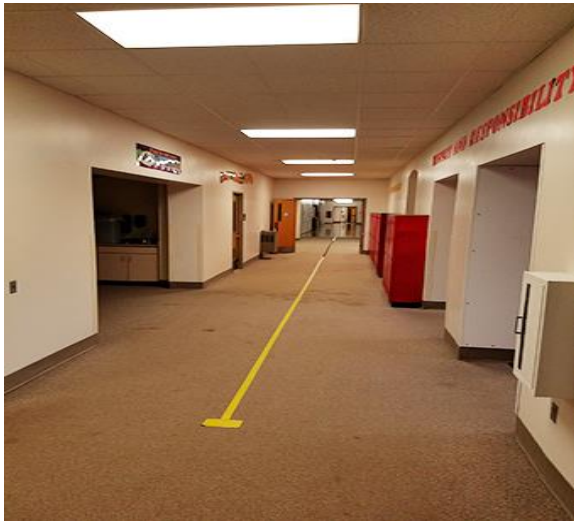
Heavy Staining at Corridor Carpet

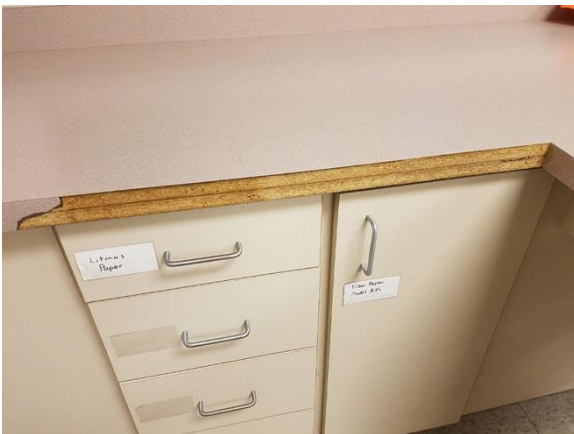
Damaged Plam Counter at Room 206

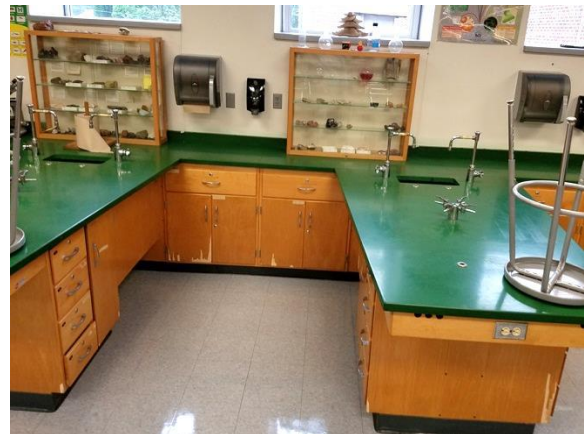
Damaged Base Cabinets at Room 306

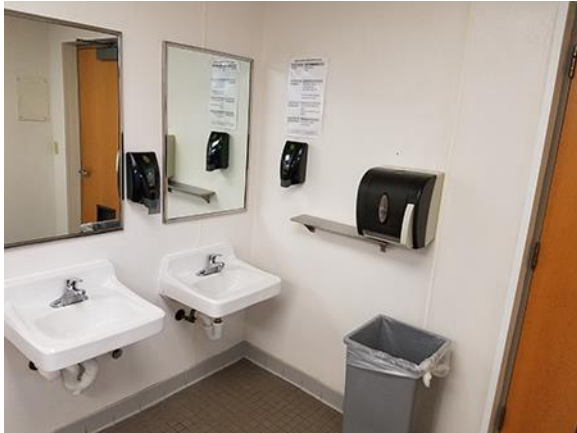
Mirror Not at ADA Compliant Height

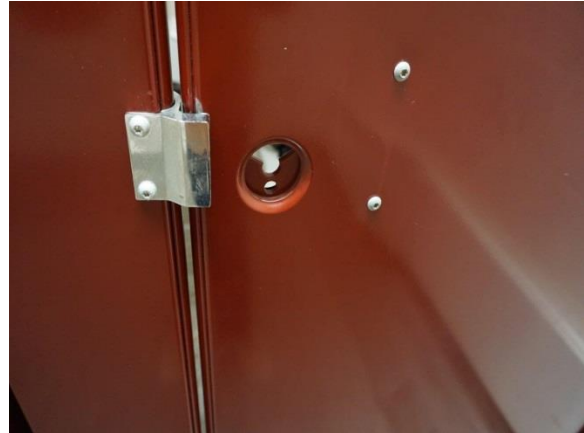
Missing Privacy Lock

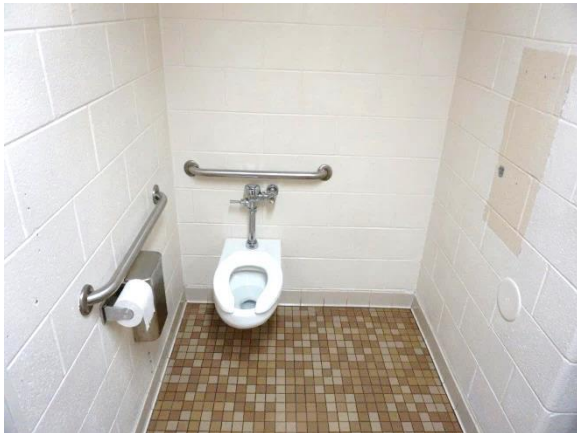
Missing Vertical Grab Bar

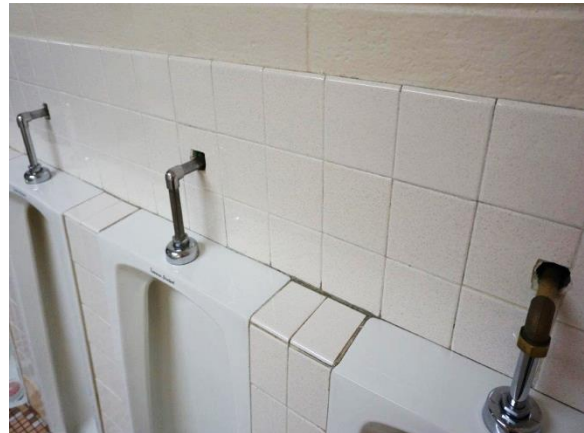
Missing Escutcheon around Plumbing Pipes

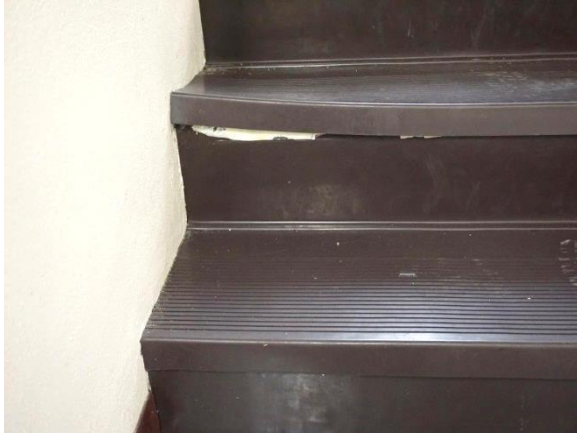
Delaminating Stair Tread

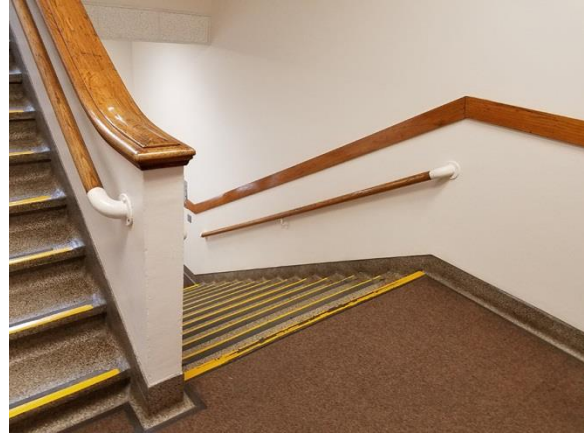
Missing Handrail Extensions at Stair S3

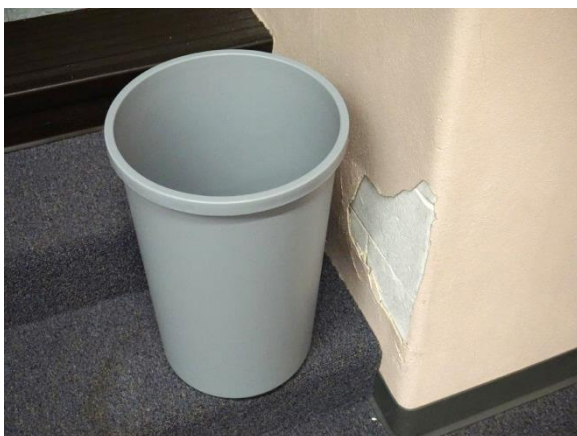
Missing Plaster at Base of Wall

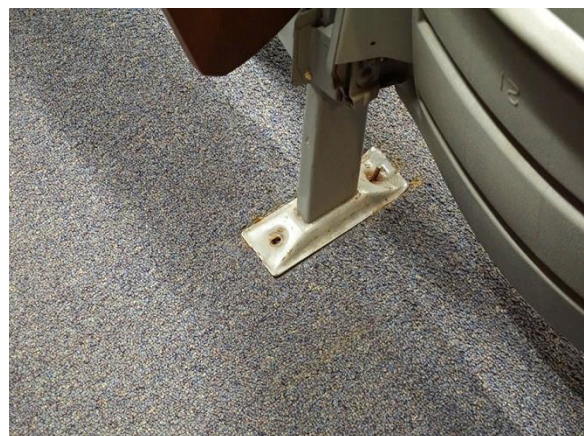
Missing Hardware at Auditorium Seats

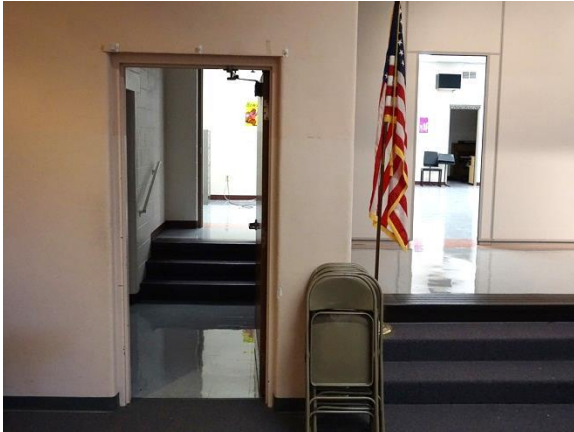
No ADA Access to Stage Area

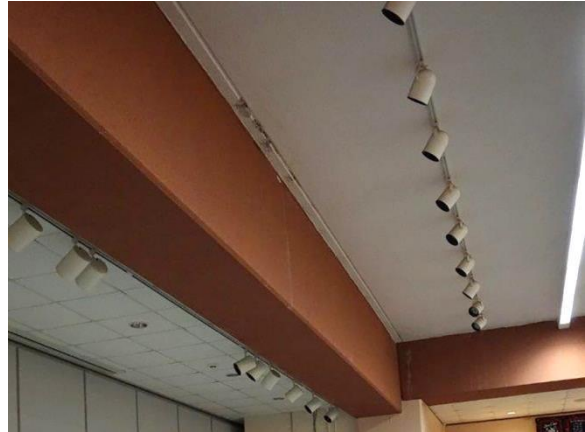
Ceiling/Bulkhead Staining From Leaking Roof

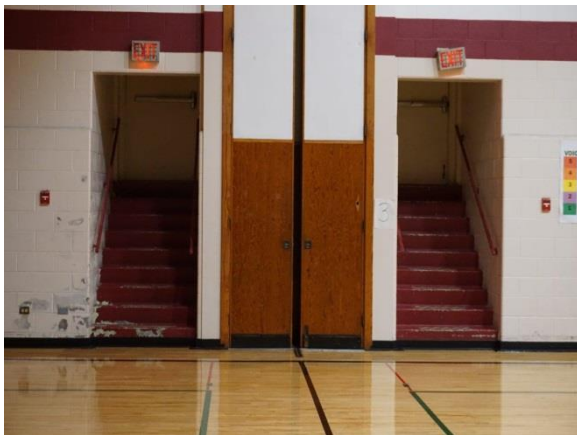
Exits Include stairs to reach grade at the Exterior

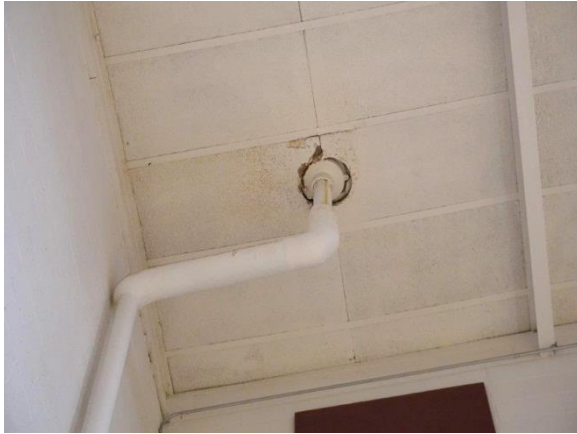
Roof Leak at Roof Drain/Conductor

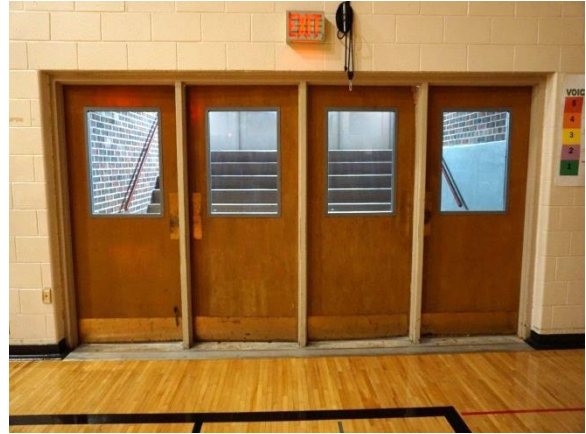
Missing Panic Hardware at Exit Doors

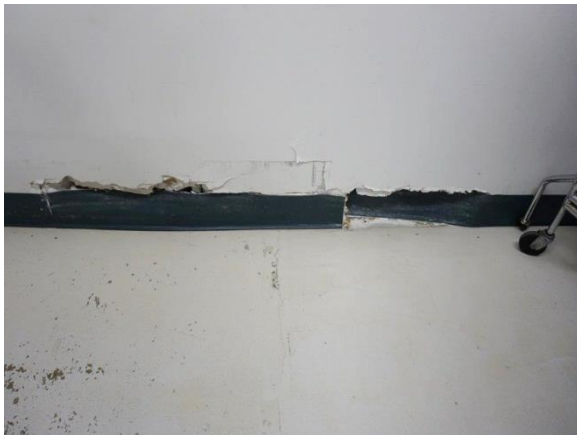
Damaged Wall and Base

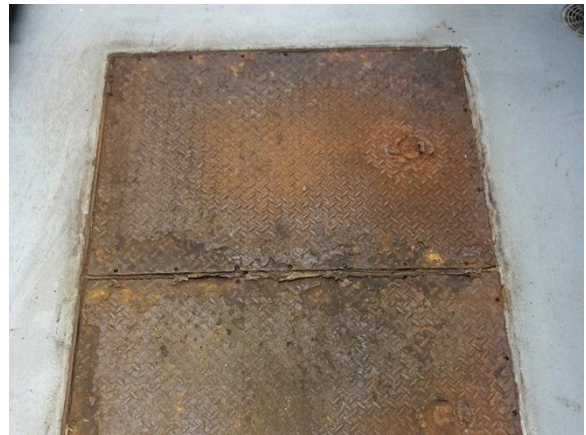
Rusted Floor Access Cover

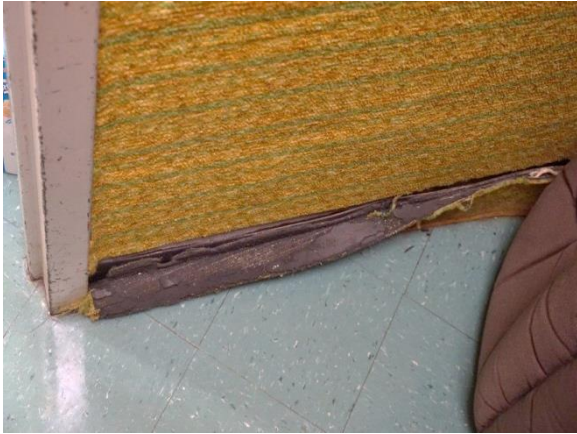
Damaged Fabric Wall Covering/Base

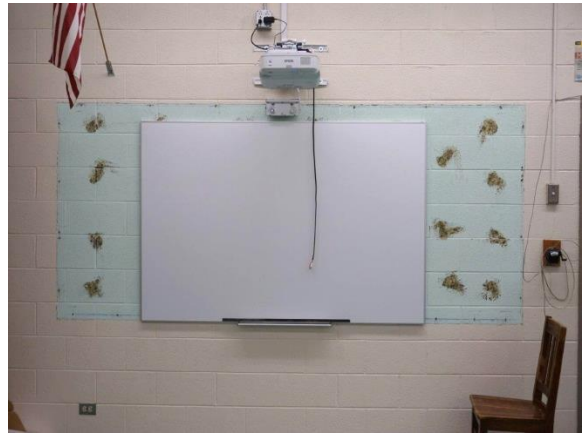
Exposed Whiteboard Attachment Area

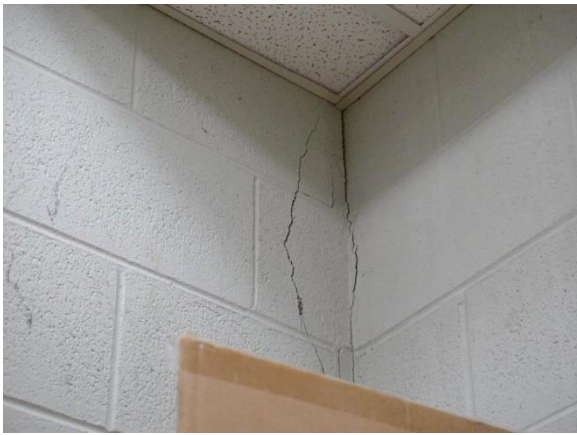
Structural Cracking at Masonry Wall Corner

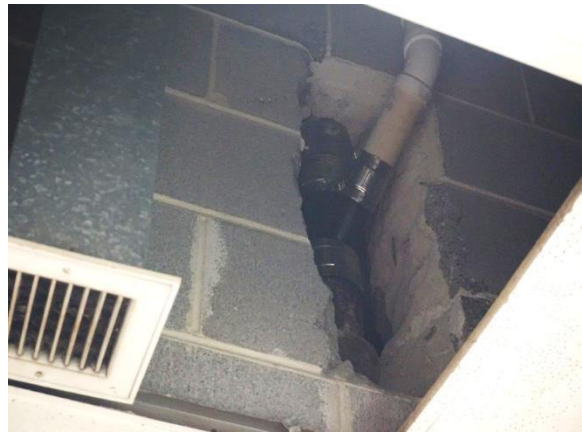
Missing Ceiling Tile Exposing Plumbing Penetration into Masonry Wall

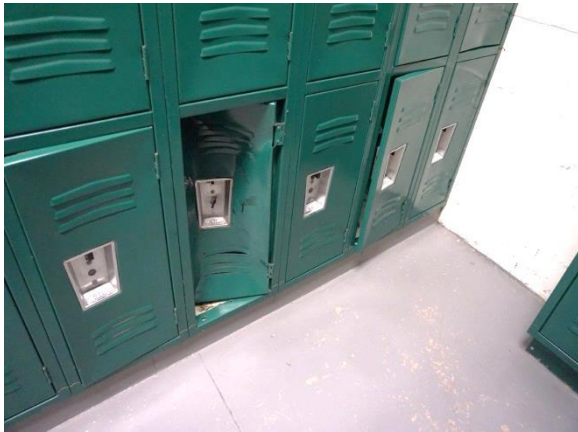
The main gym was observed to be in good condition. There were no visible signs of paint chipping/peeling, flooring degradation, etc. There was an area at the roof conductor where staining could be seen due to water leaking at that area. The locker rooms did not include many ADA provisions such as vertical grab bars at toilet rooms, accessible benches, accessible showers, required turning radius allowance, etc. Also, many lockers were heavily damaged. Showers in the toilet rooms that were reported to be abandoned should be removed and plumbing capped. Recommend to retrofit locker rooms to comply with current ADA provisions and replace damaged lockers.

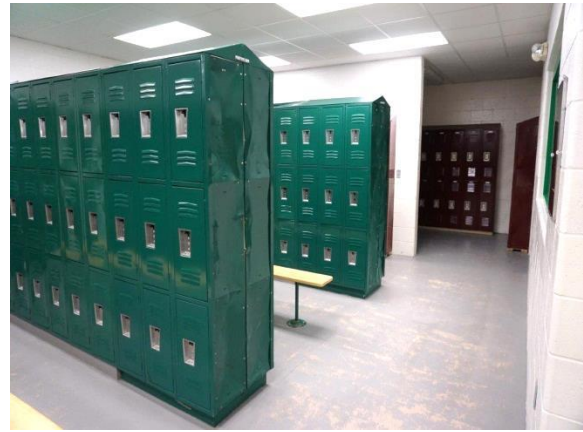
Damaged Lockers and Non-ADA Compliant Bench

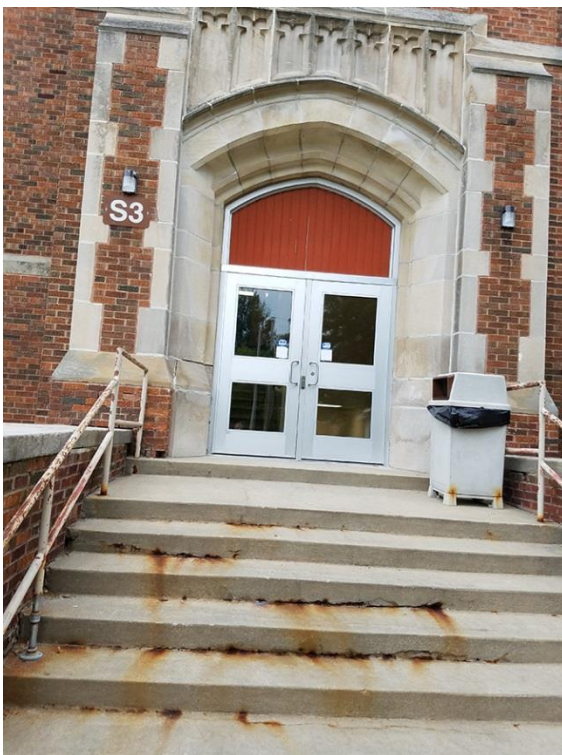
Exposed/Rusted Steel at Stair Risers

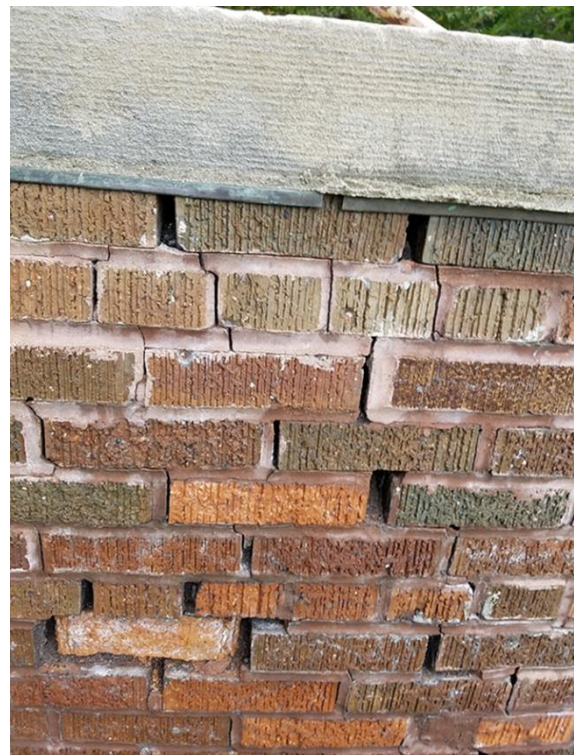
Cracked, Deteriorated Bricks, Missing Mortar

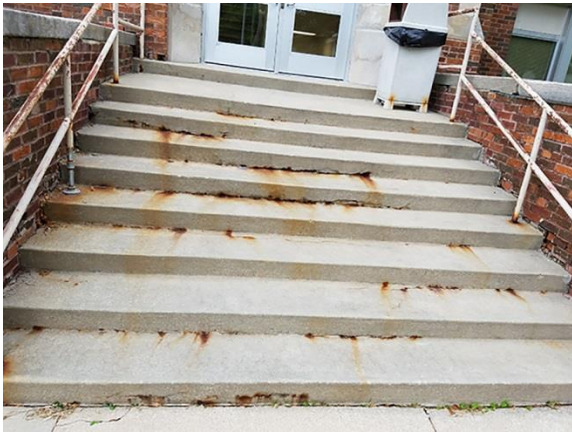
Deteriorated Exterior Stairs and Railings

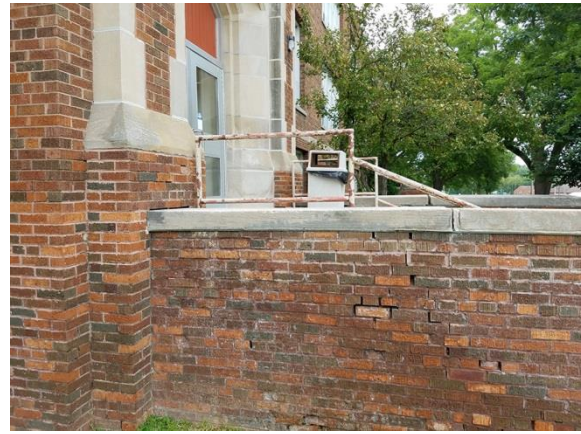
Heavily Deteriorated Masonry Stair Wall and Cap

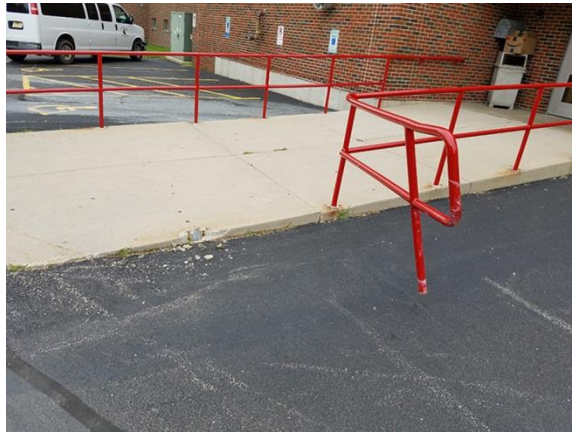
Damaged Exterior Railing

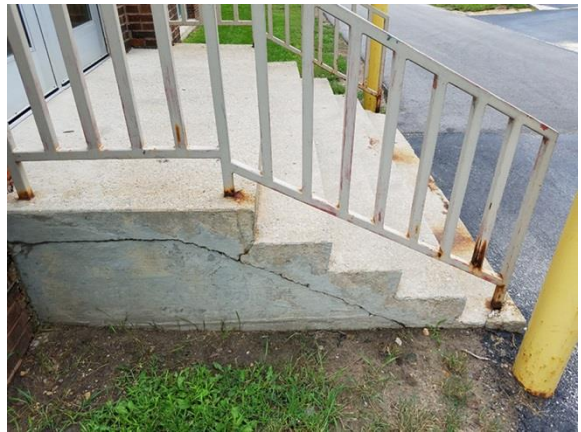
Rusting Railing Connections and Exposed/Rusting Steel

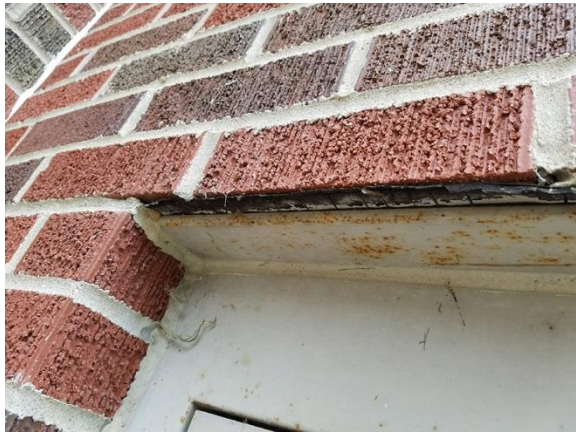
Rusted Lintel, Deteriorated Caulk/Flashing

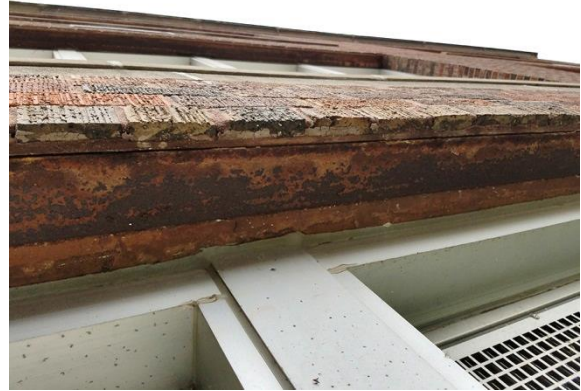
Rusted Lintel, Deteriorated Caulk/Flashing

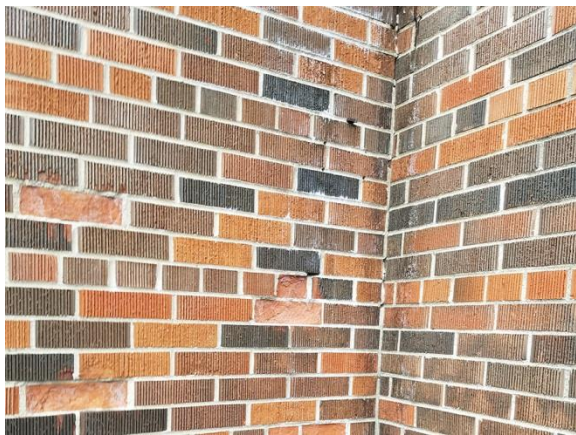
Brick Spalling at Corner

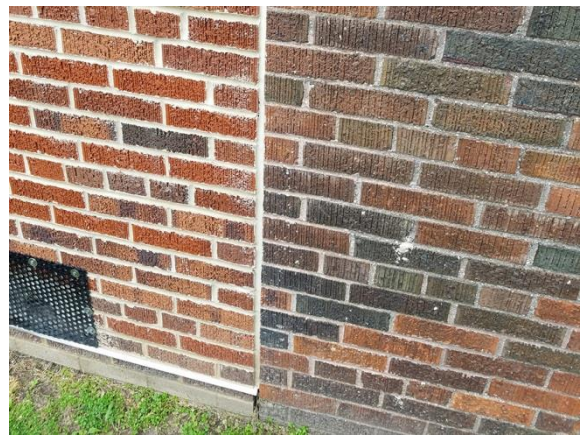
Lack of Weeps/Flashing at Base of Old Construction vs. New

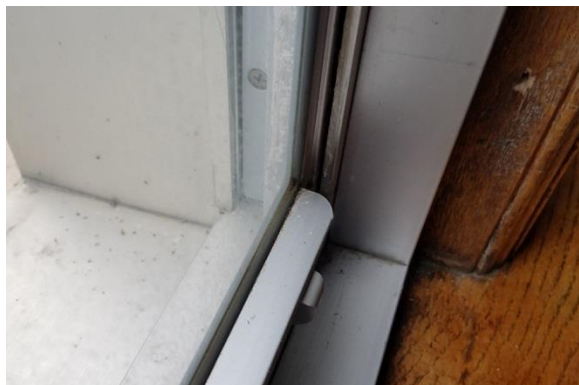
Single Pane Glazing at Original Building Classrooms

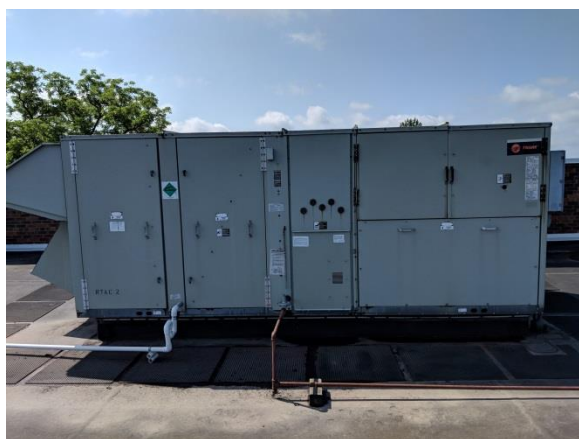
The mechanical room has an automated ventilation system that consists of a supply fan and isolation dampers to control the amount of outside air being pulled in. The typical life of an inline centrifugal fan is 25 years and the dampers are 15 years; both of which are in good condition.

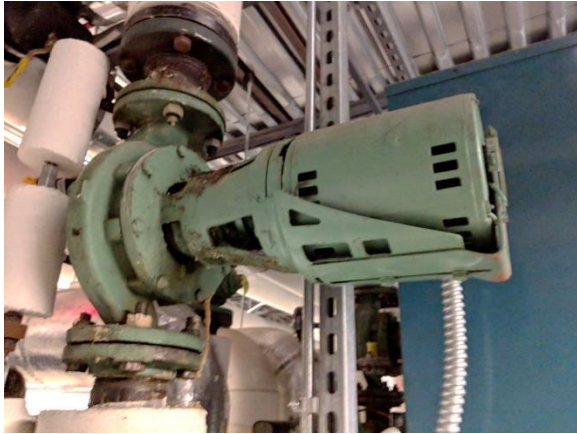
Inline Taco Boiler Pump

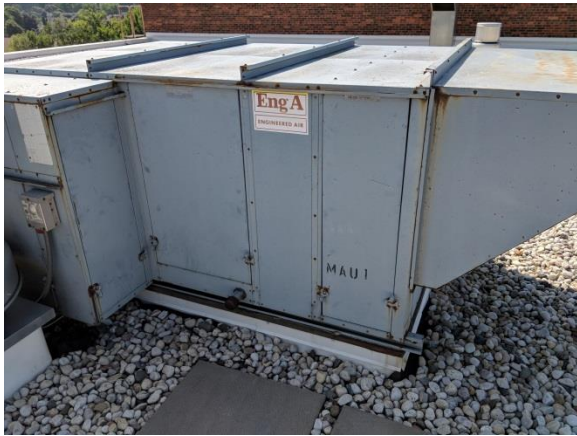
Engineered Air Make-up Air Unit

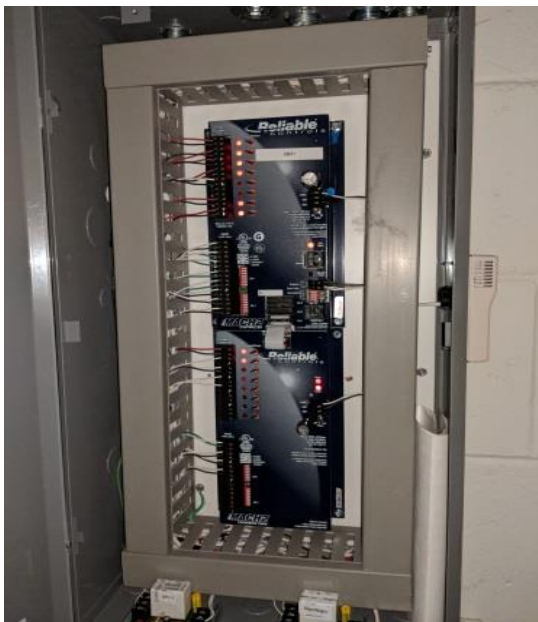
Reliable Controls Main Panel

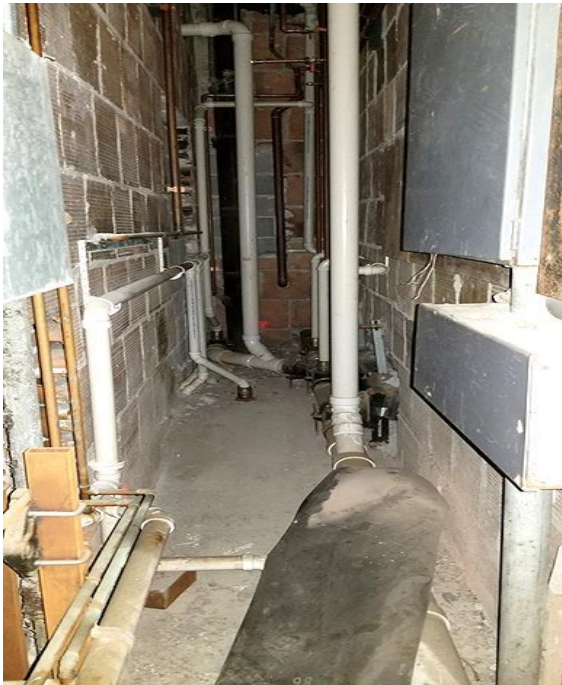
Pipe Chase with Renovated Piping

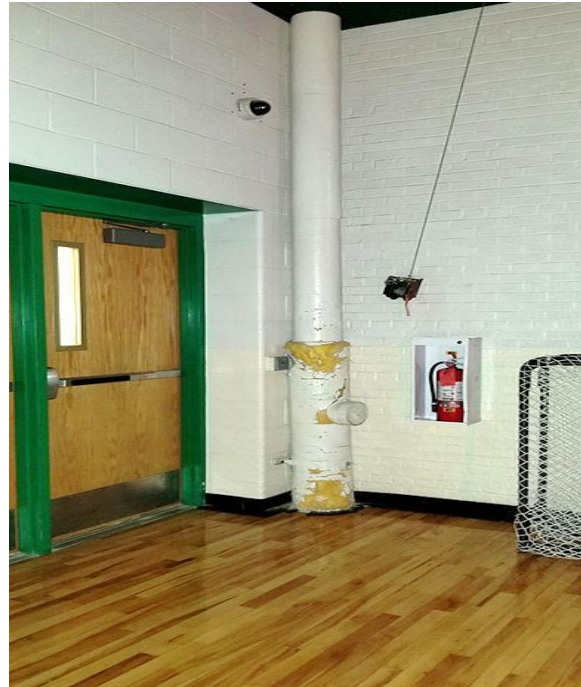
Missing/Damaged Insulation at Roof Conductor

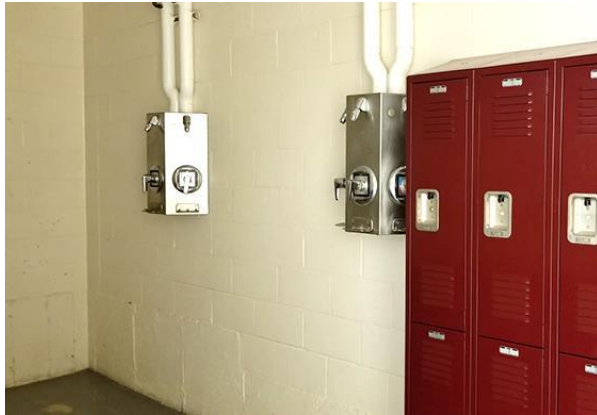
The toilet rooms consist of wall mounted water closets with manual flush valves, wall hung lavatories with manual faucet and wall mounted urinals with manual flush valves. The fixtures are in good condition and ADA compliant. Fixtures have been renovated and remodeled within the majority of the building and building additions. Shower rooms appear to be abandon and used as locker areas. Plumbing fixtures not intended to be used should be removed and capped.

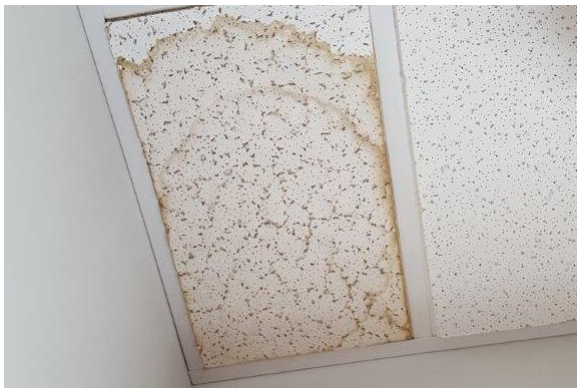
Ceiling Tile Stained at Corridor

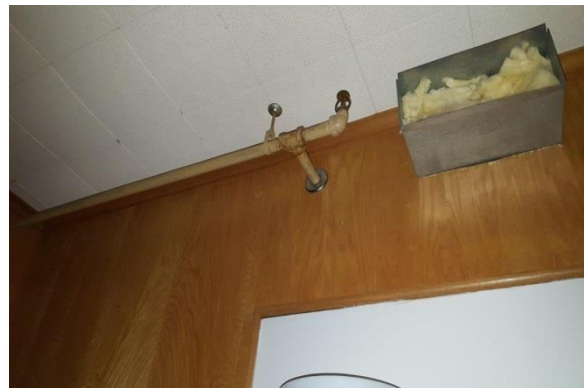
Possible Asbestos-Containing Ceiling Tiles

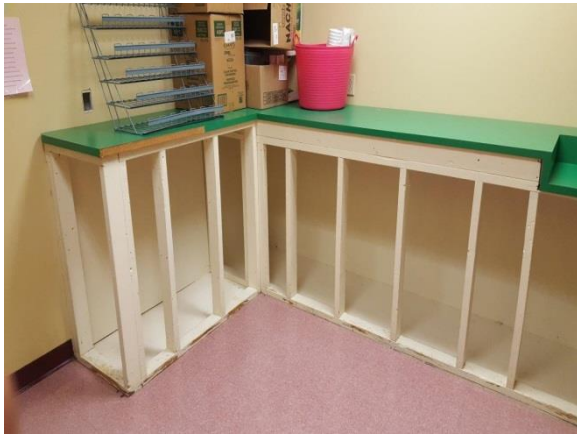
Damaged PLam Counter/Base

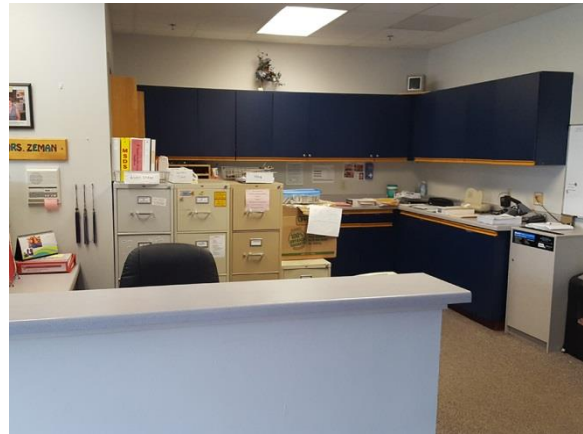
No ADA Transaction Counter at Reception

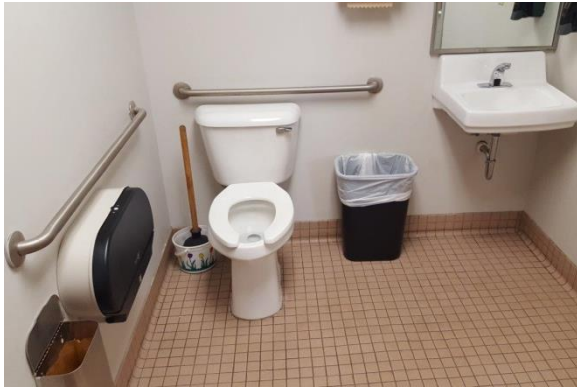
Missing Vertical Grab Bar at Faculty Restroom

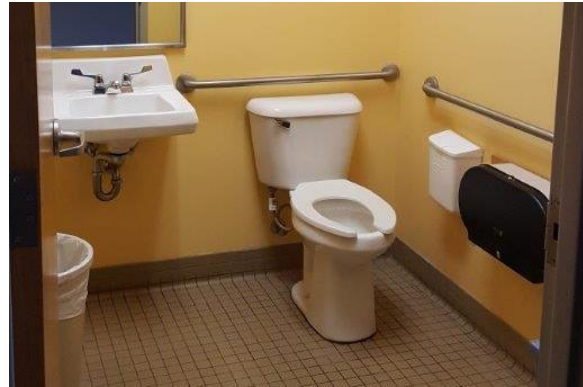
Missing Vertical Grab Bar at Women Restroom

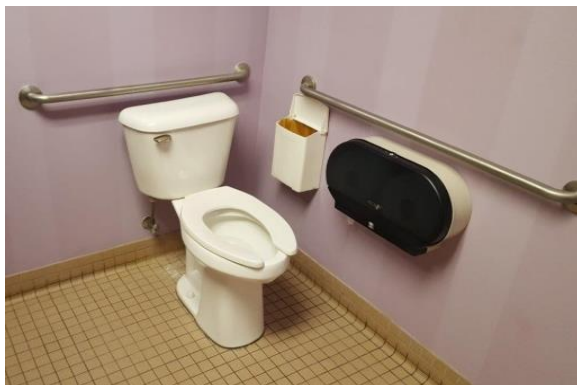
Missing Vertical Grab Bar at Men Restroom

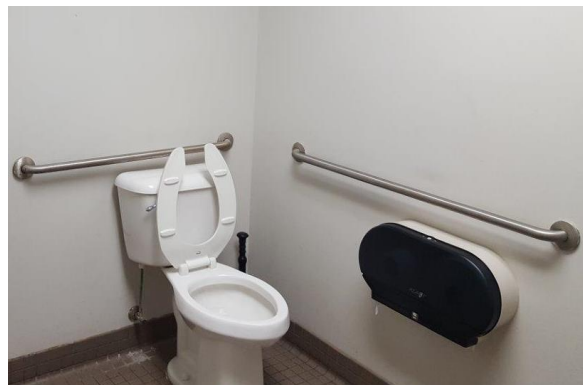
Missing Vertical Grab Bar at Women Restroom 109

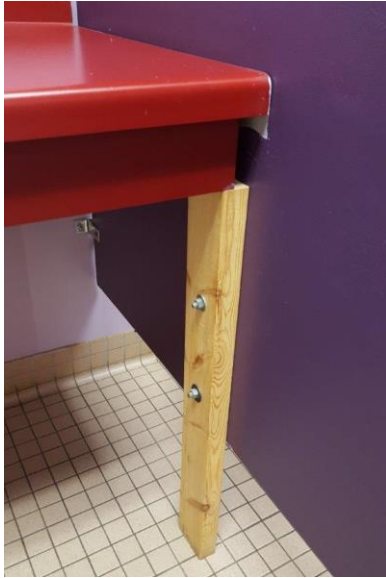
Wood 2x Framing Bolted to Partition at Women Restroom 109

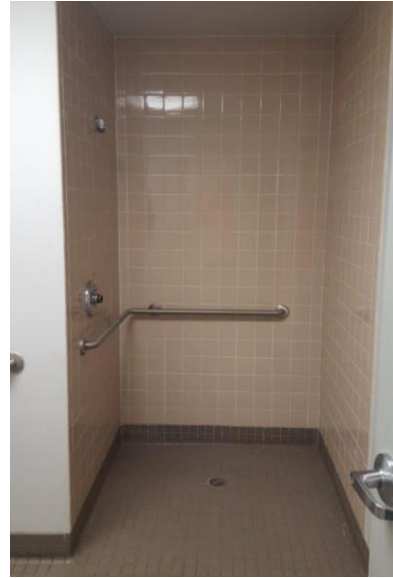
Missing Vertical Grab Bar at Both Men & Women Restroom Shower

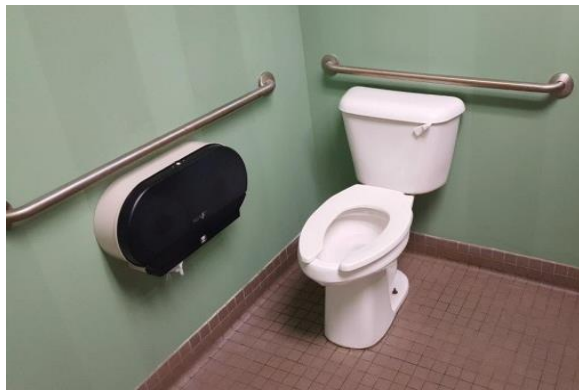
Missing Vertical Bar at Men Restroom 110

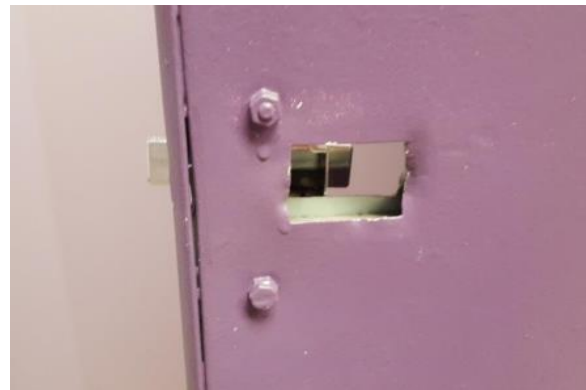
Missing Stall Lock at Women Restroom 109

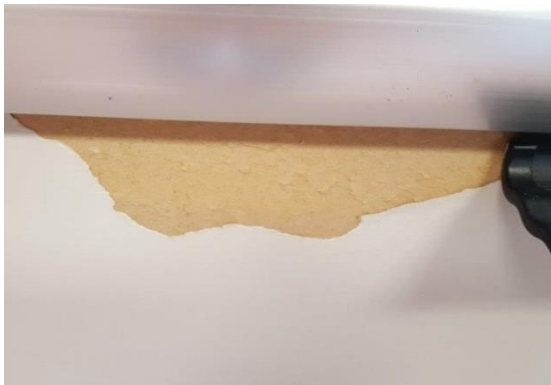
Damaged Gypsum Wall at Classroom

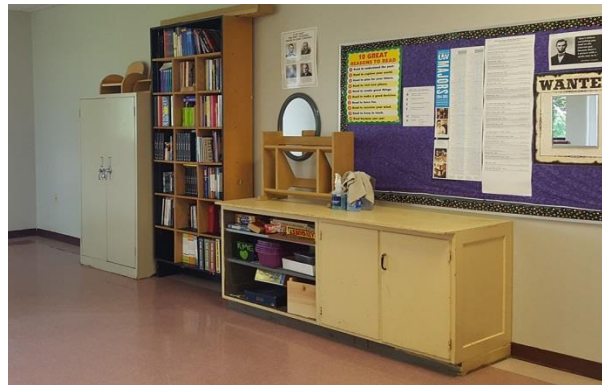
Worn/Scratched Casework

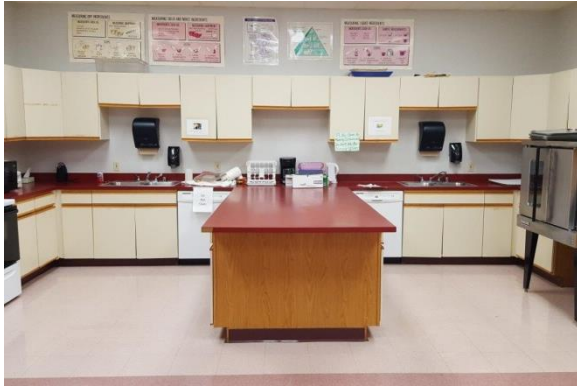
Sinks Don't Meet ADA Requirements

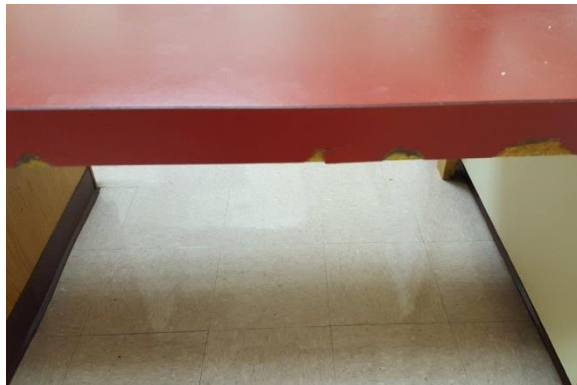
Damaged Countertop Edges

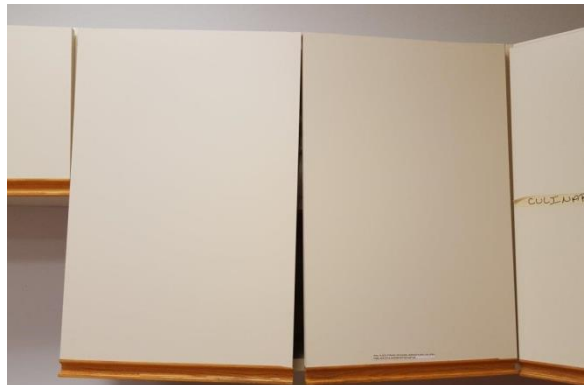
Broken Cabinet Hinges

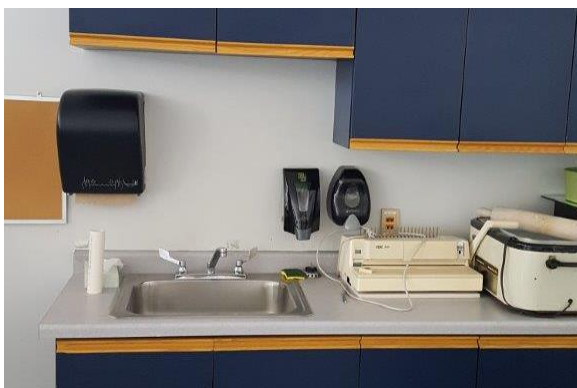
Sink Doesn't Meet ADA Requirements

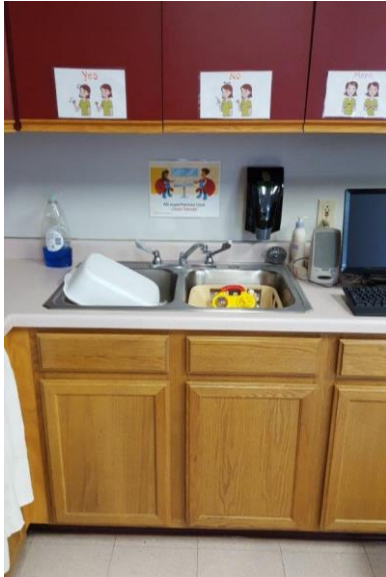
Sink Doesn't Meet ADA Requirements

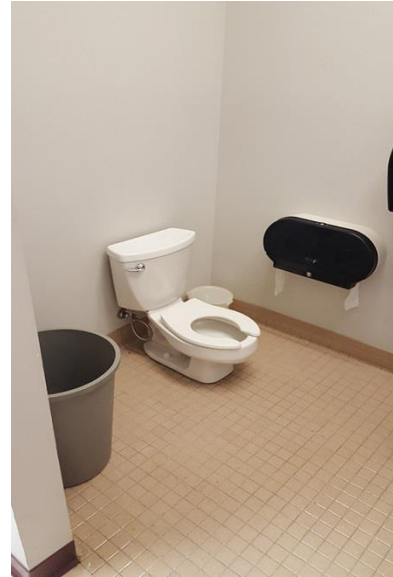
Missing Grab Bars at Child Restroom

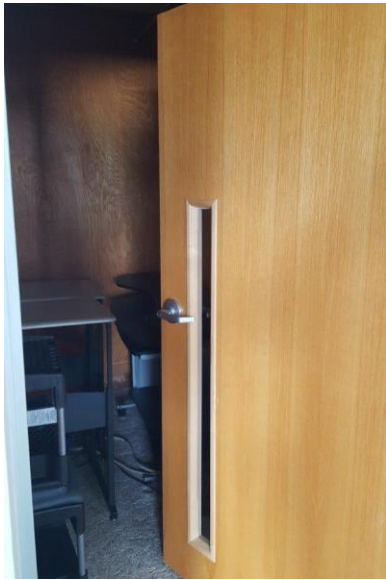
Door Installed Upside Down at Storage Room

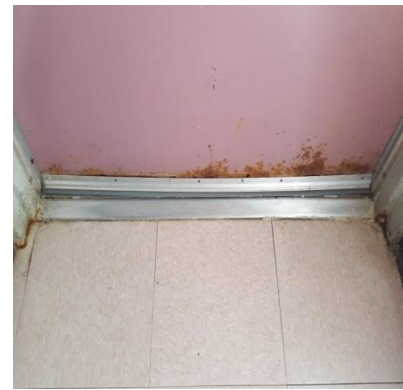
Rust Forming at Base of Exterior Door

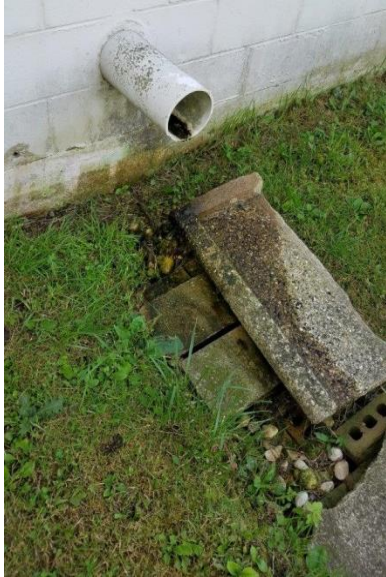
Erosion of grade at Roof Conductor Outlet

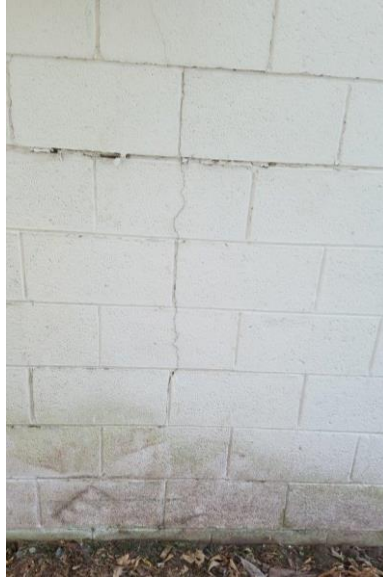
Foundation & Masonry Cracks

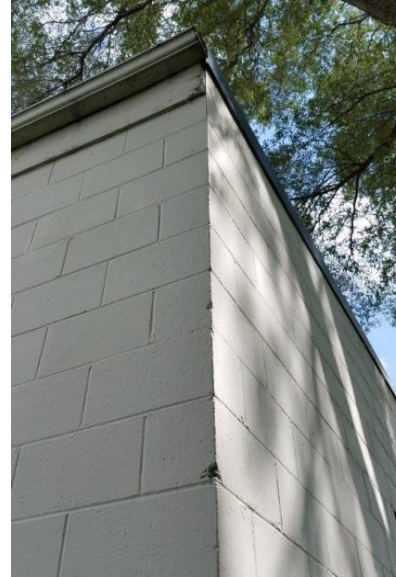
Missing Control Joints

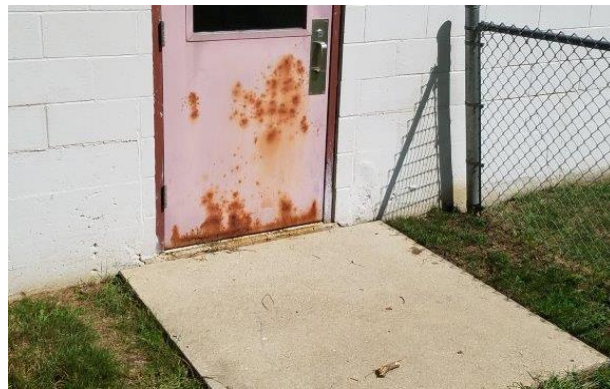
Rusted Exterior Door

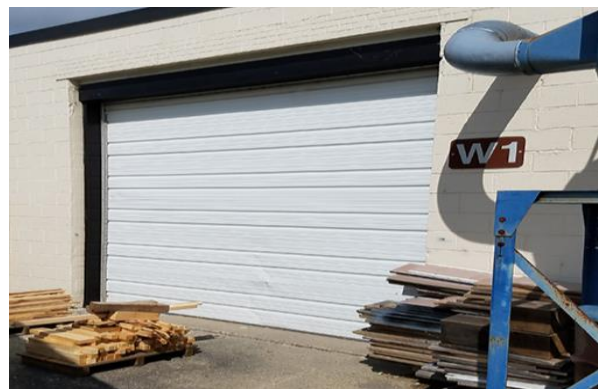
Exterior Overhead Door

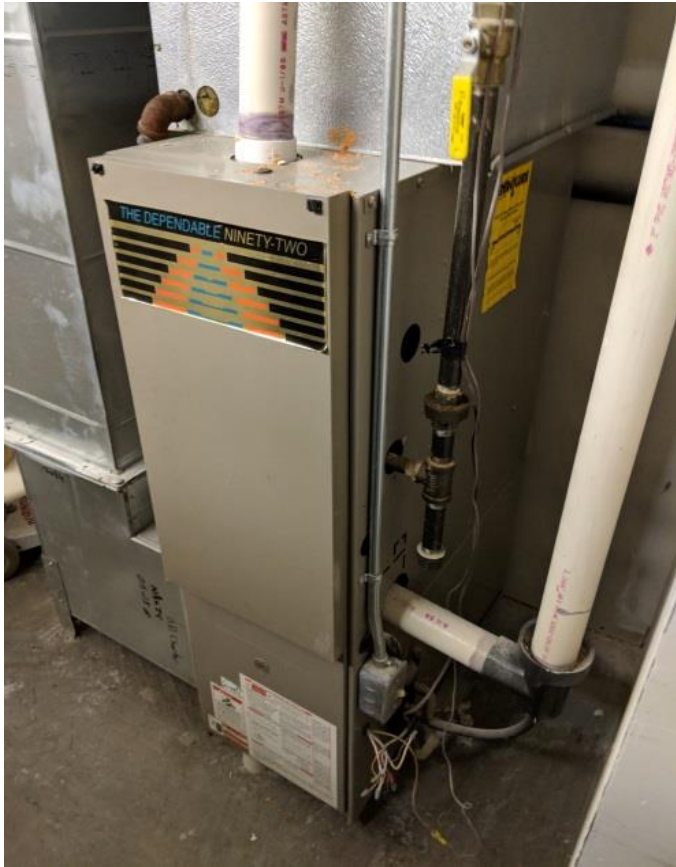
There is a Goodman furnace with an accompanying cooling coil and condensing unit that should be replaced on the roof serving part of the building.

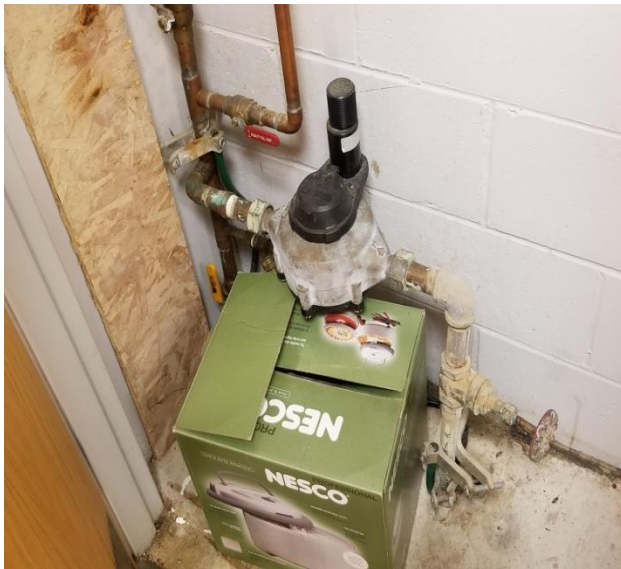
Water Service to Building

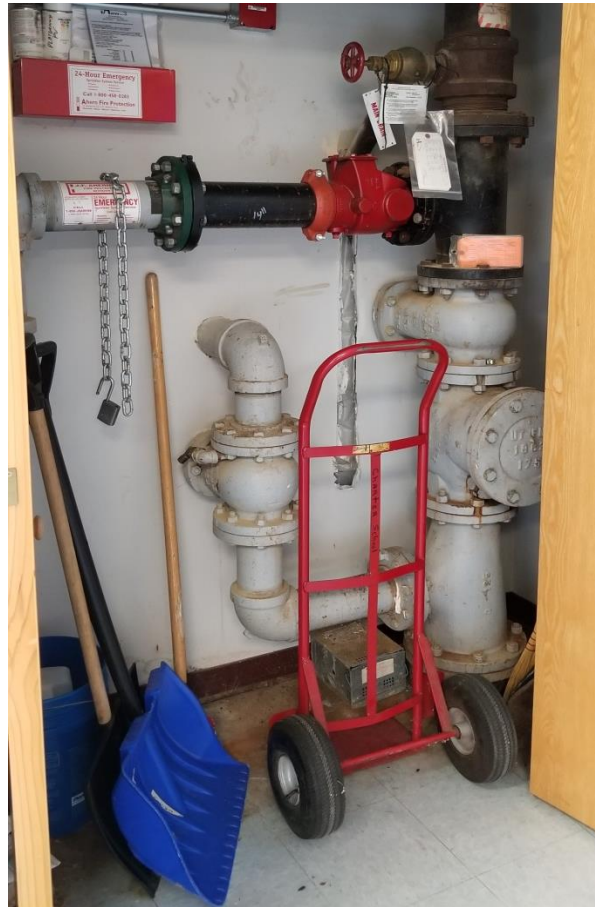
Stand Pipe/Valve for Sprinkler System

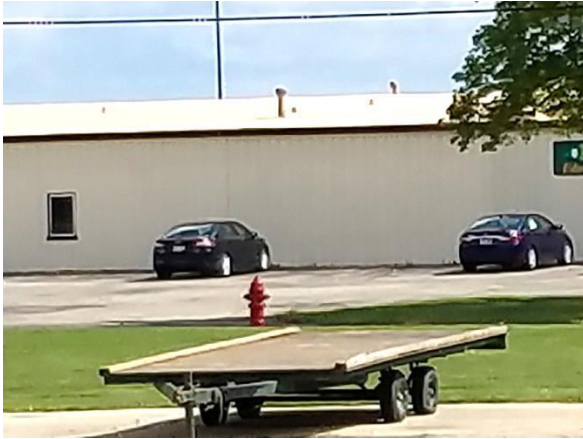
Existing PVC Roof Membrane

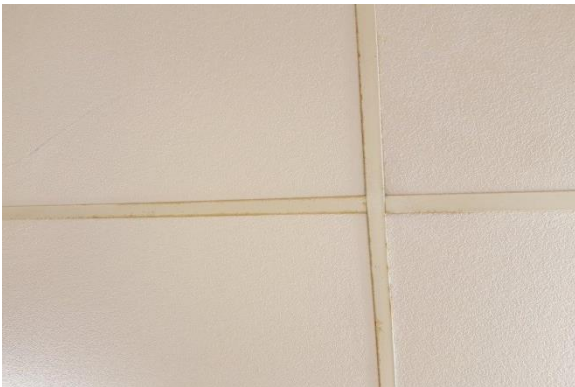
Ceiling Grid Rusting at Women's Restroom

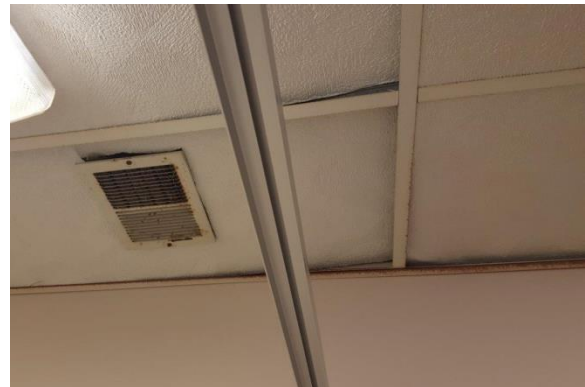
Ceiling Tile Rusted & Damaged at Men's Restroom
