2018 Facility Assessment Plan

Prepared by:

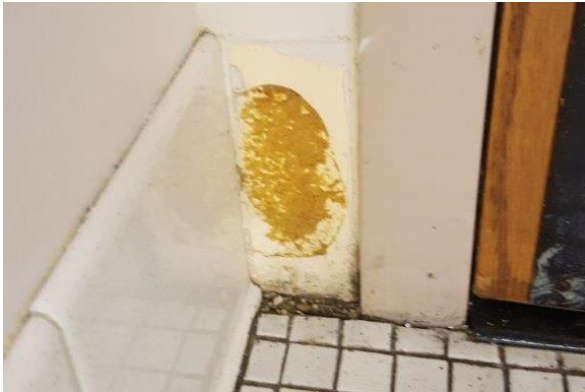
Missing Tile Base at Girls Restroom

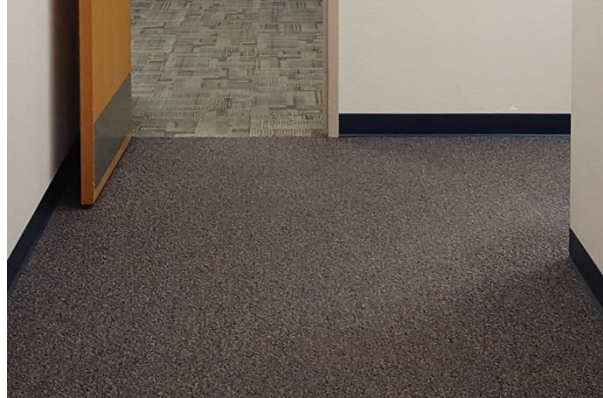
Carpet Transition at Corridor

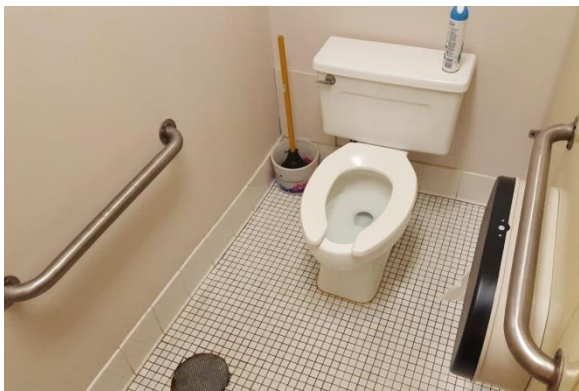
Missing Vertical Grab Bar and Clearance Issue at Women's Restroom

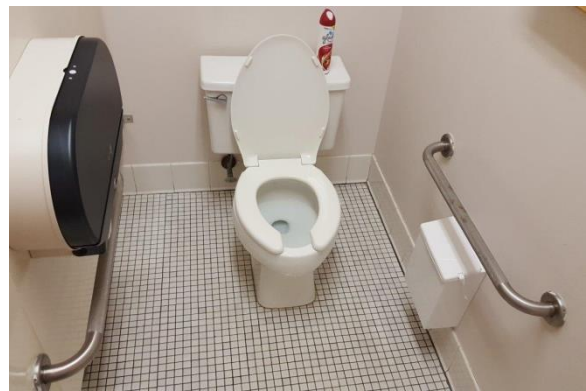
Missing Vertical Bar and Clearance Issue at Men's Restroom

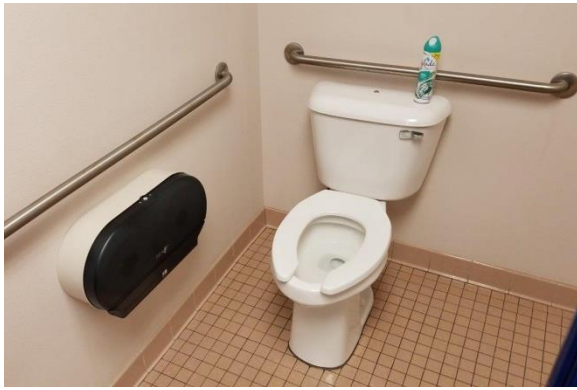
Missing Vertical Grab Bar at Men's Restroom

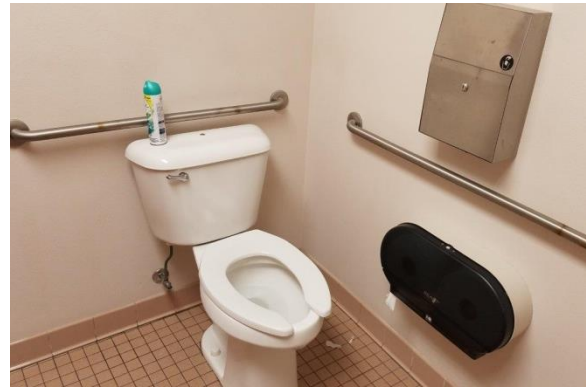
Missing Vertical Grab Bar at Women's Restroom

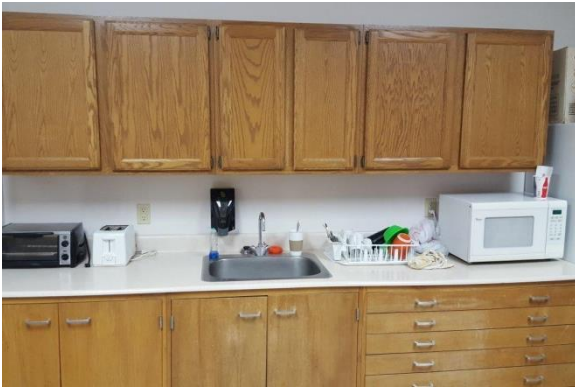
Non-ADA Compliant Counters/Fixtures at IMC Office Area

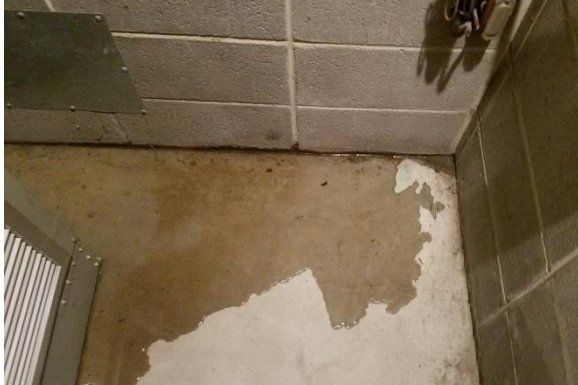
Water Leakage at Boiler Room

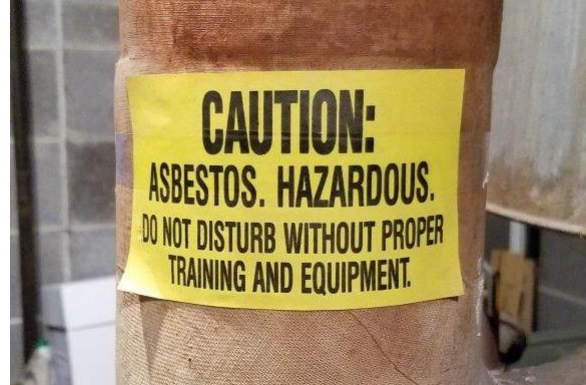
Asbestos Contamination Indicated at Boiler Room

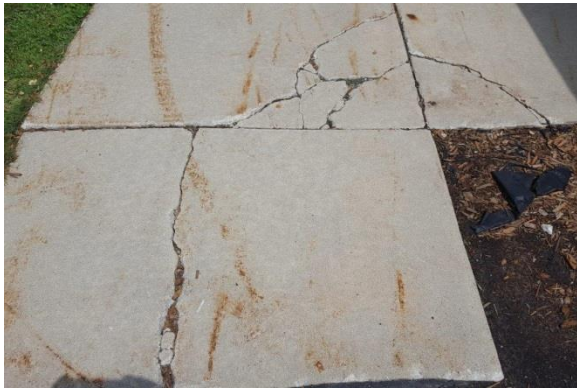
Cracks on Exterior Concrete Slab at Main Entrance

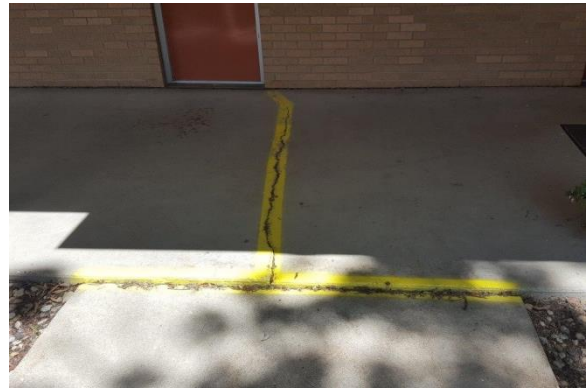
Cracks on Exterior Concrete Slab at Sidewalk

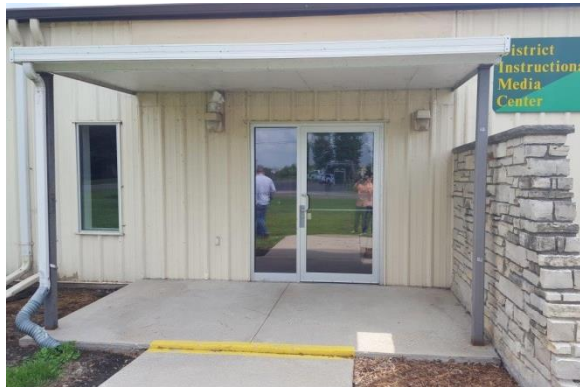
Non-ADA Compliant Entry, Rusted Column Base at S-2 Entrance – Pupil Services

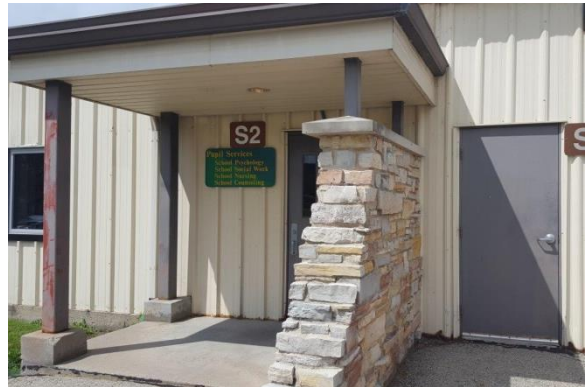
Non-ADA Compliant Entry at District Instructional Media Center Entrance

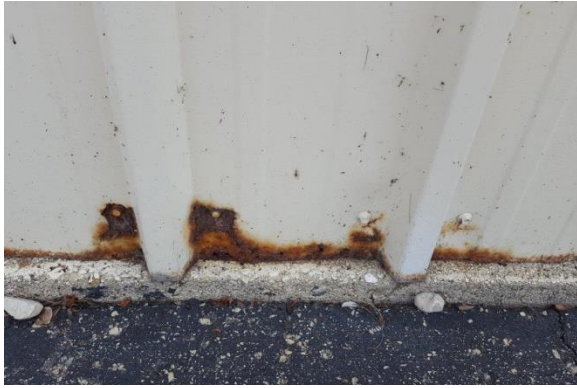
Rusted & Dented Siding

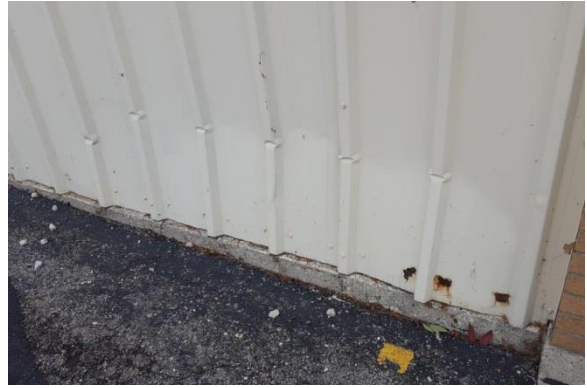
Rust at Base of Siding Walls

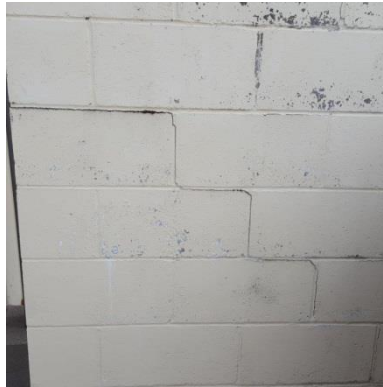
CMU Cracks & Peeling Paint

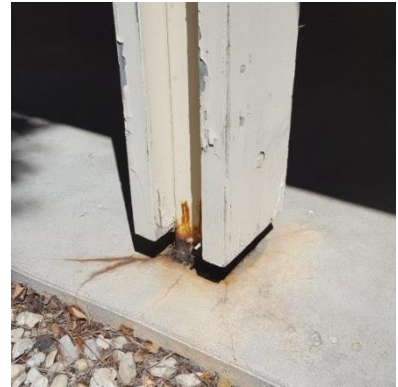
Rusted Column Post & Chipped Paint

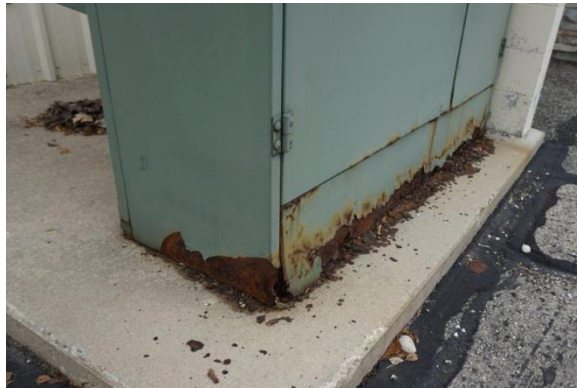
Major Rust on Base of Electrical Unit

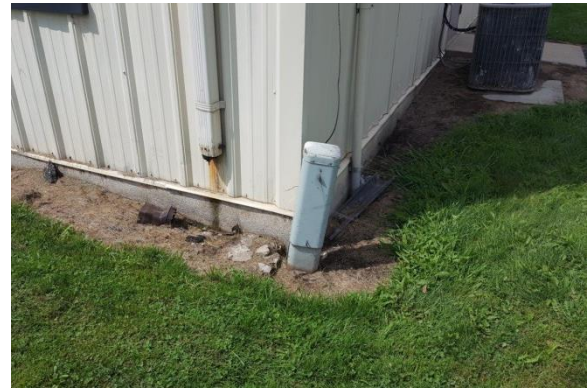
Displaced Electrical Equipment, Missing Downspout

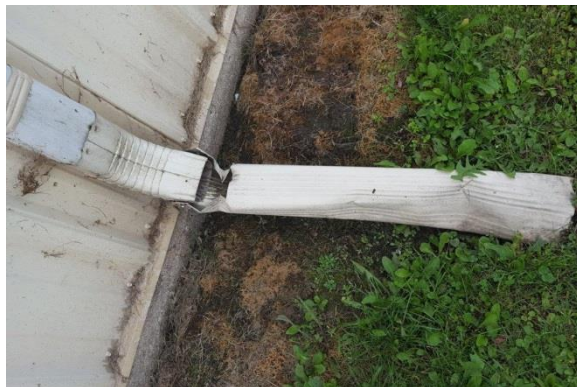
Damaged & Dented Downspout & Extension

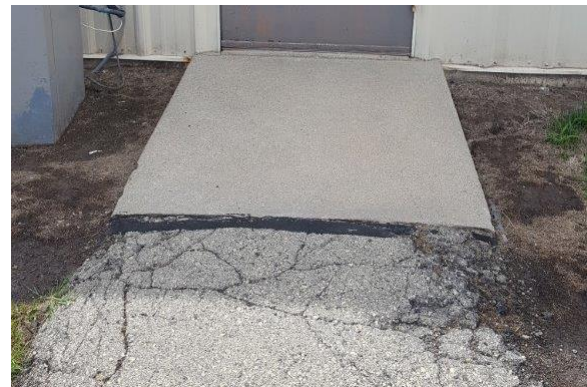
Unleveled & Cracked asphalt at Entry/Exit

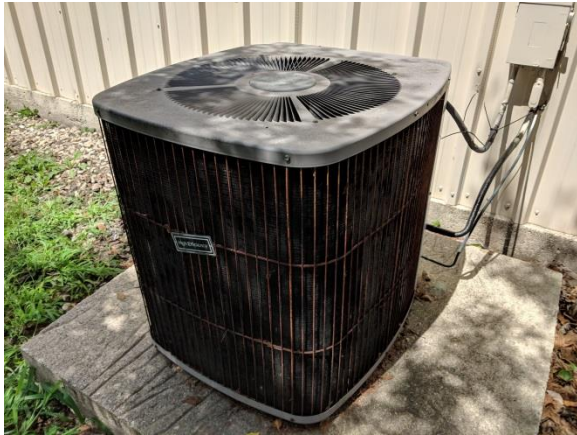
Carrier Air Cooled Condensing Unit

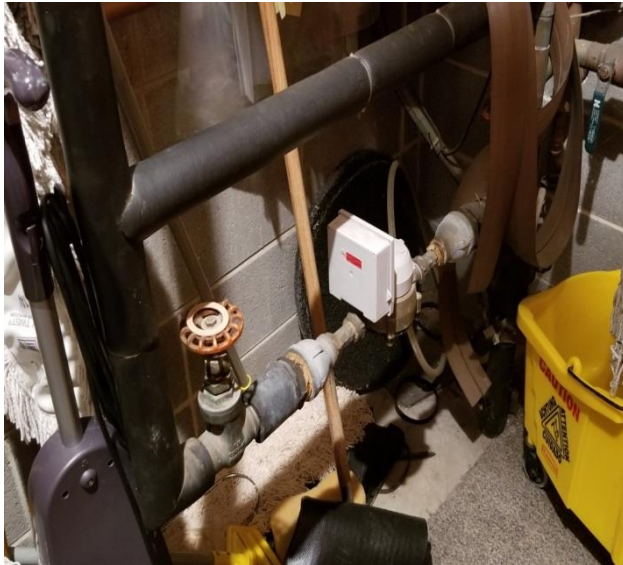
Water Service to Building

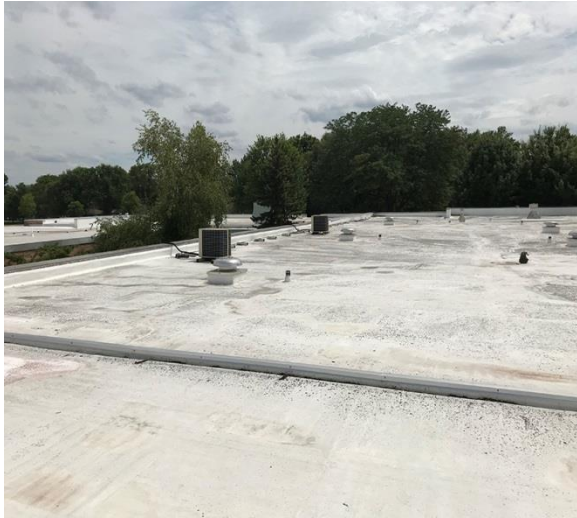
TPO Roofing with Scrim Showing

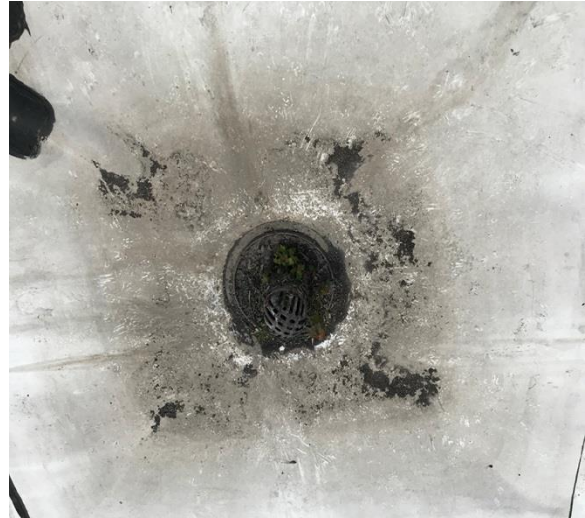
Deteriorated/Plugged Roof Drain

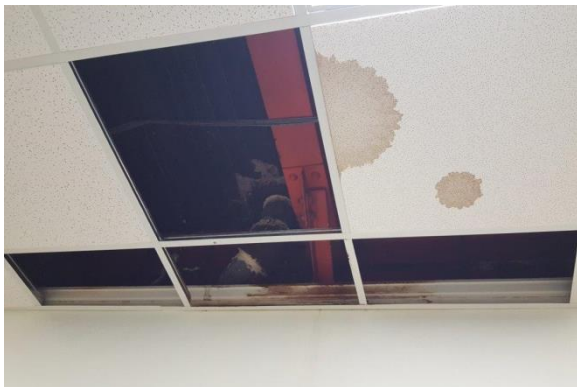
Ceiling Tile & Grid Stained & Missing Tiles at Corridor

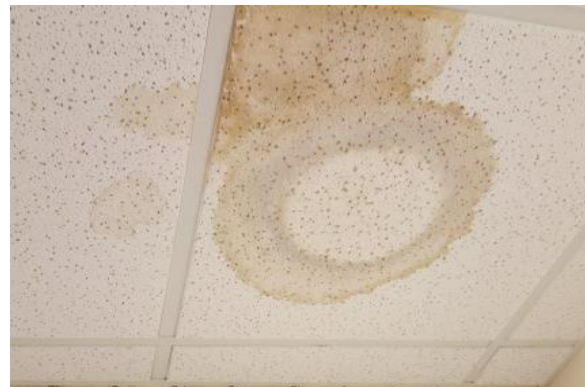
*Ceiling Tile Stained by Water Damage at
Workroom 231*

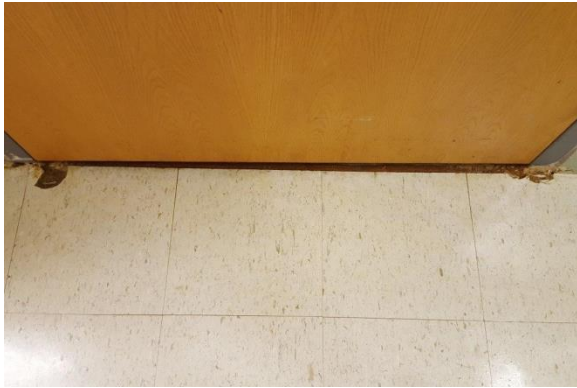
Broken Tile at Corridor Storage Door

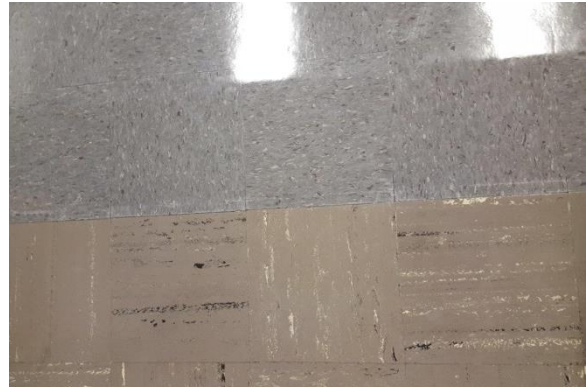
Two Different Tile Styles at Staff Lounge 227

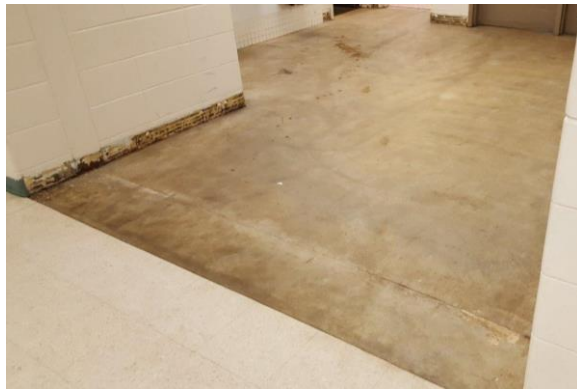
Missing Flooring & Baseboard at Corridor

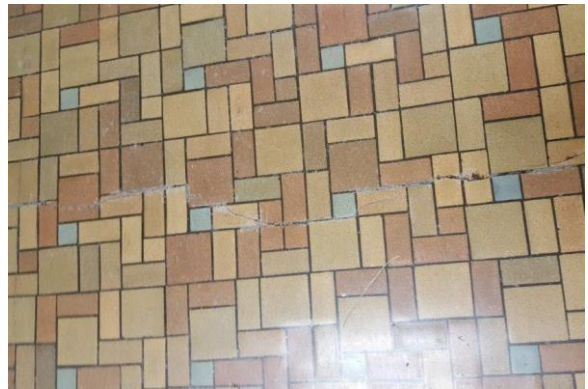
Cracks on Ceramic Tile Flooring

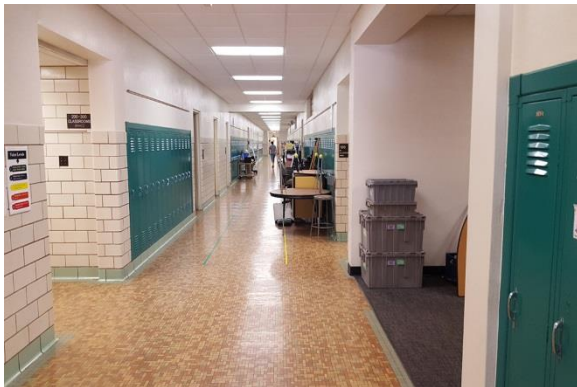
Typical Corridor with Ceramic Tile

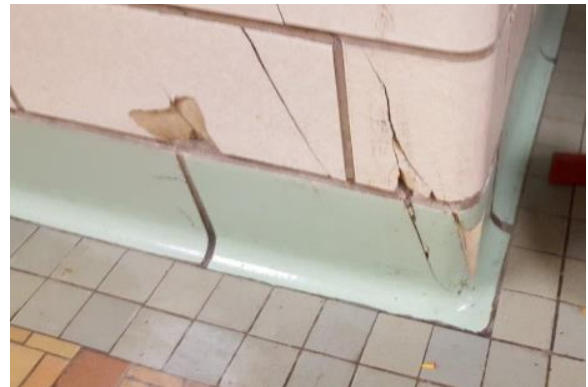
Damaged & Cracked Glazed CMU and Wall Base at Store Corridor

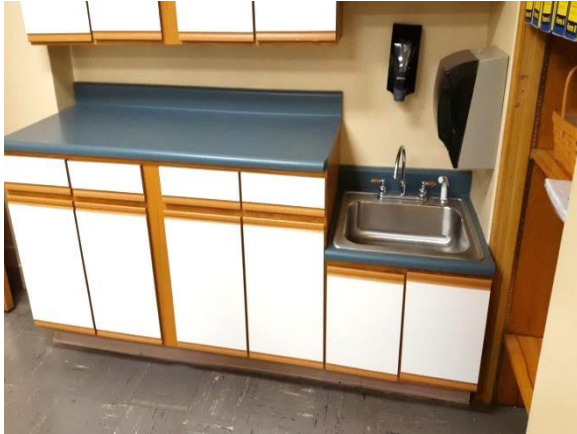
Non-ADA Compliant Casework/Sink

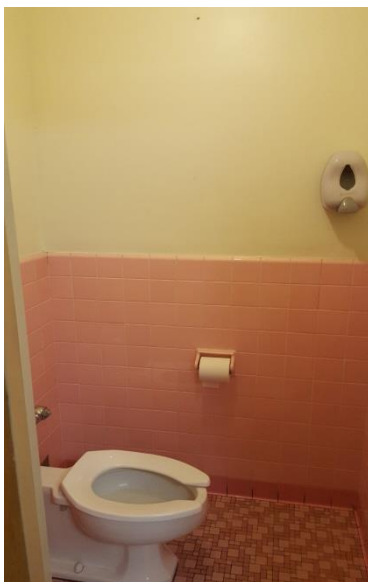
*2 Shared Stalls Divided By Partition
at Boy's Restroom*

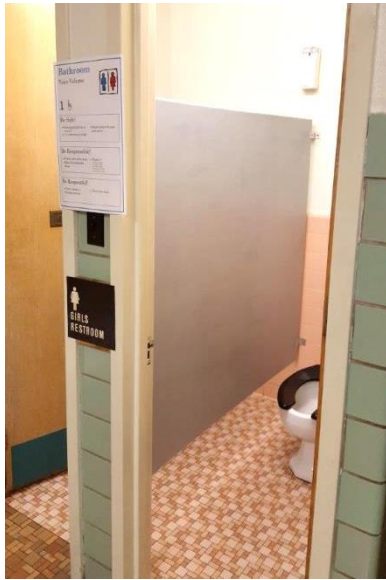
Missing All ADA Grab Bars & Door Width Doesn't Meet ADA Standards at Boy's Restroom

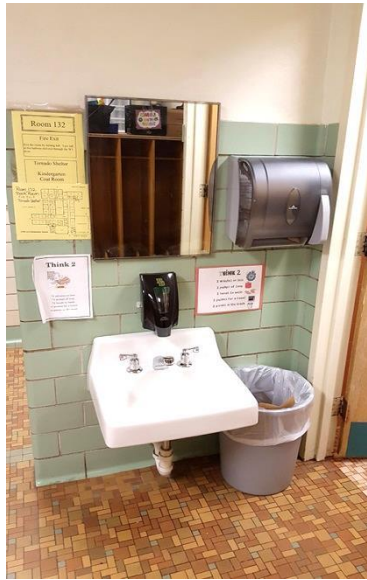
Non-ADA Compliant Plumbing Fixtures

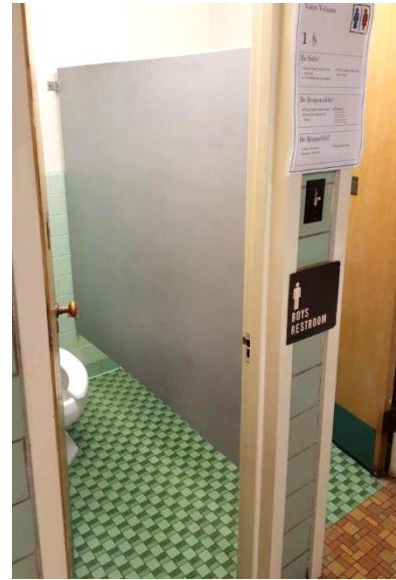
Missing All ADA Grab Bars & Door Width Doesn't Meet ADA Standards at Girl's Restroom

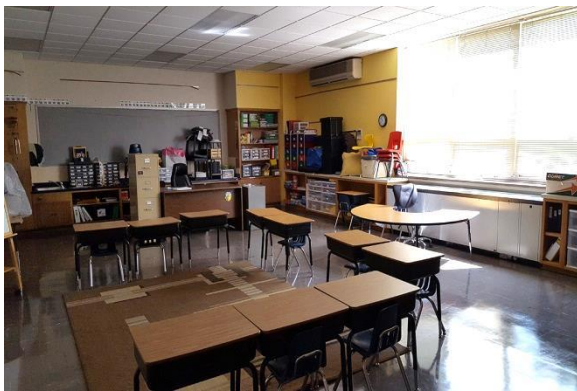
Typical Classroom Layout - Casework

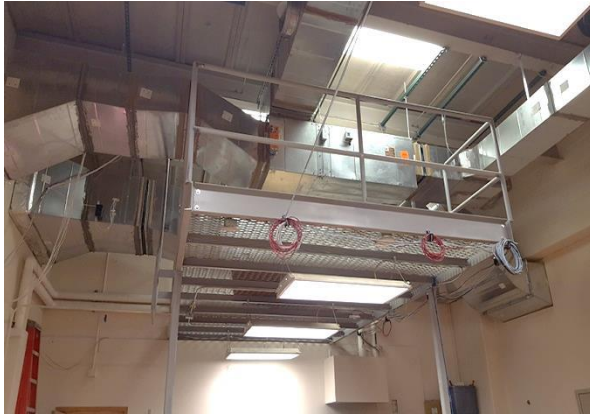
Mechanical Mezzanine Installed at Stage Area

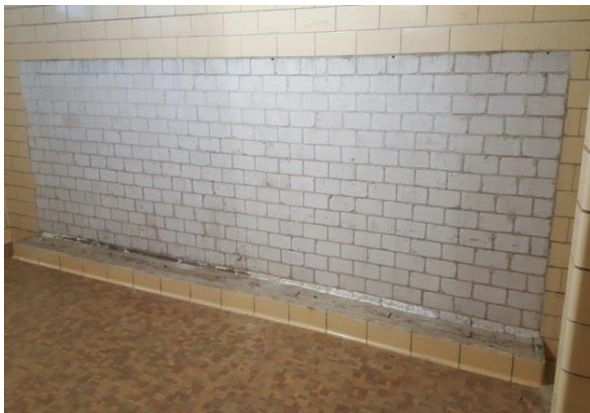
Cracks on CMU Wall at Removed Lockers at Locker Rooms

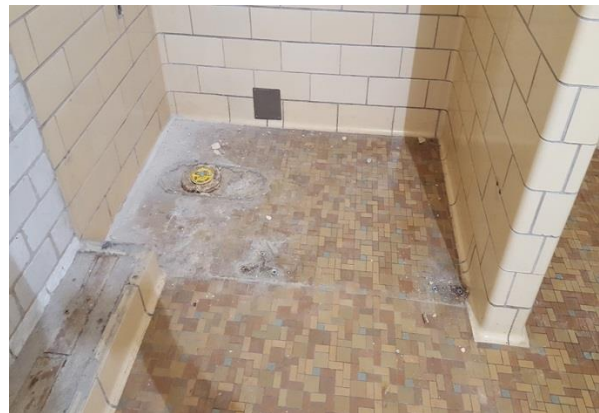
Abandoned Plumbing Fixtures at Locker Room

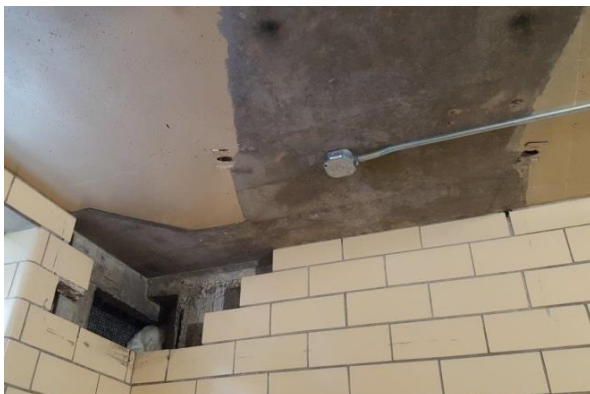
Ceiling/Wall Damage for created Mechanical Opening

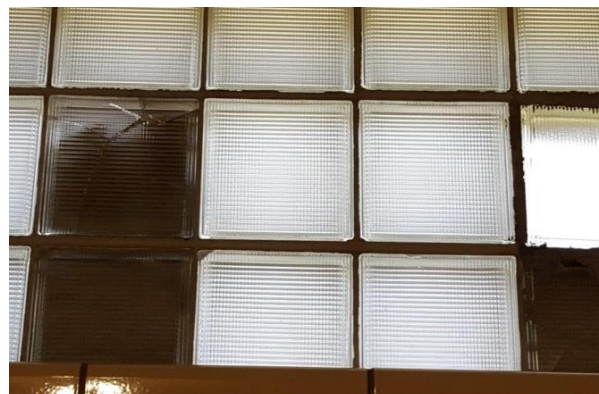
Cracked Glass Block Windows at Basement Locker Rooms

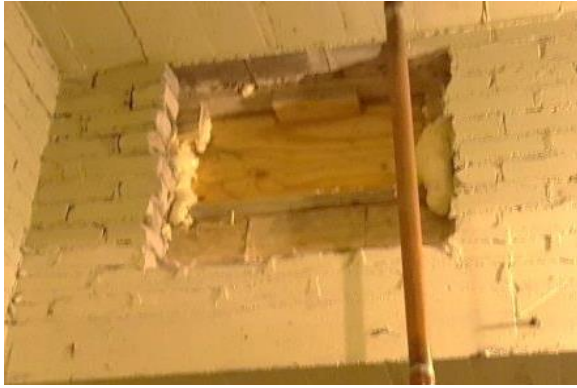
Loose Masonry at Opening at Boiler Room

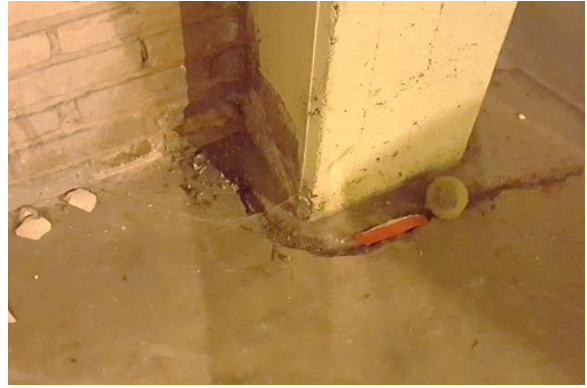
Large Crack at Column Floor Base at Boiler Room

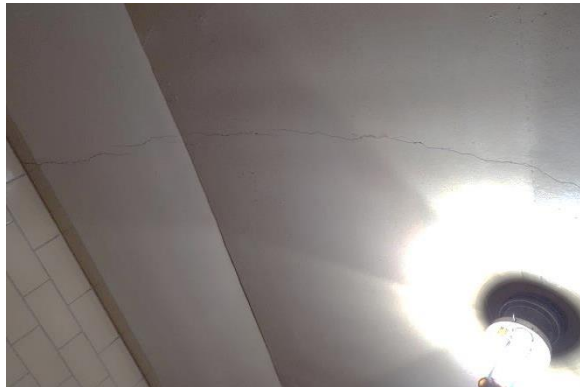
Cracks on Ceiling at Boiler Room – Basement

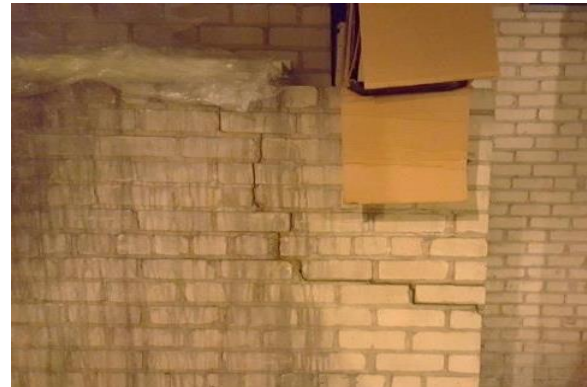
Cracks on Masonry Walls at Locker Room – Basement

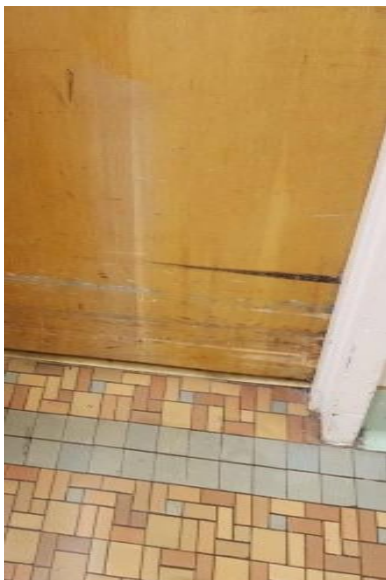
Missing Door Plate & Damage

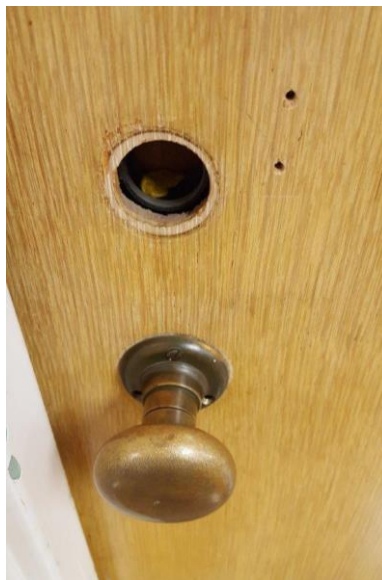
Missing Door Lock at Storage Door

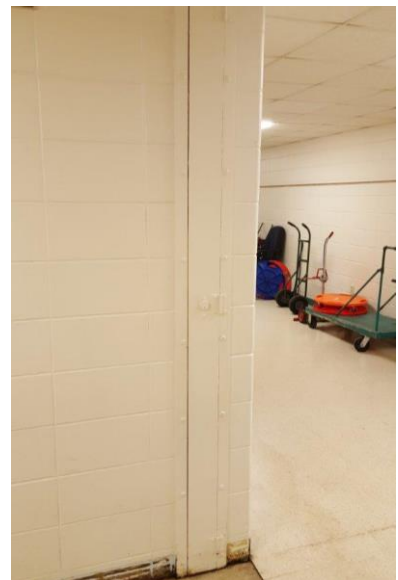
Corridor Gate Abandoned/Damaged

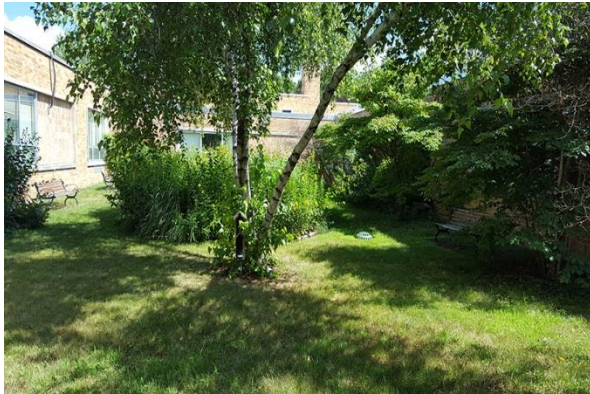
Interior Courtyard Area

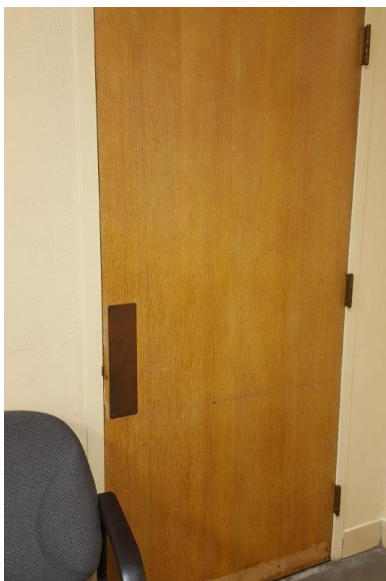
Abandoned Connecting Door at Staff Lounge 227

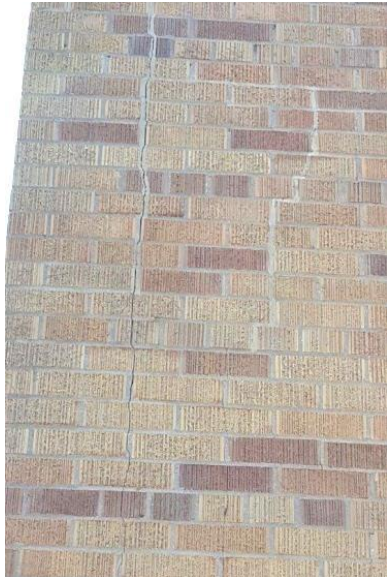
Cracking along Masonry Wall

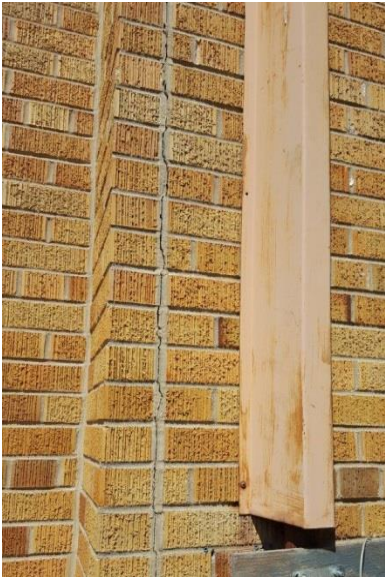
Masonry Control Joint Cracks

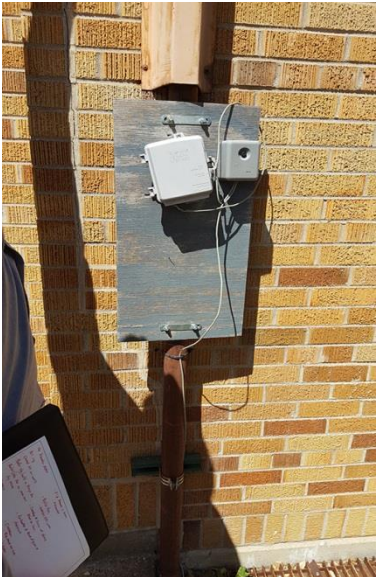
Abandoned Communication Wires

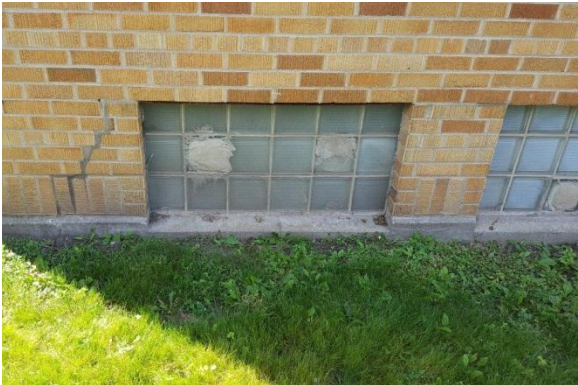
Damaged & Patched Glass Block Windows; Masonry Repairs

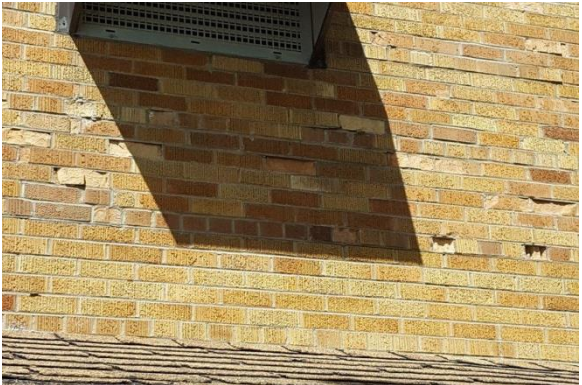
Spalling Brick Above Roof Area

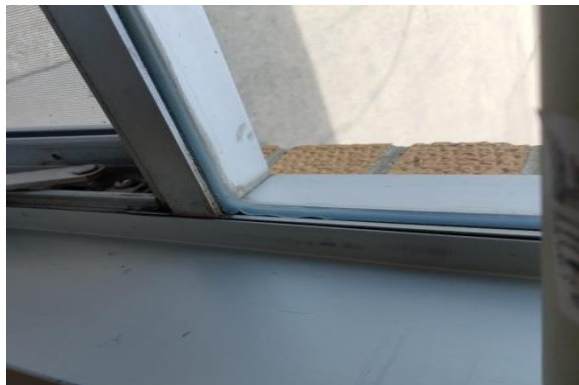
Single Pane Glazing at Original Building Classrooms

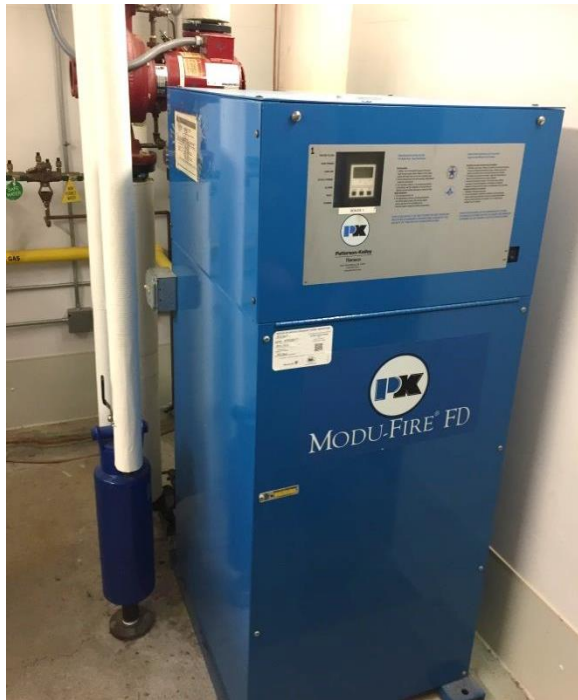
Patterson Kelley Condensing Boiler

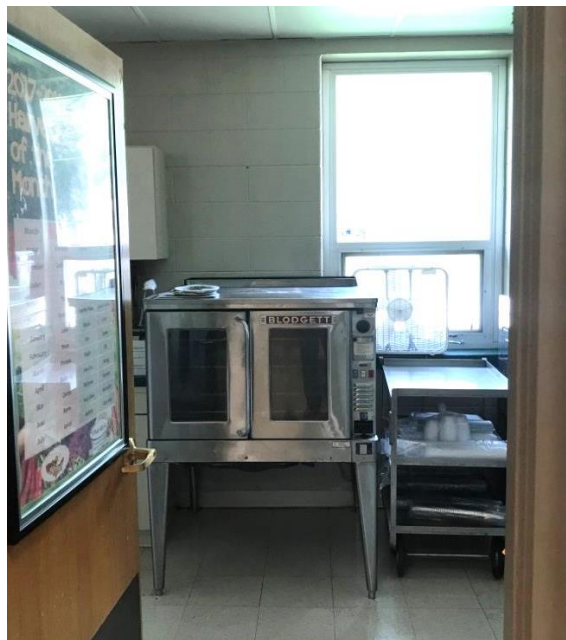
The computer classroom connected to the media center needs to be further analyzed for proper ventilation. There were no ventilation exhaust hoods observed in the kitchen which is a “gray” area in regards to the current International Mechanical Code (IMC) and falls upon the local code inspector’s interpretation. According to the IMC 2015, Type II kitchen hoods must be installed above cooking or dishwashing appliances that produce heat and moisture and/or products of combustion.” This kitchen may require a type II commercial hood over equipment that produces heat or moisture.

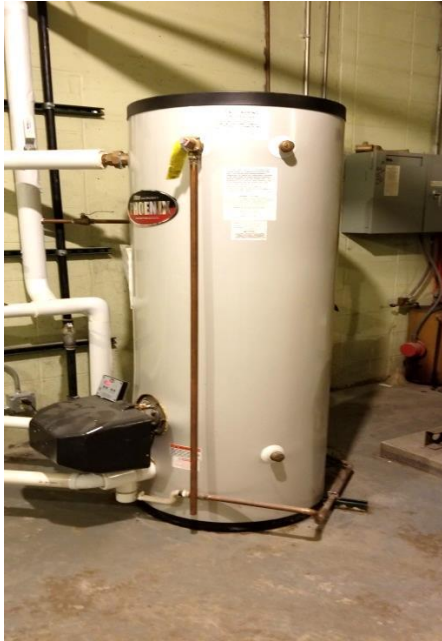
The majority of the water is heated with a Phoenix sealed combustion water heater located in the lower floor mechanical room. The water heater is a newer unit and has been upgraded from the original HWH. The heater is in good condition and appears in good working condition.

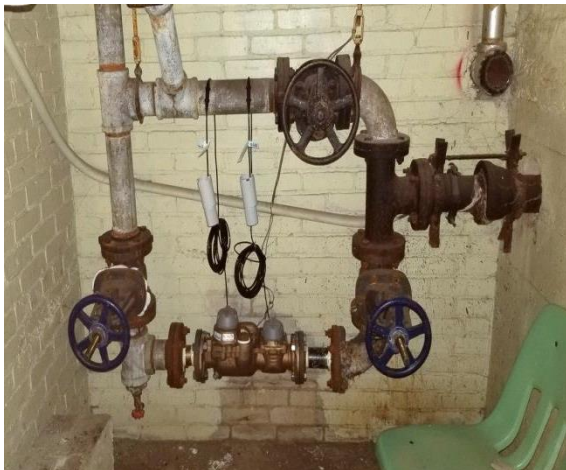
The sanitary drainage system serves the building plumbing fixtures and floor drains. The ground floor sanitary systems drain by gravity to the municipal sewer with lift stations in the lower level. Piping is typically original to the building and constructed of cast iron hub and spigot and galvanized with cast iron fittings. Renovated areas have been piped with no-hub CI and PVC piping where allowed by code compliance. The newer piping appears to be in good condition for the age of the building. Building has abandon shower rooms at the lower level. Recommend disconnection of all shower rooms waste vent and water piping if intent is to abandon the current locker rooms.

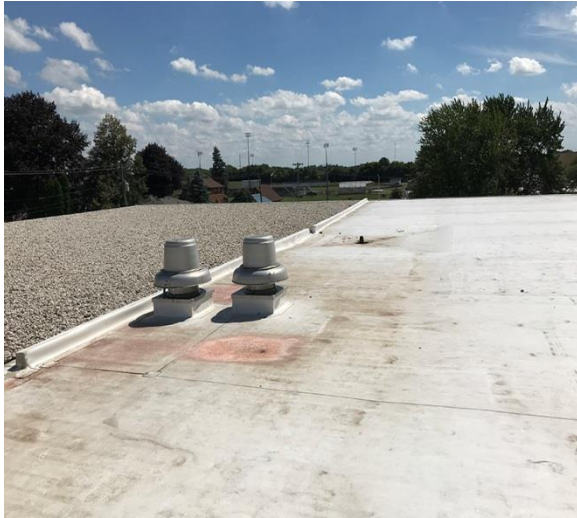
Existing Ballasted and Fully Adhered Membrane Roof

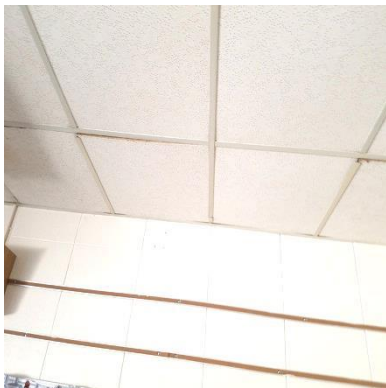
Rusted/Degraded Ceiling Tile

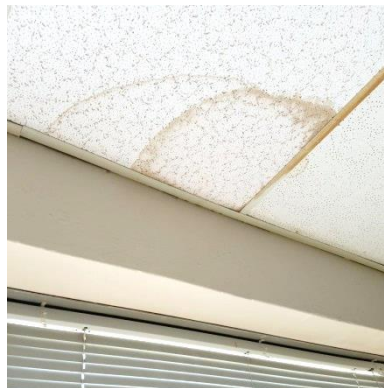
Ceiling Tile Grid Sagging & Stained at Kindergarten Room 112

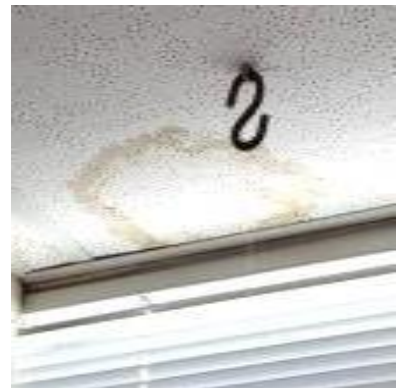
Ceiling Tile & Grid Degradation at Grade 2 - Room 100

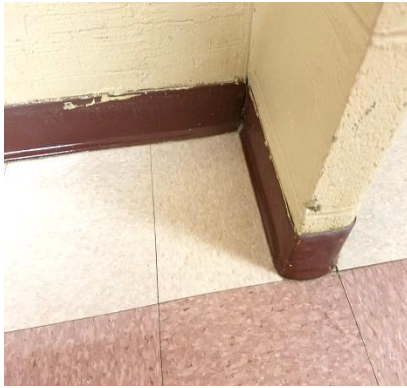
Base Delamination and Damage

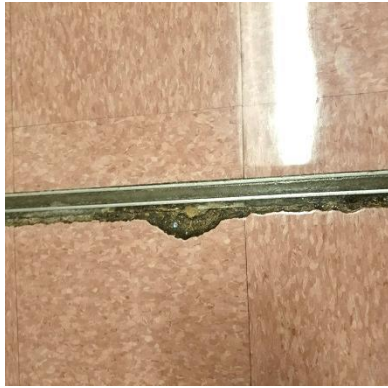
Chipping Vinyl Tile at Building Expansion Joint

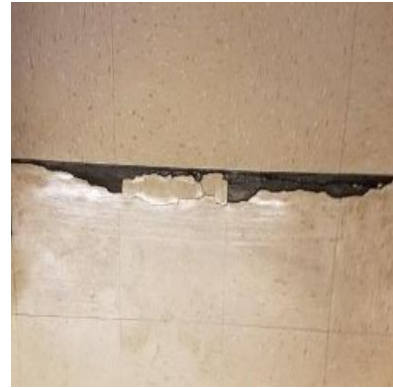
Damaged Vinyl Tile at Classroom 206

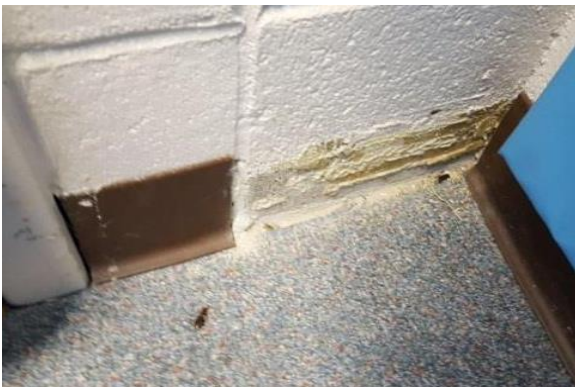
Missing Wall Base Transition

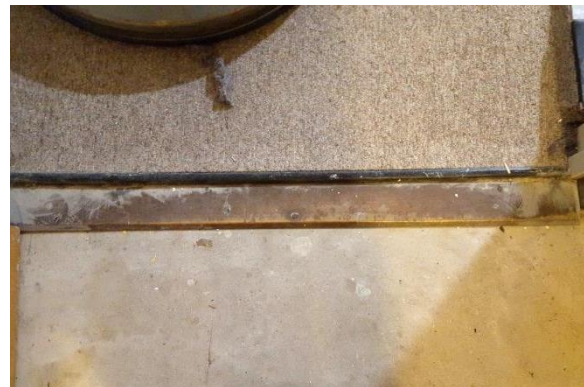
Damaged Floor Transition at Gym – Storage Room

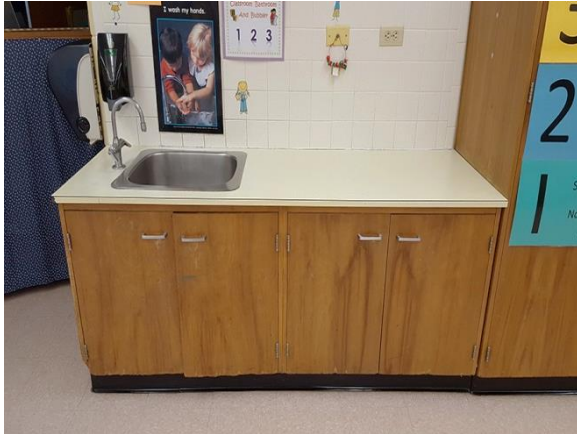
Non-ADA Compliant and Damaged Casework/Sink at Classroom

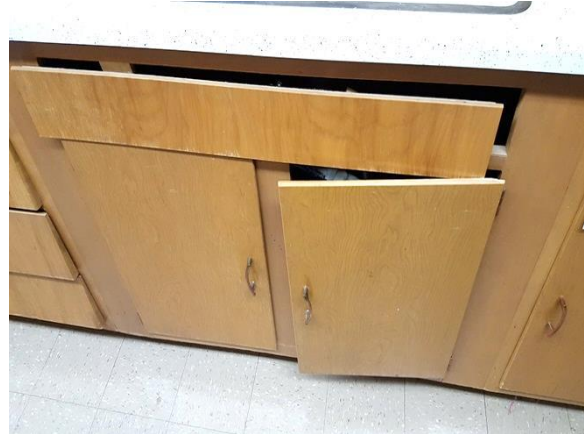
Damaged Wood Base Cabinet at Classroom

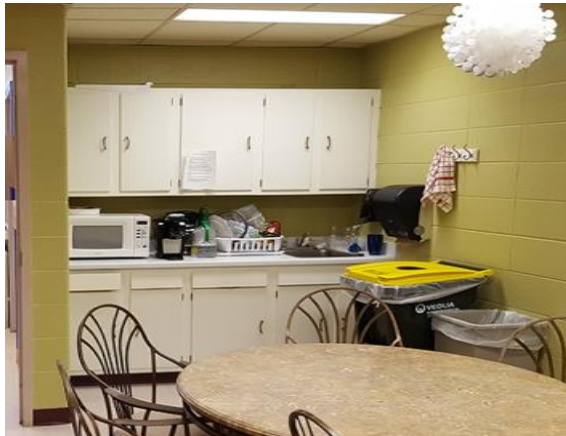
Non-ADA Compliant Casework at Break Room

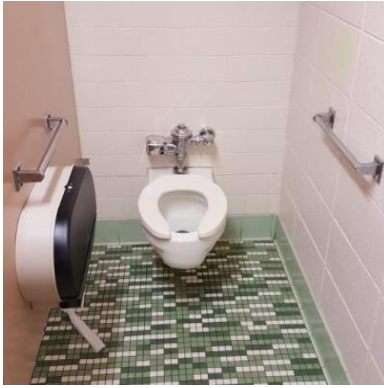
Incorrect/Missing Grab Bar Locations at Girl's Restroom; Clearance Issues

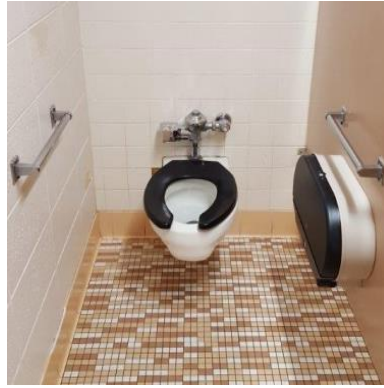
Incorrect/Missing Grab Bar Locations; Clearance Issues at Boy's Restroom

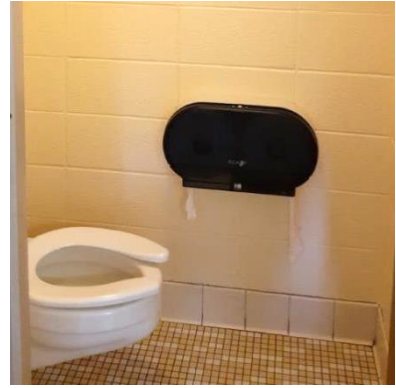
Missing Grab Bars at Kindergarten Restrooms

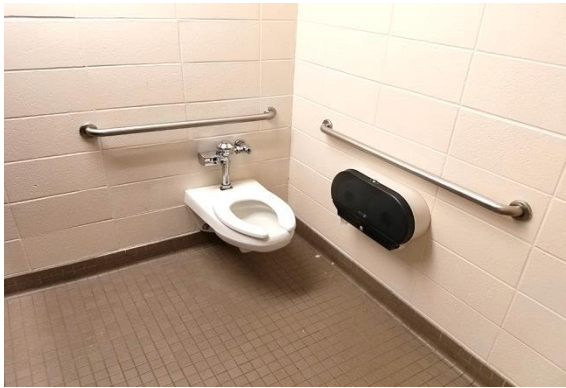
No Vertical Grab Bar Installed at ADA Toilet Stall

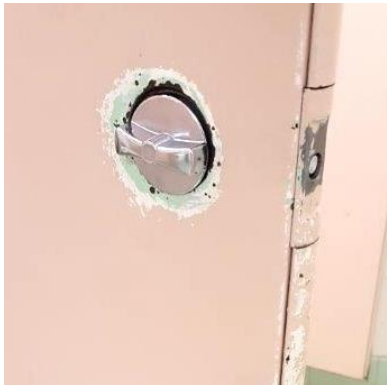
Broken Privacy Lock at Girl's Restroom

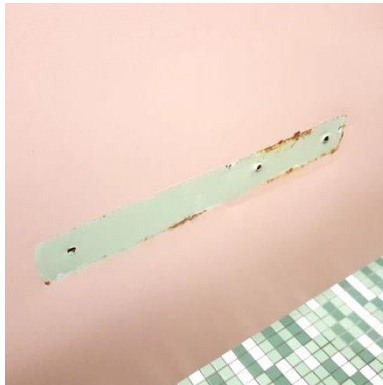
Missing Grab Bar at Girl's Restroom

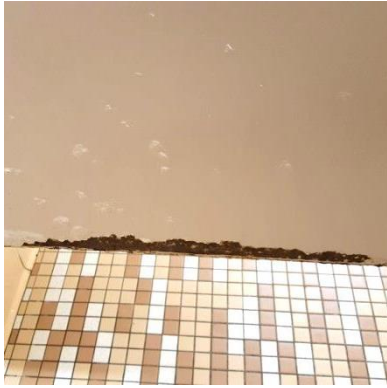
Rust on Toilet Partition

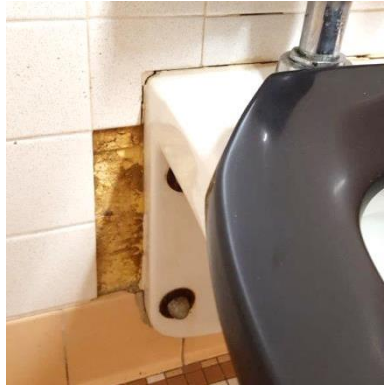
Missing Tiles Around Toilet Fixture

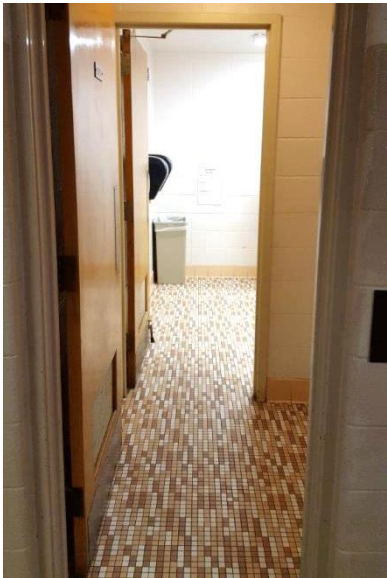
Non-ADA Compliant Toilet Vestibule Clearance at Girls Restroom

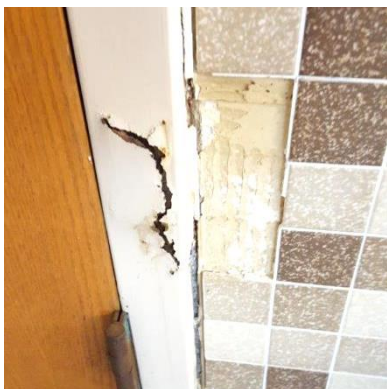
Broken Wall Tiles & Rusted Door Frame at Kindergarten 112

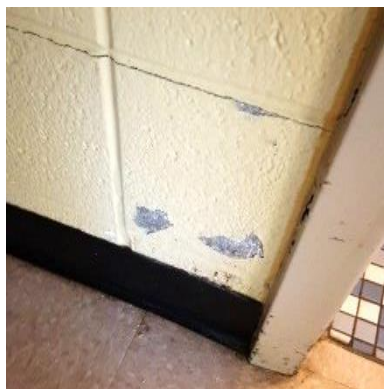
CMU Wall Cracks & Chipping Paint at Kindergarten 112 - Bathroom

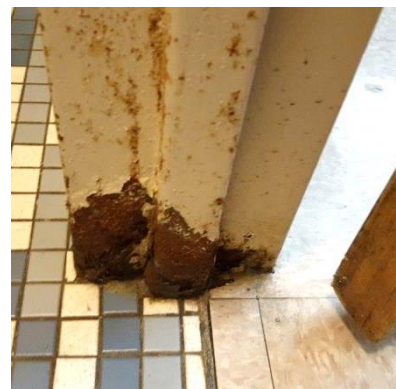
Rusted Door Frame Base at Kindergarten 112 - Bathroom

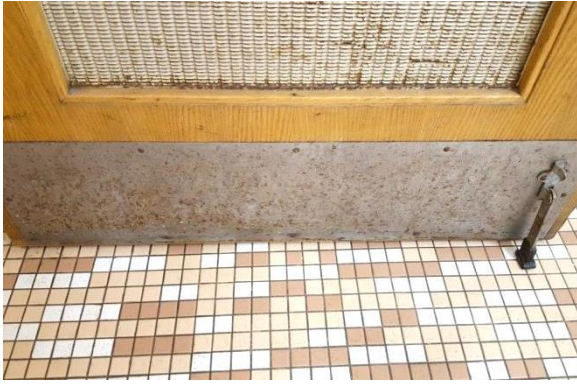
Rust on Door Plate at Boys & Girls Bathroom

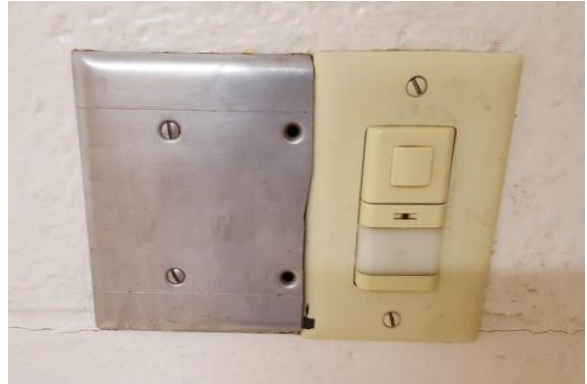
Custom-made Switch Cover at Boy's Restroom

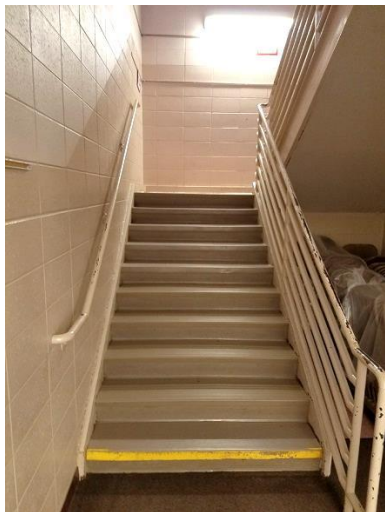
Chipped Paint at Railing and Stair Tread

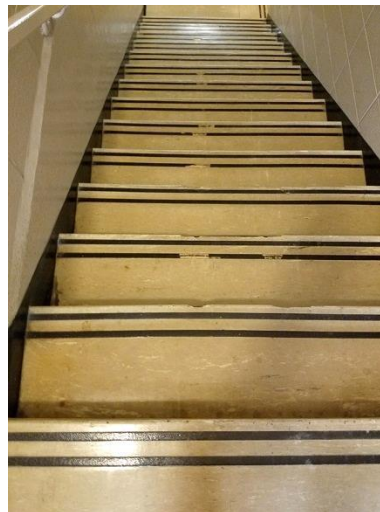
Worn and Damaged Stair Treads Leading to Basement

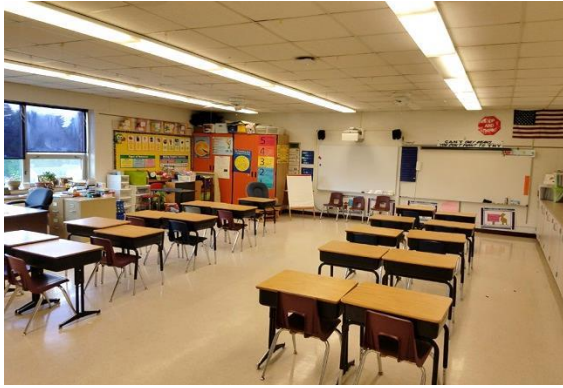
Typical Classroom Layout - Addition

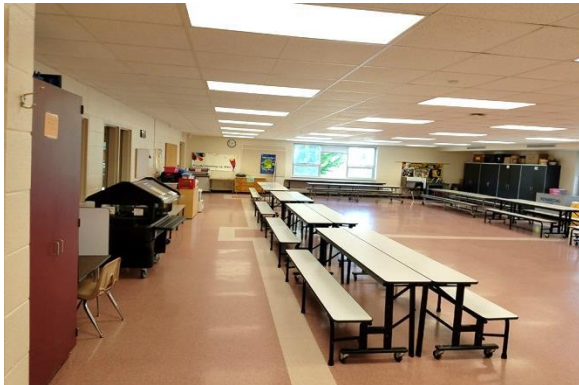
The multipurpose room located in the addition is typically used as a lunch room and includes an attached kitchen. Overall, the space is in relative good condition aside for some minor maintenance-level issues. The Learning Center (I.M.C.) is also located in the addition and is in good condition as well aside for some minor maintenance-level issues. Renovation is not recommended at these areas.

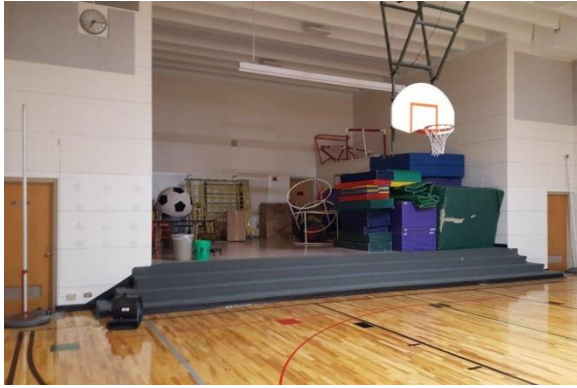
No ADA Ramp Access to Stage Area

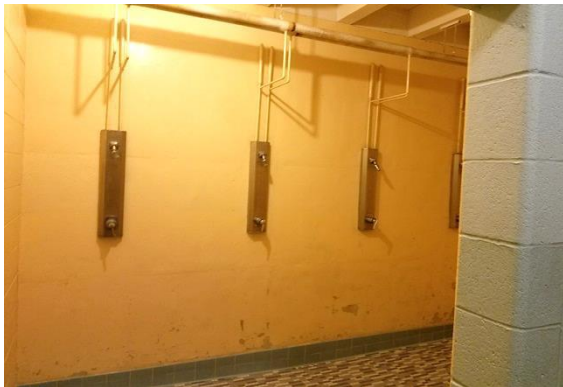
Abandoned Showers in Locker Rooms

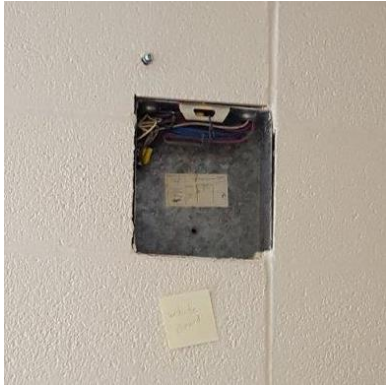
Exposed Wiring & Missing Covers at Classrooms

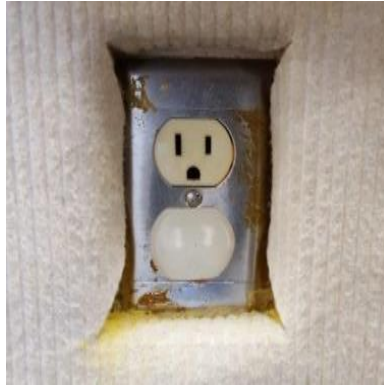
Outlet Enclosed by Padding & Visible Corrosion at Classroom 116

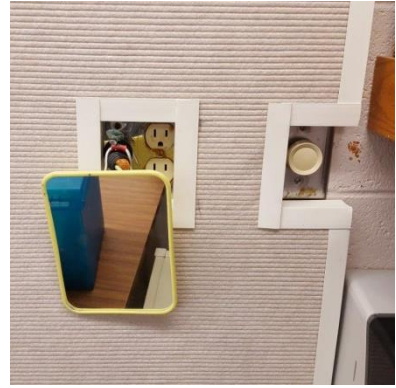
Electrical Components Concealed/ Enclosed at Classroom 116
