2018 Facility Assessment Plan

Prepared by:

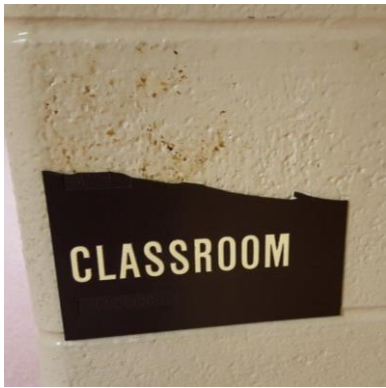
Electrical Components Concealed/ Enclosed at Classroom 116

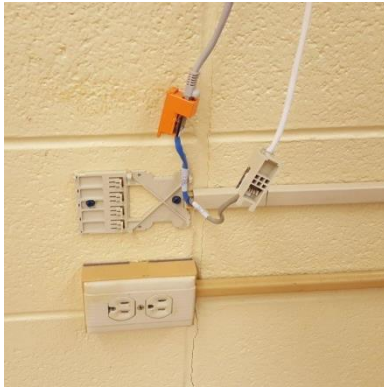
Exposed Wiring at Kindergarten Room 112

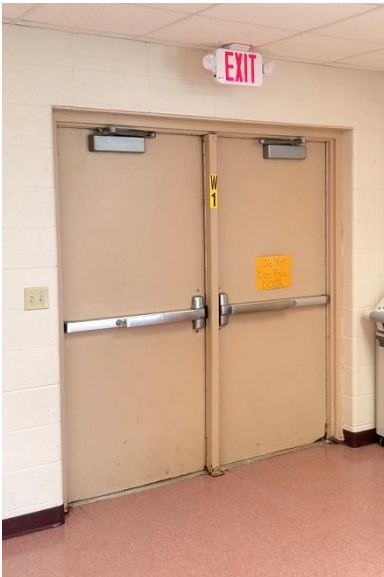
Rusting Exit Door at Multipurpose Room

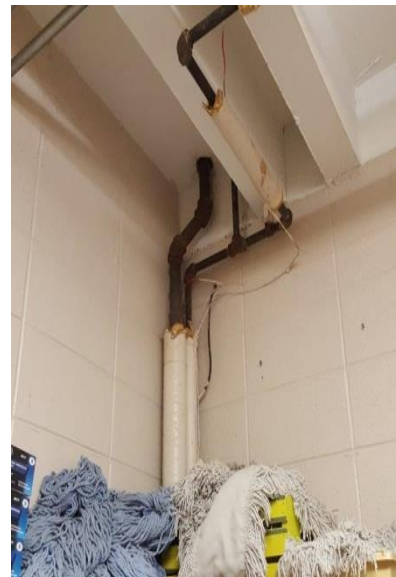
Exposed Pipes at Storage Room 109

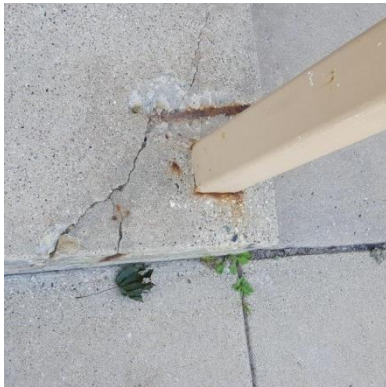
Rust at Exterior Column Base

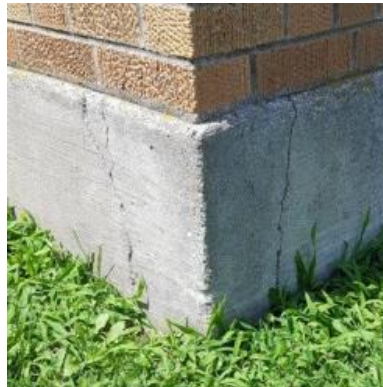
Foundation Crack at Corner

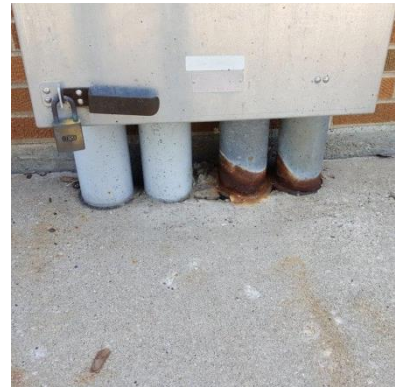
Rusting at Electrical Equipment

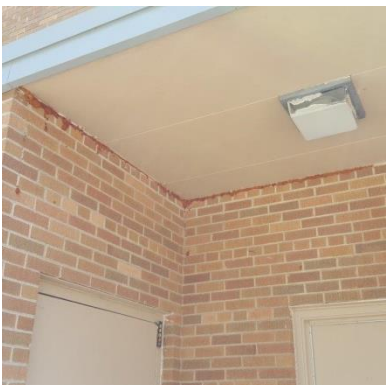
Exposed foam insulation at soffit

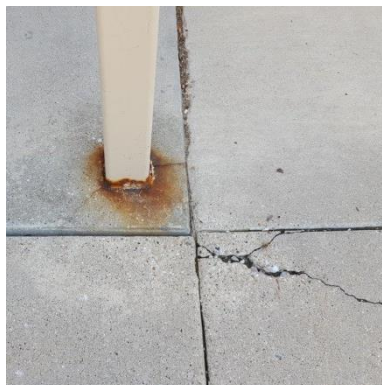
Concrete Cracks & Rusted Column Base

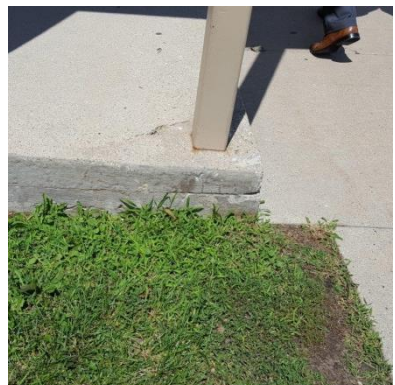
Heaving Concrete Stoop

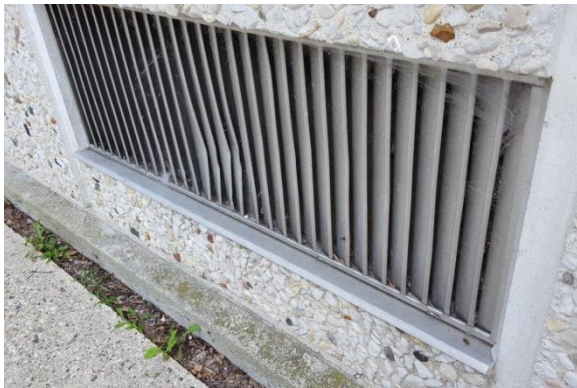
Damaged & Dented Louvers

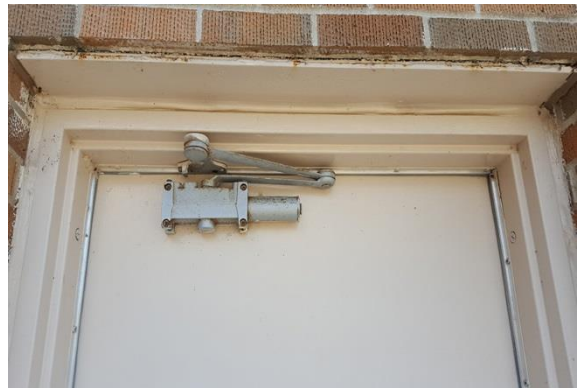
Rust at Steel Lintel

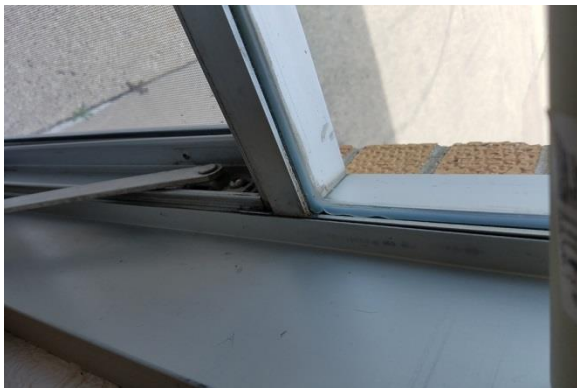
Single Pane Glazing at Original Building Classrooms

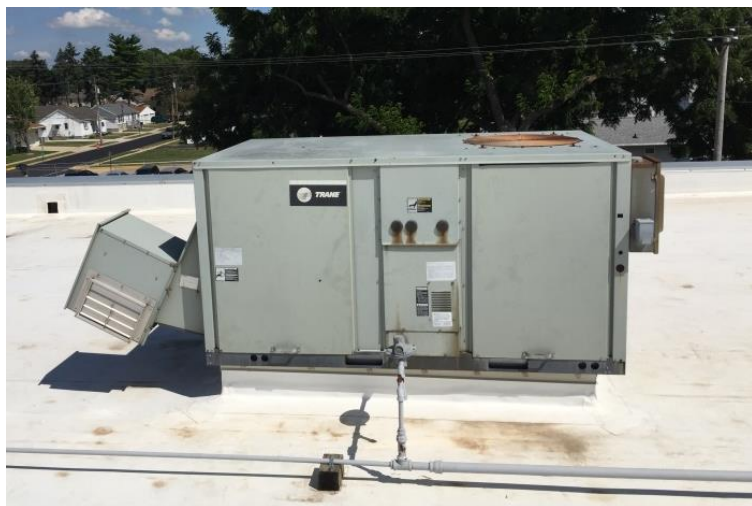
There were three (3) Trane rooftop units observed which have been reported to be replaced this summer and are in great condition.

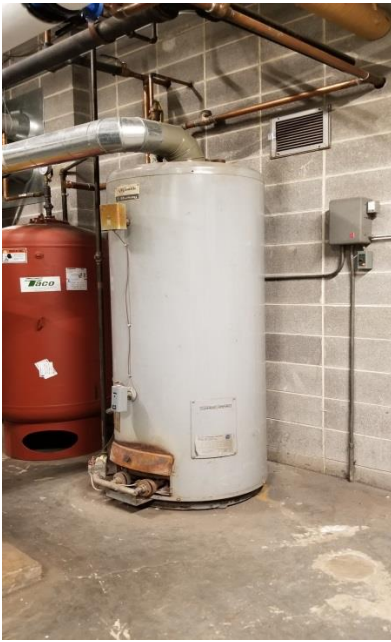
The water is heated with a gas fired tank type water heater located on the lower floor level mechanical room. The water heater appears to be original to the building construction. The water heater should be replaced in the near future.

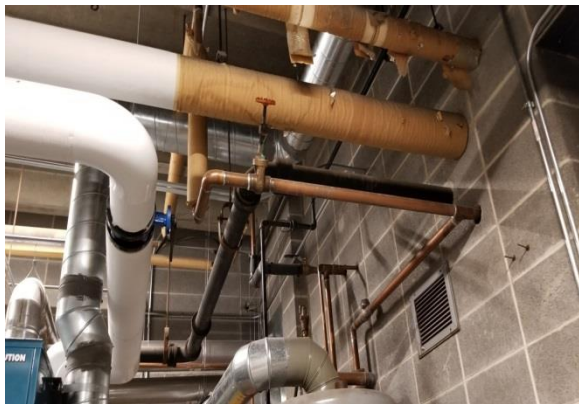
The sanitary drainage system serves the building plumbing fixtures and floor drains. The sanitary drainage systems drain by gravity to below ground sewage system. Piping is typically original to the building and constructed of cast iron hub and spigot, galvanized with cast iron fittings. PVC piping has been used in areas of renovation and repair. The piping appears to be functioning for the age of the building. Areas where plumbing fixtures are abandon or are being used for other reasons than the initial intent (shower rooms used as storage), plumbing should be capped and or removed.

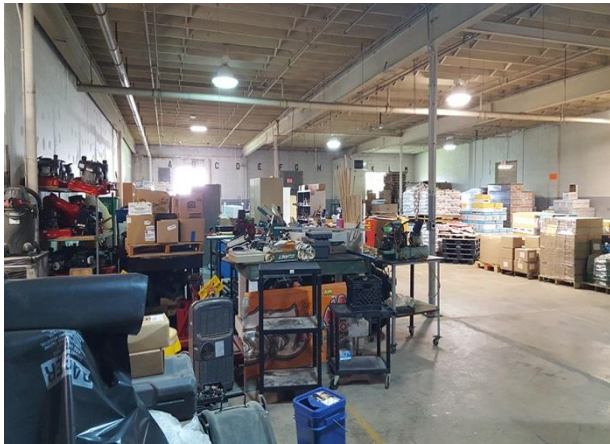
Uninsulated Storage/Maintenance Area

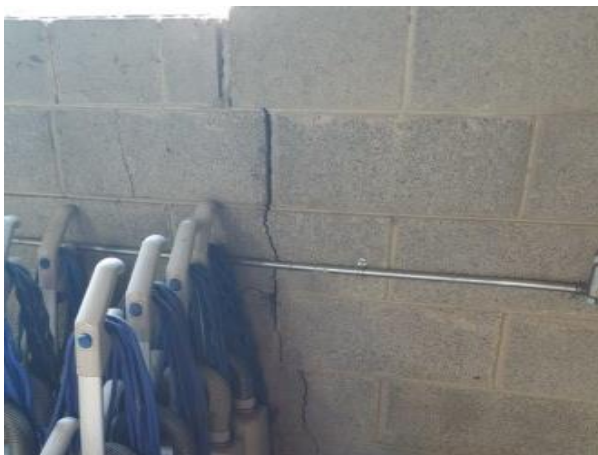
Cracks on Interior CMU Wall

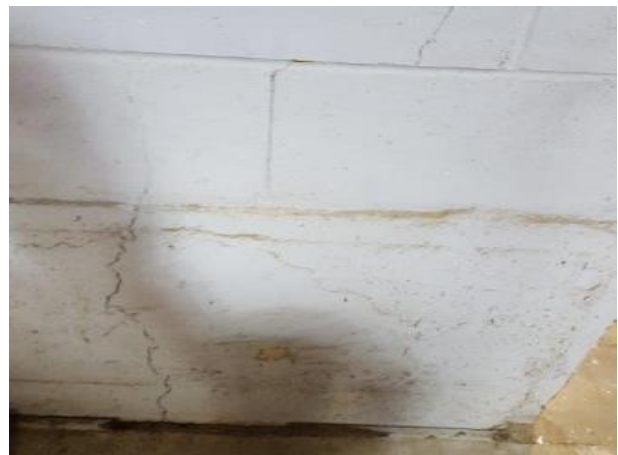
Cracks on Exterior CMU Wall

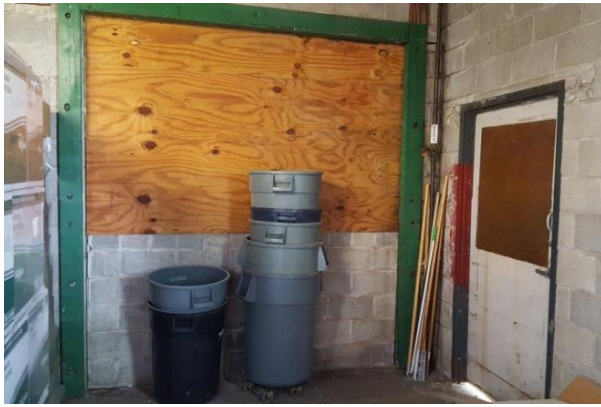
Boarded Up Garage Opening & Door Window

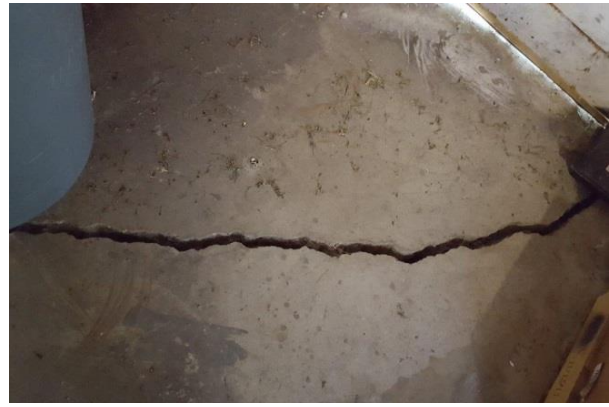
Concrete Slab Cracks

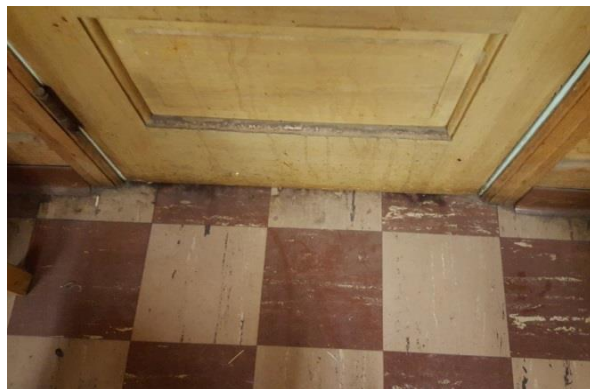
Non-ADA Compliant Door Width at Toilet Room; Possible Asbestos in Vinyl Tile

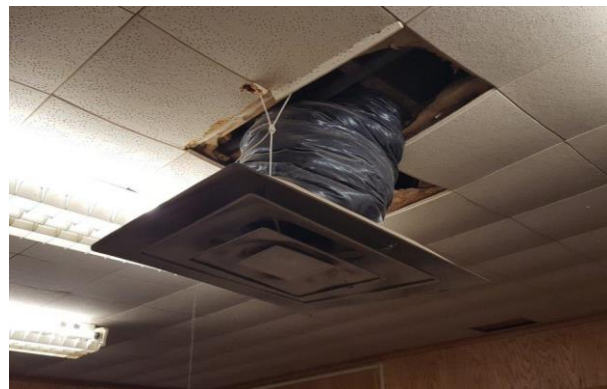
Deteriorated/Damaged Ceiling and Diffuser

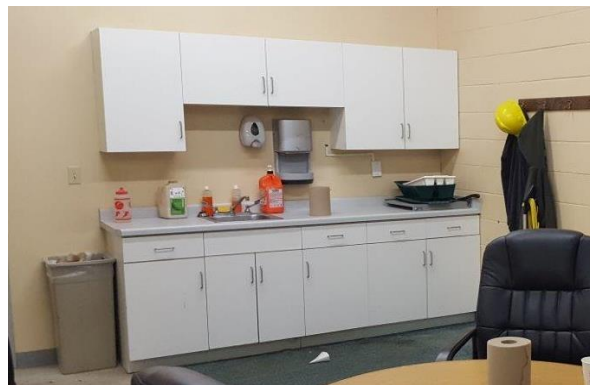
Non-ADA Compliant Casework/Sink at Break Room

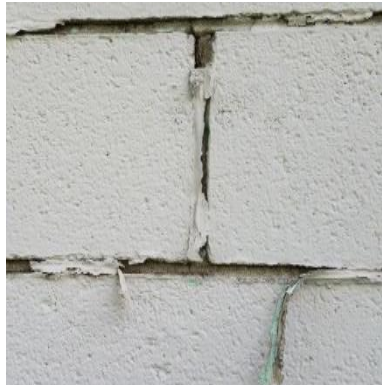
Failing Mortar Joints

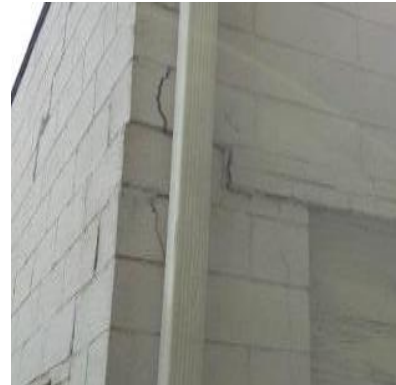
Major Cracking/Displacement at CMU Corner

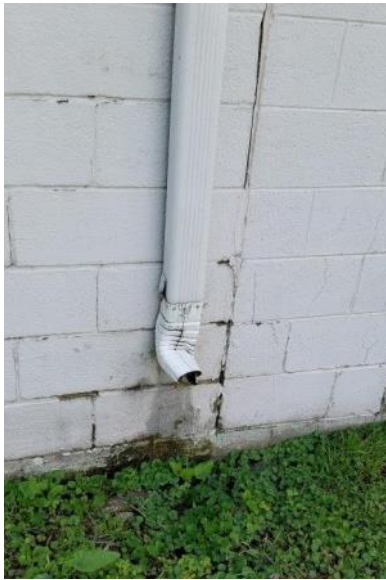
No Downspout Termination

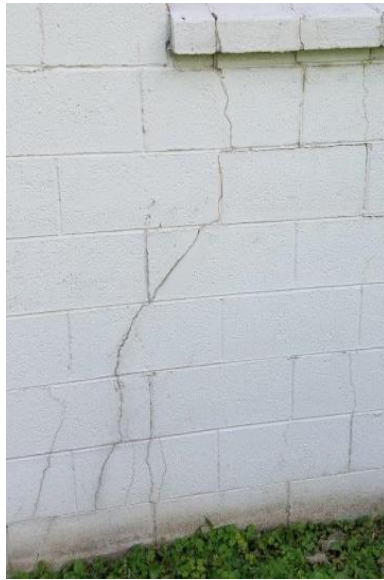
Cracking From Window Opening to Foundation

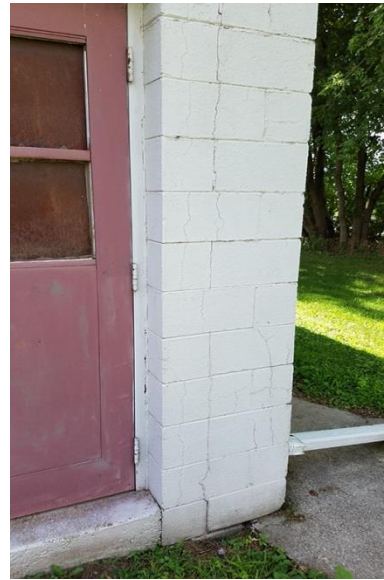
Cracking at CMU Corner

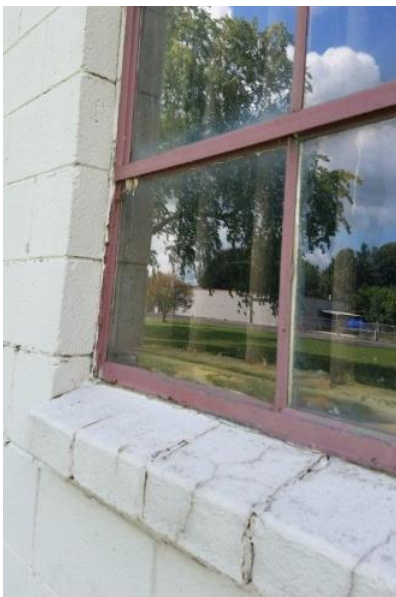
Original Single Panel Window

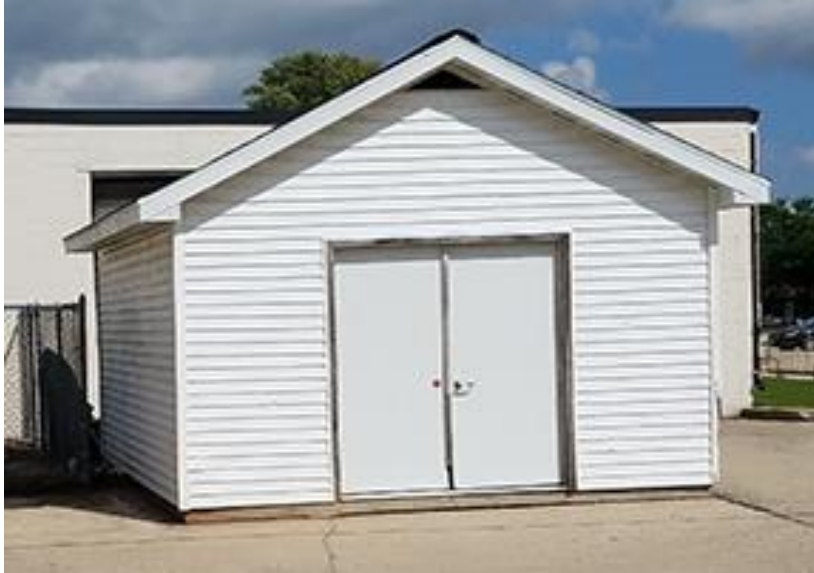
Exterior Wood Storage Shed

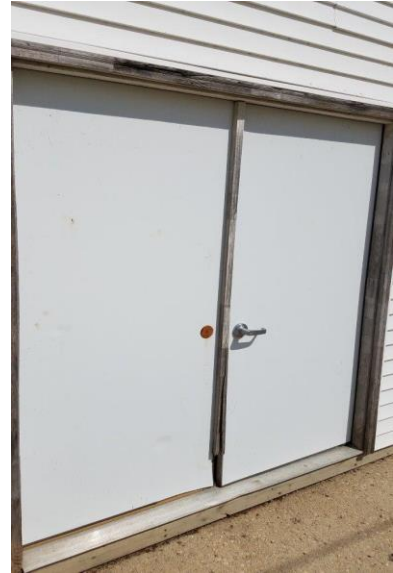
Doors in Deteriorated Wood Frame

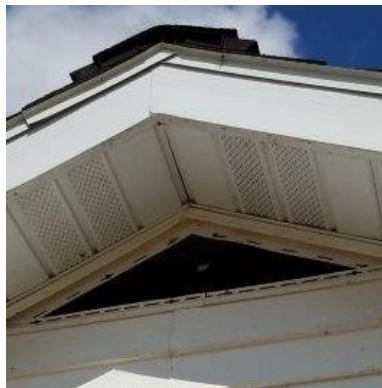
Missing Vinyl Siding

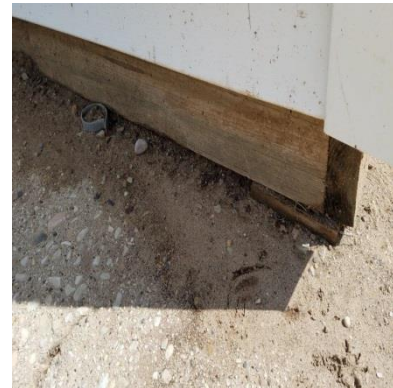
Wood Framing for Foundation

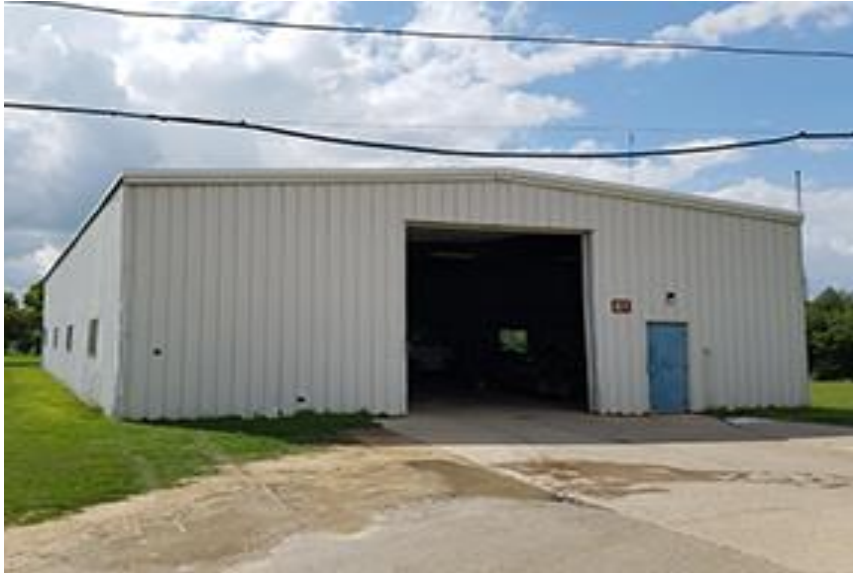
Exterior Metal Storage Shed

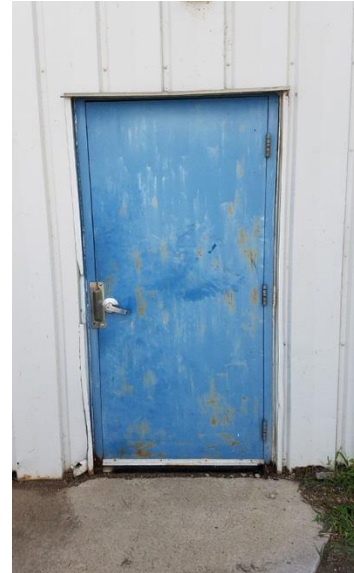
Damaged Exterior Door

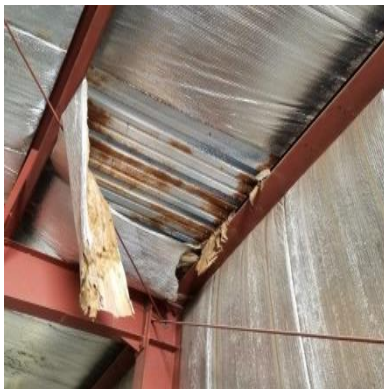
*Deteriorated Metal Deck and
Insulation*

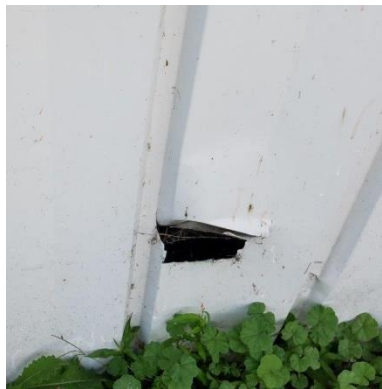
Damaged Metal Siding

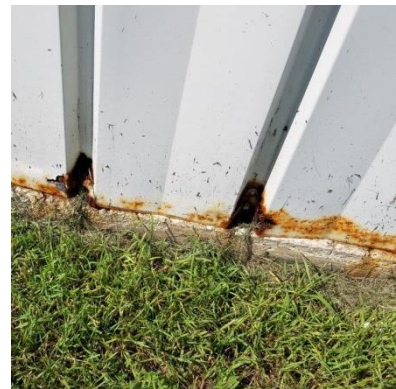
Rusted Metal Siding at Base

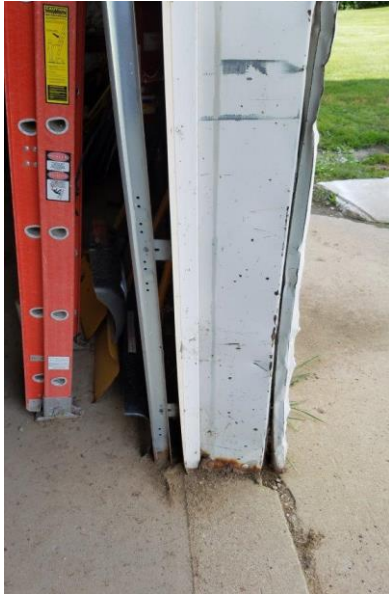
Damaged Overhead Door Jamb

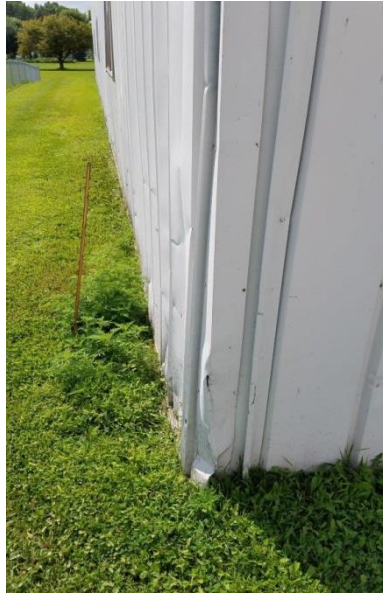
Damaged Metal Siding Corner

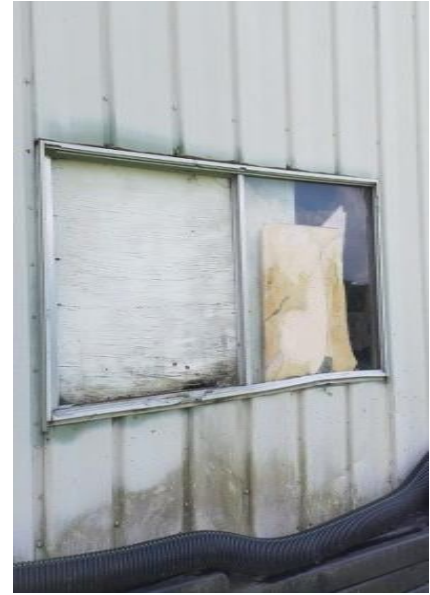
Damaged/Infilled Window

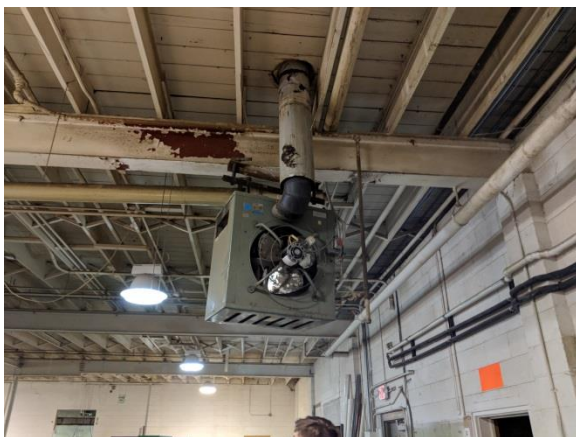
Peerless Gas Fired Unit Heater

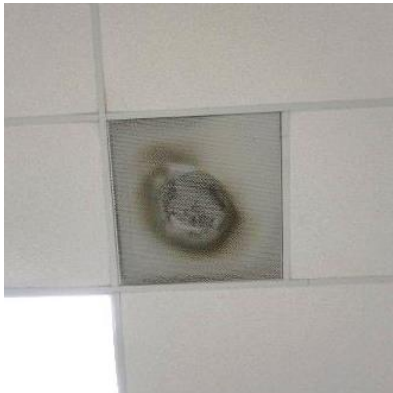
The acoustical ceiling tiles in most areas were observed to be in good condition. There was some observed staining at ceiling tiles in the Multipurpose Room. At locations where a roof is directly above stained tiles, further analysis is recommended to determine the cause of the staining as the roof may be leaking at these areas. There were various minor maintenance-level defects/damage to acoustic ceiling tiles and should be corrected as necessary

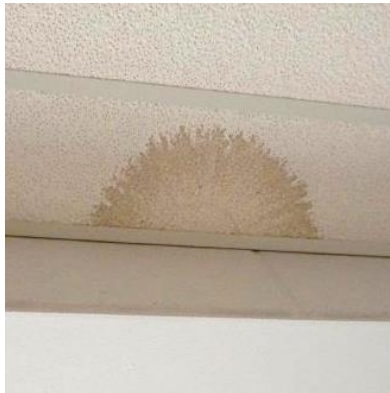
Stained Ceiling Tile at Multi-Purpose

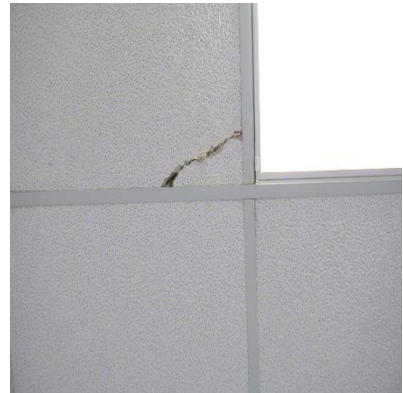
Damaged Ceiling Tile

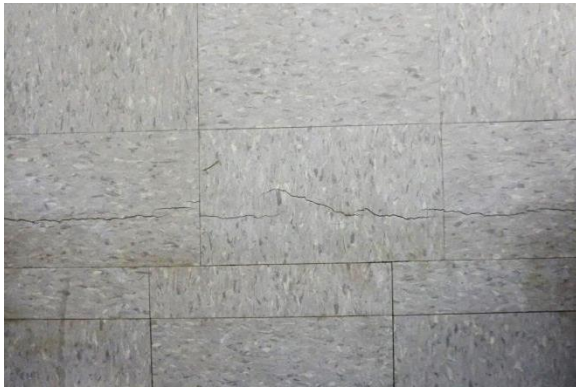
Cracked Vinyl Tile at Art Room

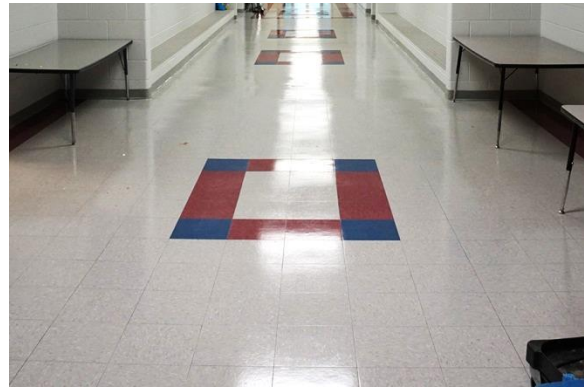
Typical Vinyl Tile at Corridors

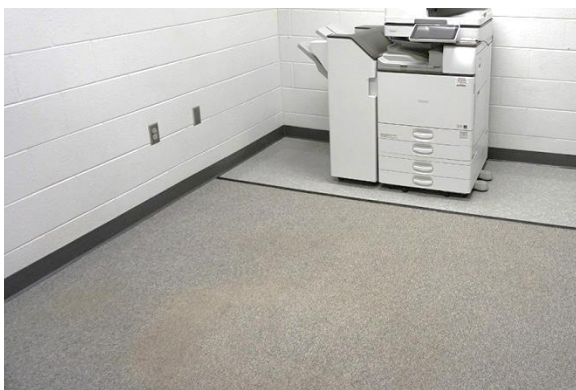
Heavy Carpet Staining at Copy Area

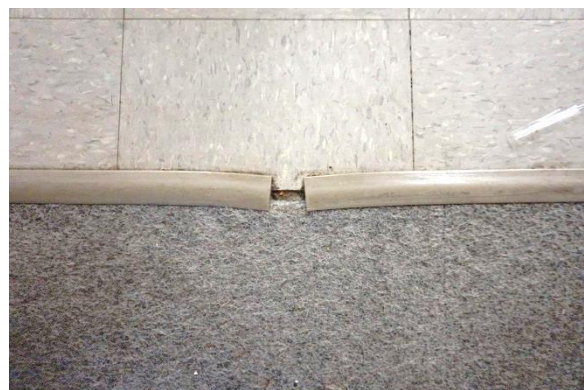
Missing Transition at Carpet/Vinyl Tile

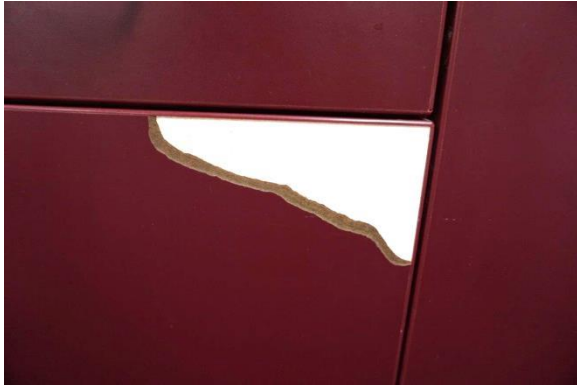
PLam Chipping on Casework

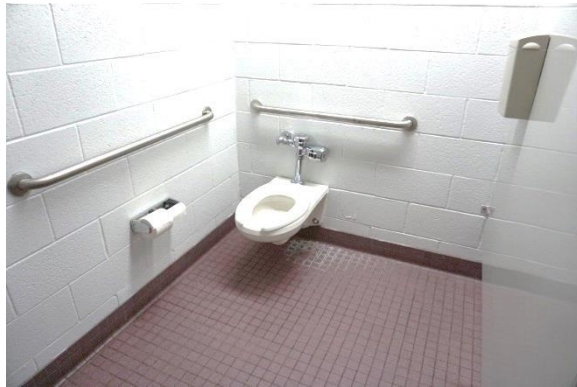
Missing Grab Bar at Men's Restroom

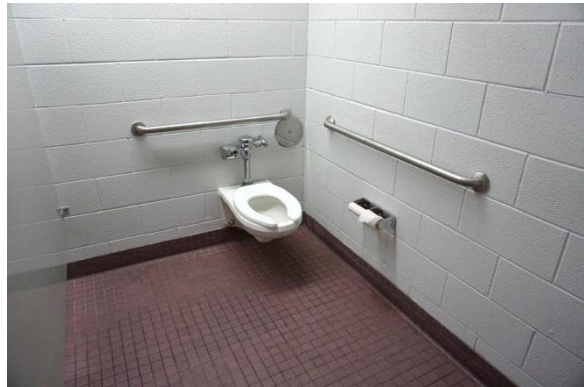
Missing Vertical Bar at Women's Restroom

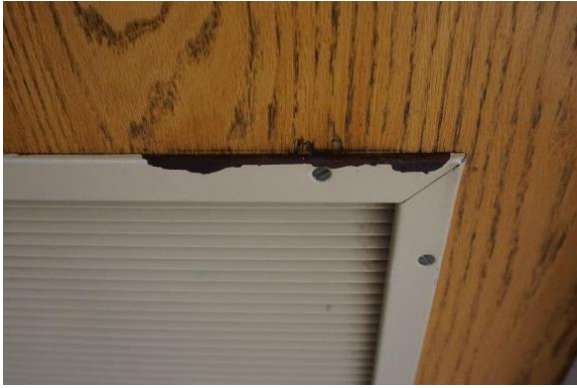
Rust on Door Louver at Men Restroom

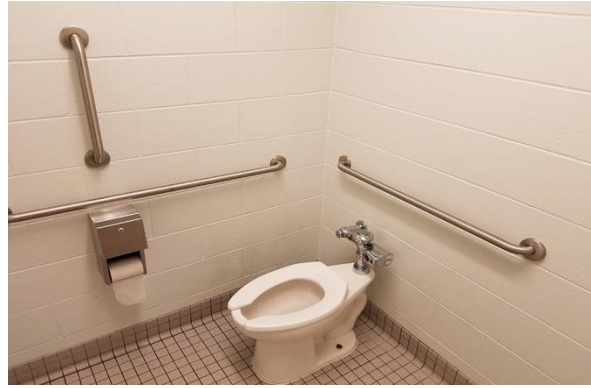
Vertical Grab Bar Installed at Child Restroom

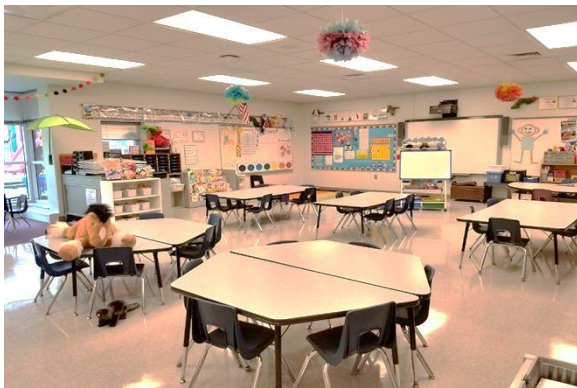
Typical Classroom Layout

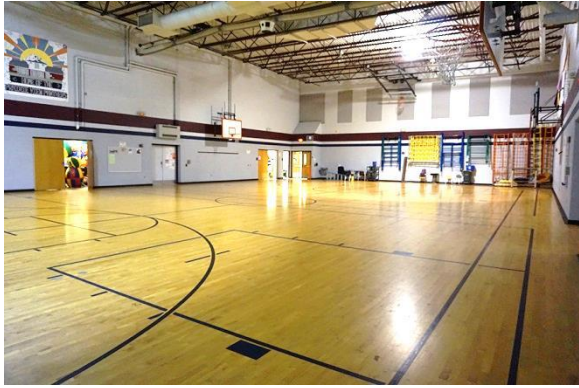
The Gymnasium was observed in good condition with only minor maintenance-level issues such as broken outlet covers, minor scuffing on walls, and some chipping paint. These issues should be corrected.

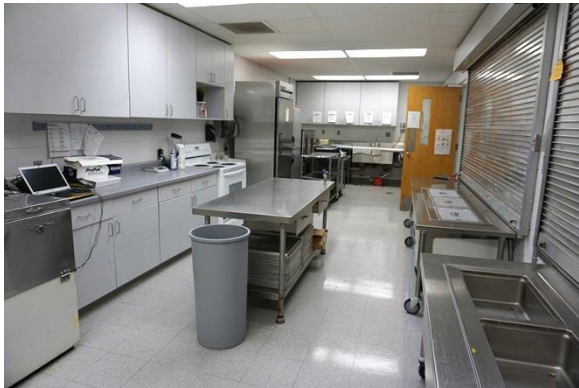
The Kitchen and Cafeteria area were observed in good condition aside for some minor maintenance-level issues such as missing light switch and outlets covers. The kitchen area was very clean and the equipment/casework was in good condition. No improvements recommended at this time.

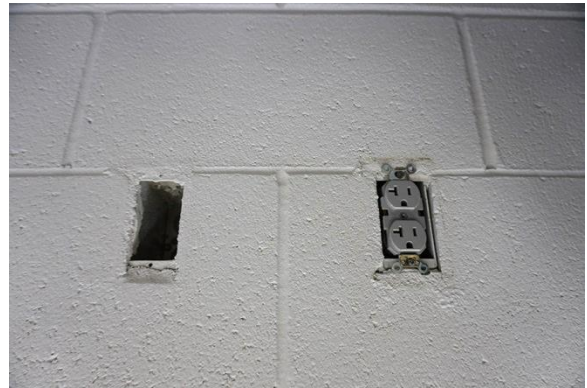
Missing Outlet Covers in Cafeteria

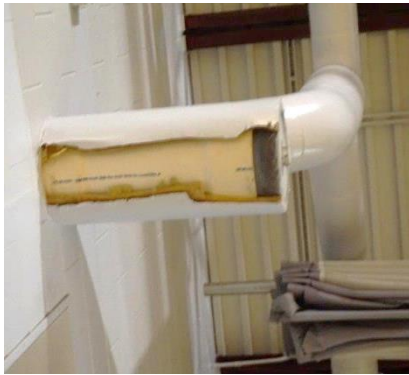
Damaged Insulation at Gymnasium

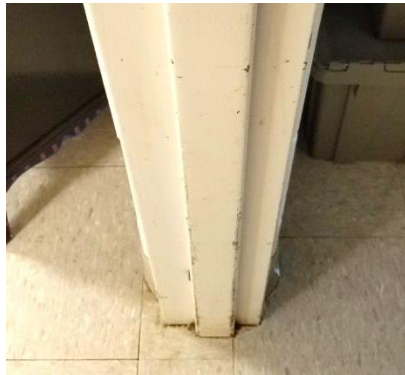
Scratched/Rusted Door Frame

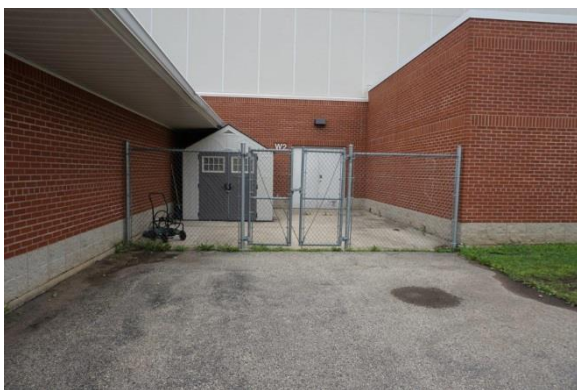
Egress Route Blocked at Exit W2

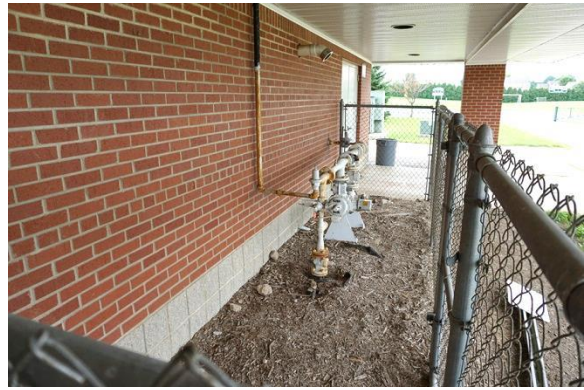
Rusted Pipes Between Entrances W-4 & W-3

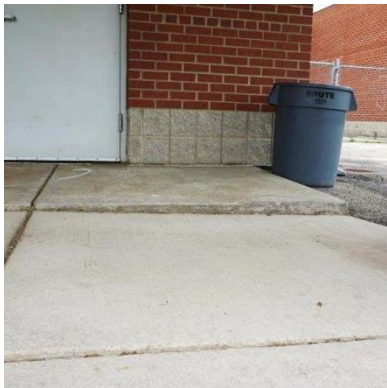
Heaving Concrete Walks

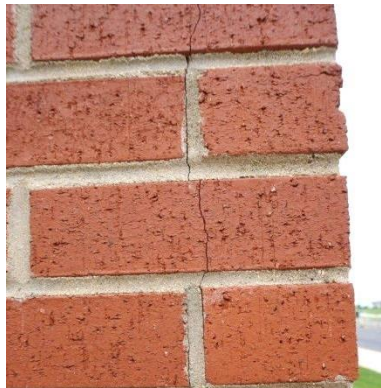
Cracks on Brick Façade

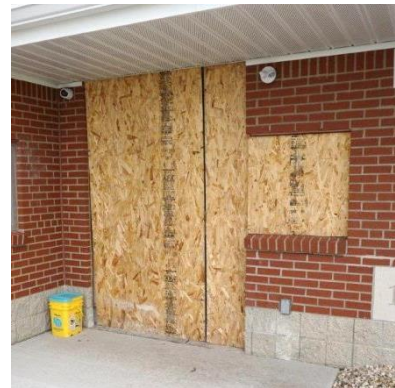
Construction Near Main Entrance

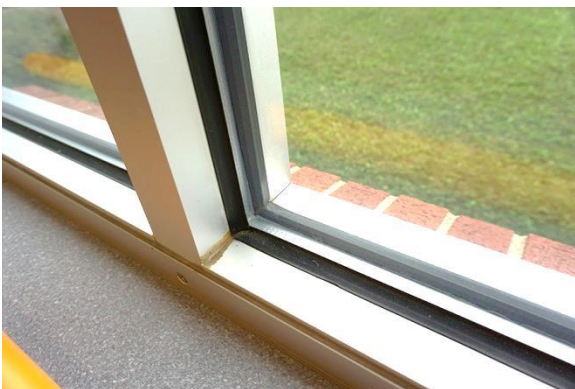
Insulated Glazing Throughout Building

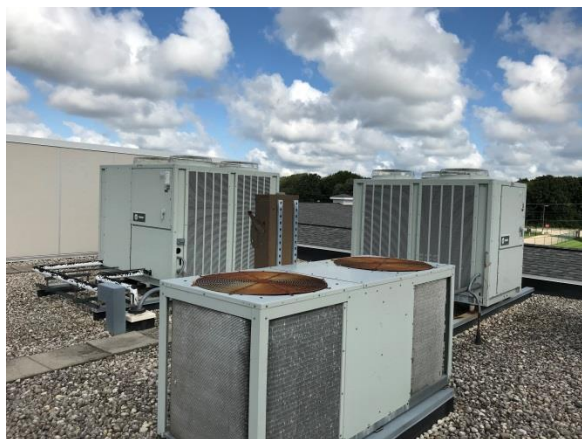
Air Cooled Condensing Units on Roof

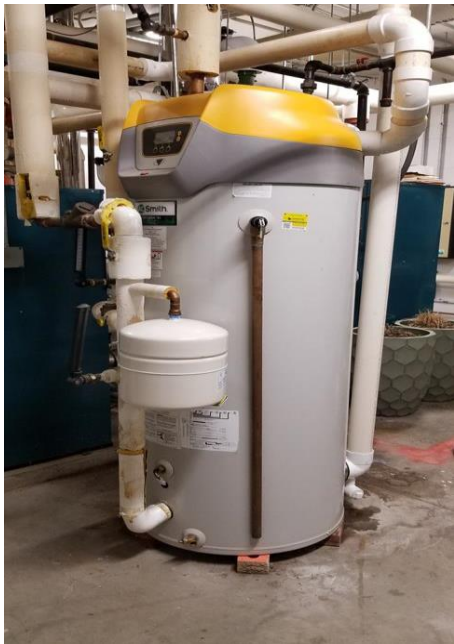
The domestic hot water is heated with an A.O. Smith Cyclone high efficiency HWH located on the mechanical room. The water heater is in good condition and appears to be functioning properly. Water systems are typically insulated throughout.

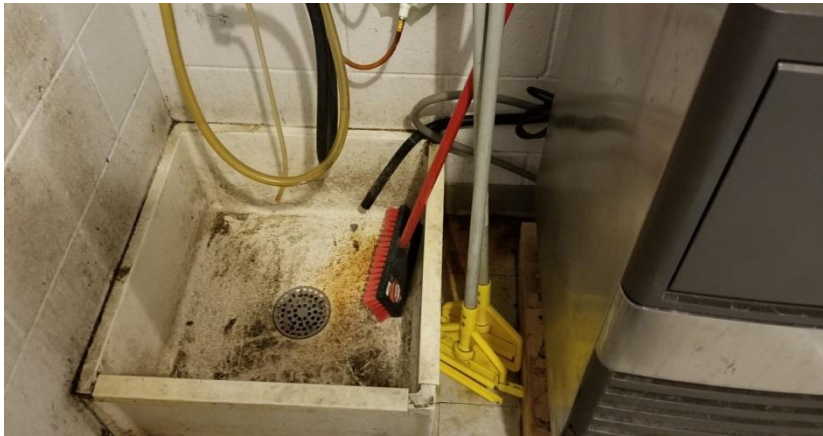
The sanitary drainage systems drain by gravity to the municipal sewer. Piping is typically original to the building and constructed of cast iron and PVC piping. The piping appears to be in good condition with no apparent drainage issue. Cafeteria food serving area is equipped with an ice machine that drains to the service sink serving the area. Current code compliance requires the ice machine to have its own dedicated drain.

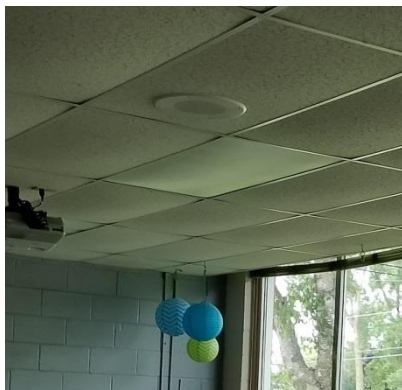
Ceiling Tile Sagging at Classroom 100

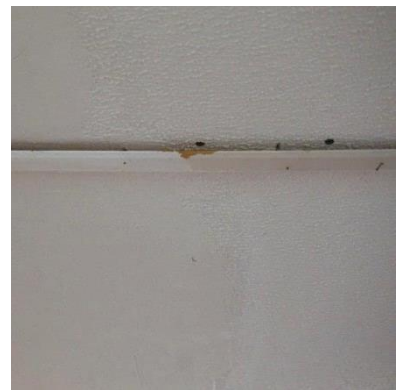
Ceiling Water Damage at Staff Restroom

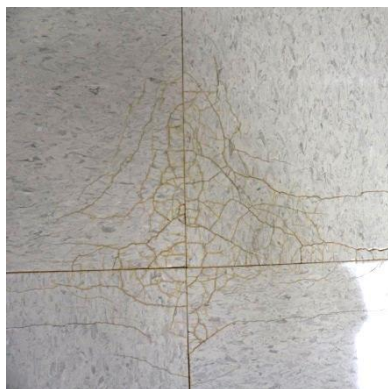
Cracked Vinyl Tile at Corridor

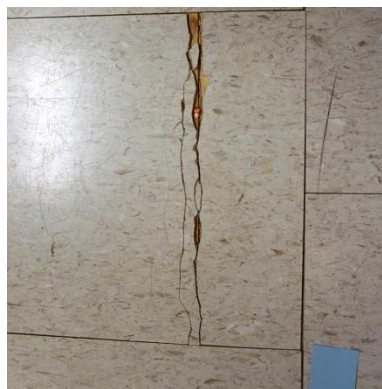
Cracked/Deteriorated Vinyl Tile

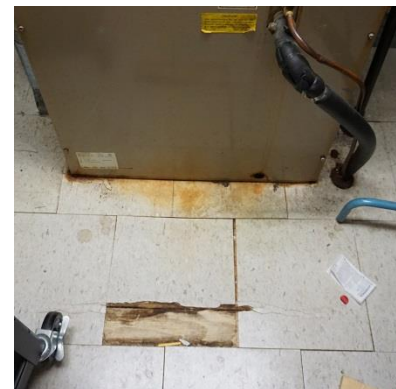
Cracked/Deteriorated Vinyl Tile at Mechanical Room

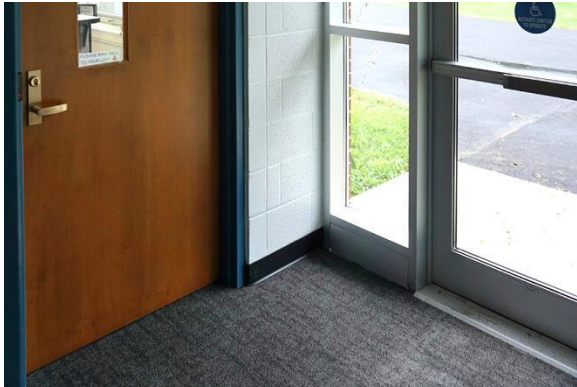
Newer Carpeted Areas Near Main Entry

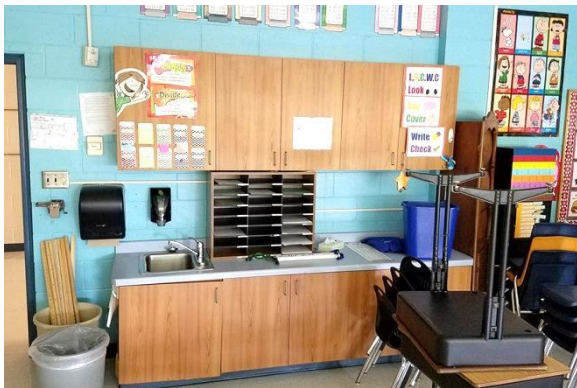
Non ADA Compliant Casework at Classroom 102

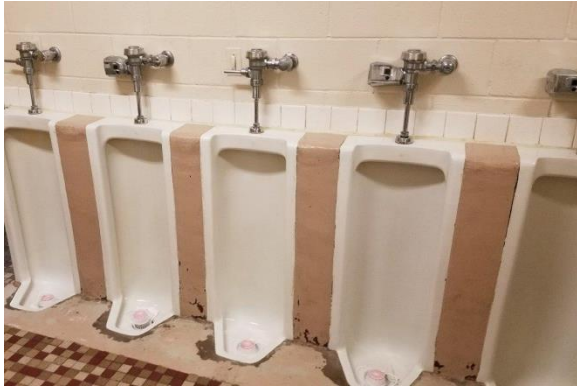
Flaking Paint at Boys Restroom Floor

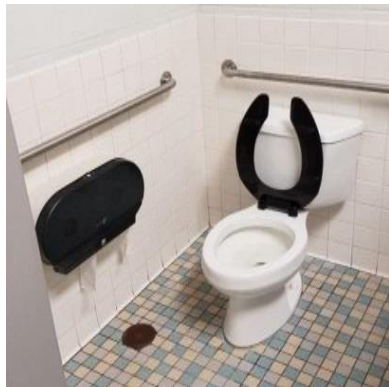
Missing Vertical ADA Grab Bar at Boys Restroom

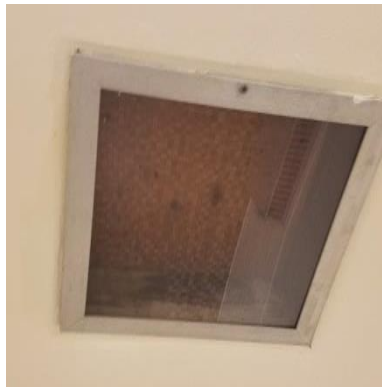
Abandoned Sky Light Boys Restroom

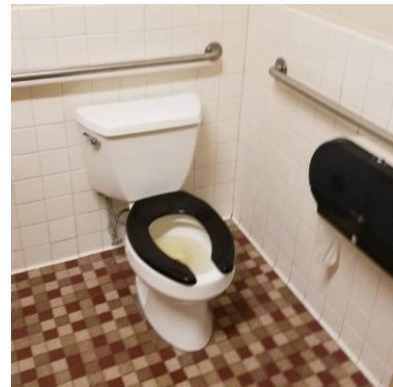
Missing Vertical ADA Grab Bar at Girls Restroom

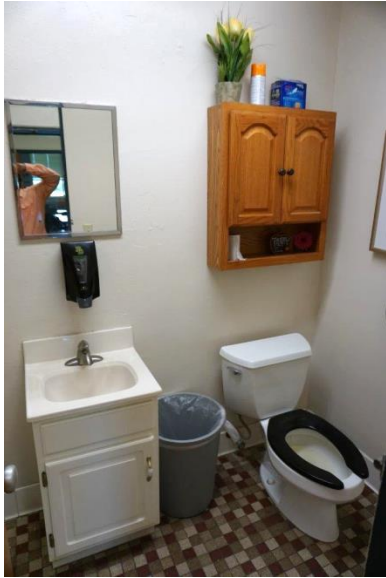
Non-ADA Compliant Staff Restroom

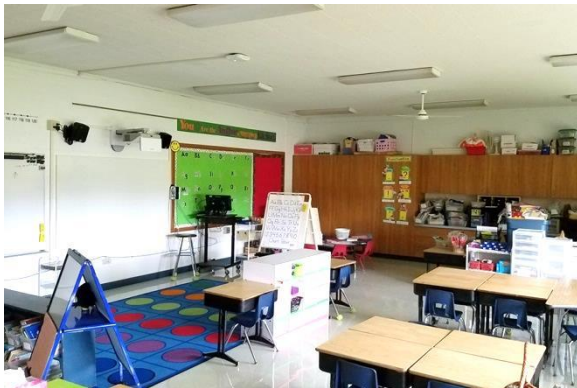
Typical Classroom Layout – Original Building

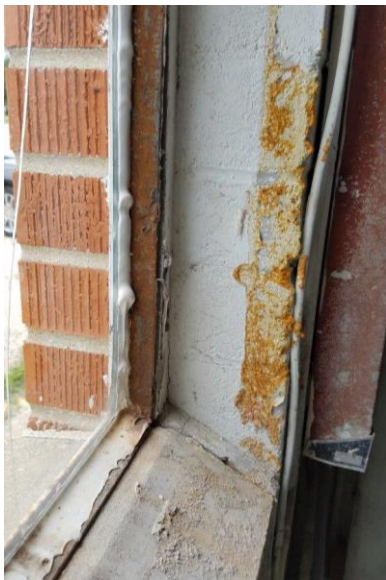
Rusted Window Frame/Deteriorating Caulk

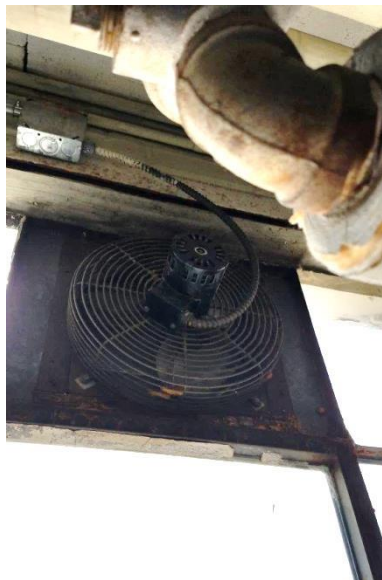
Single Pane Window, Ventilation Fan

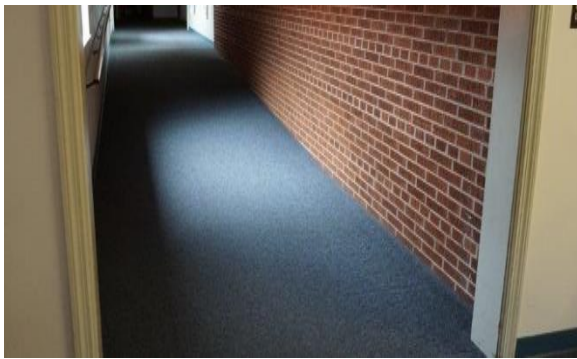
Non-Ada Compliant Ramp at Shed Module

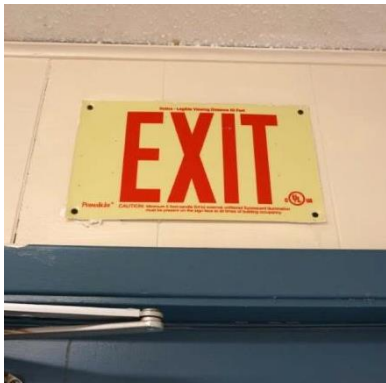
Non-Illuminated Exit Sign

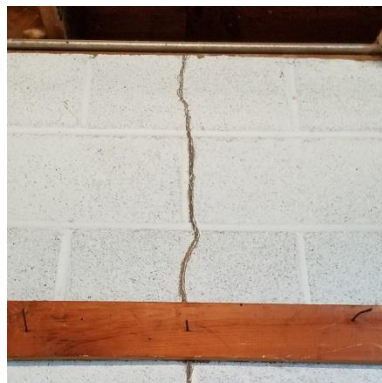
Cracking CMU Wall at Storage Room

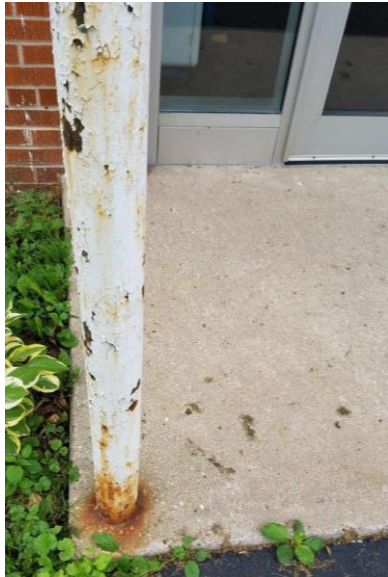
Rust at Canopy Column Base

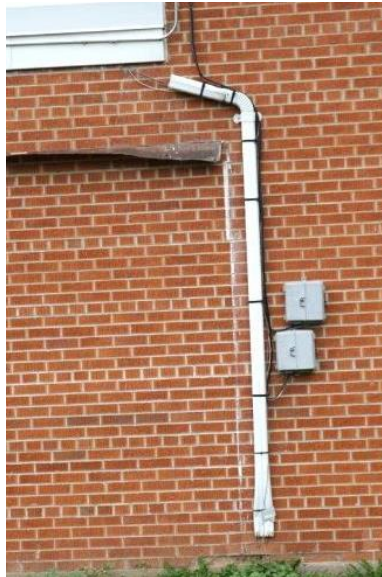
*Gutter Assembly Used as Conduit,
Exposed Wires*

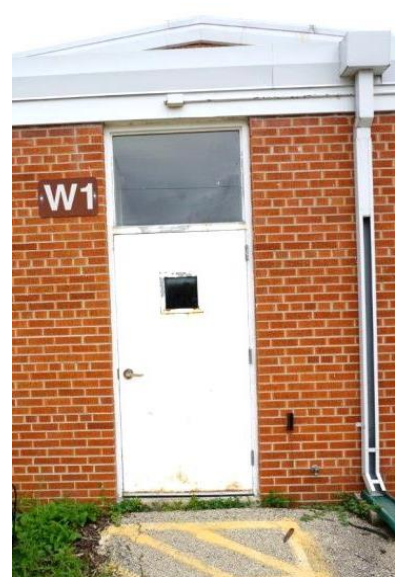
*Rusted Door/Frame, Stoop Settlement
at Exit/Entry*

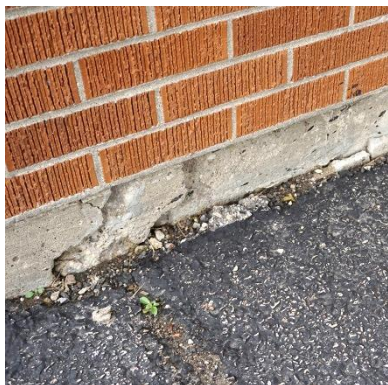
Cracking at Foundation

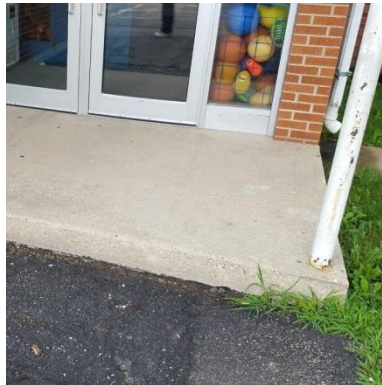
*Rusted Canopy Column Base; Stoop
Settlement*

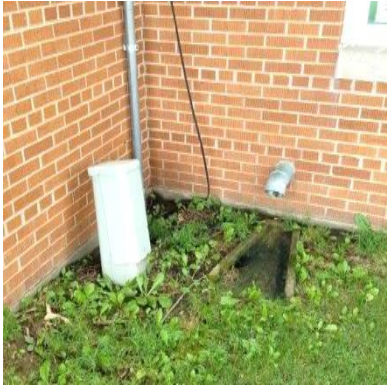
Improper Conductor Termination,
Grade Settlement

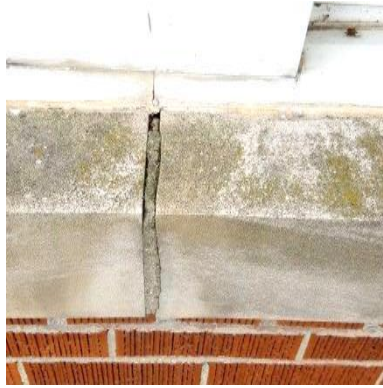
Concrete Lintel Deterioration

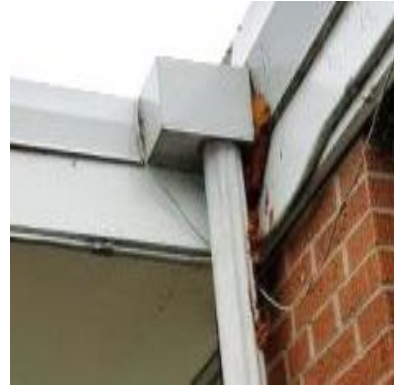
*Leaking Conductor/Gutter; Exposed
Insulation*

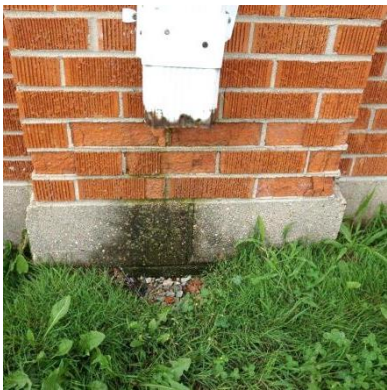
Missing Downspout, Foundation
Discoloration

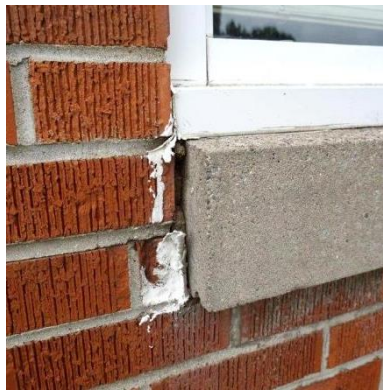
Improper Flashing Installation at
Window Sill

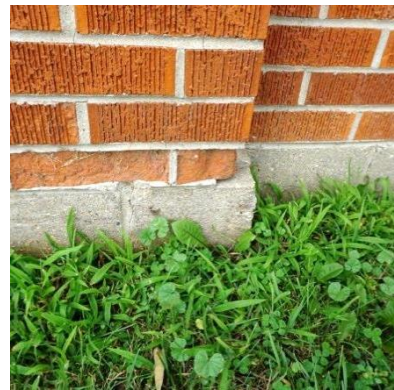
Spalling Masonry at Base of Wall

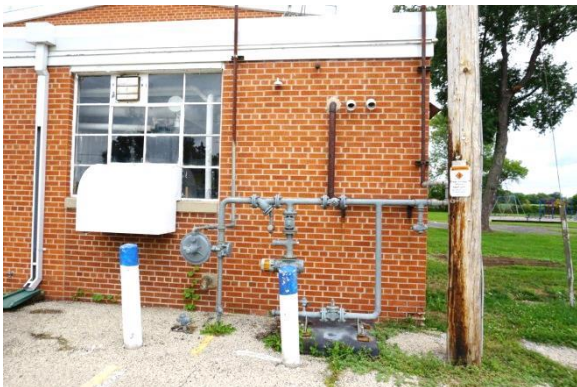
Piping/Ventilation at Mechanical Room Exterior

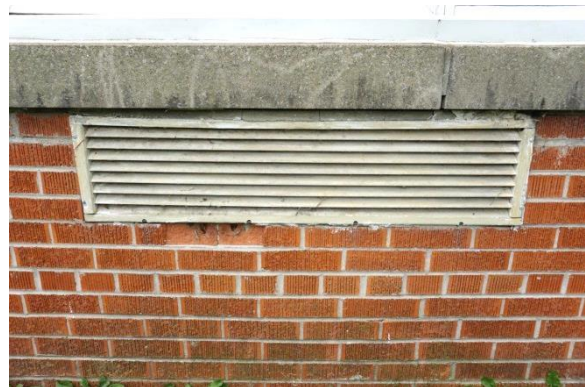
Rusted and Damaged Louver

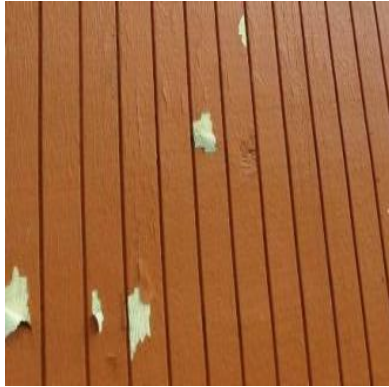
Flaking Paint at Wood Cladding

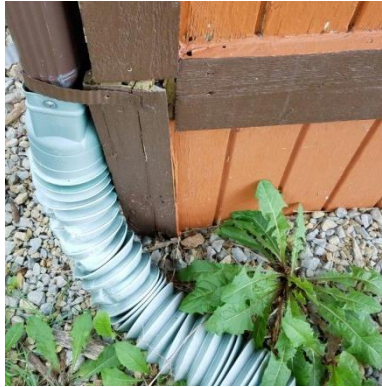
Wood Trim Deteriorating at Base

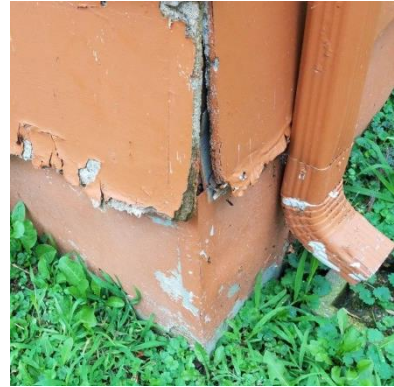
Wood Siding Deteriorating At Base

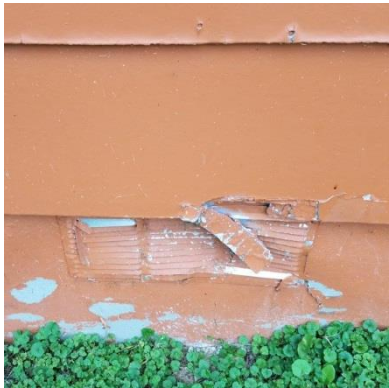
Dented & Damaged Vent & Siding
