2018 Facility Assessment Plan

Prepared by:

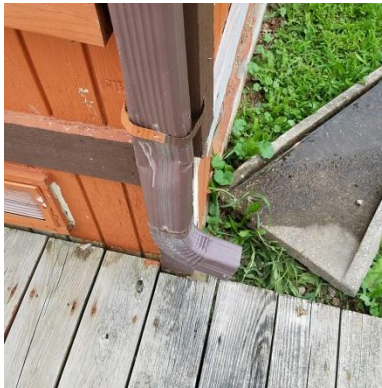
Improper Drainage; Rotted Wood Decking

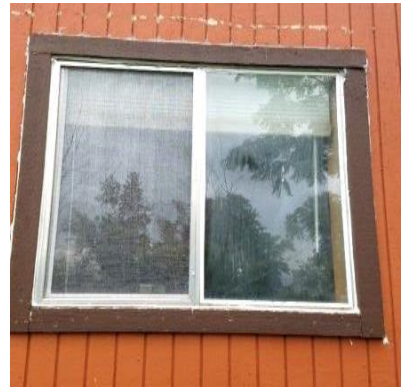
Deteriorated Single Pane Window

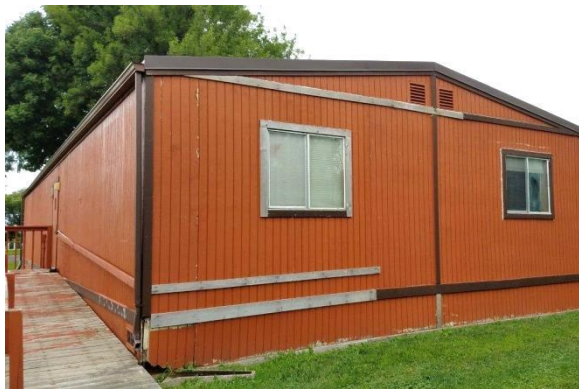
Exterior Envelope/Ramp Deterioration

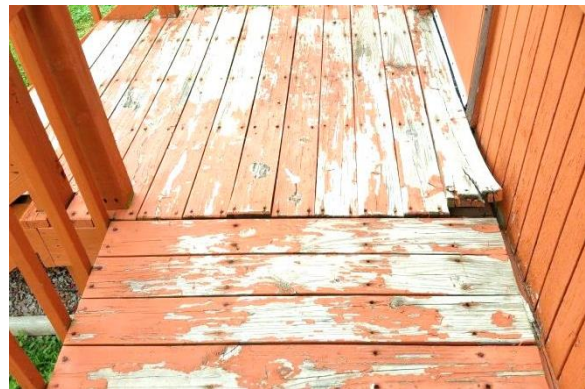
Non-ADA Compliant Ramp, Decking Worn/Deteriorating

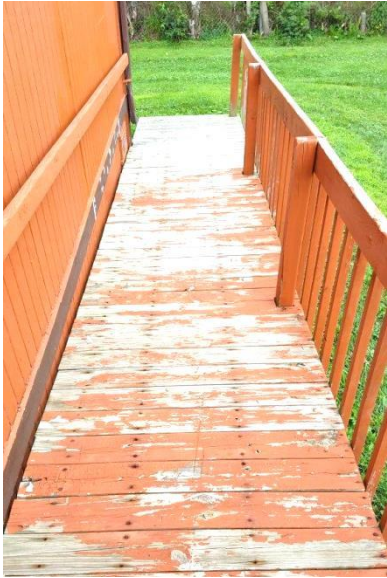
Non-ADA Compliant Ramp, Structure Deteriorating

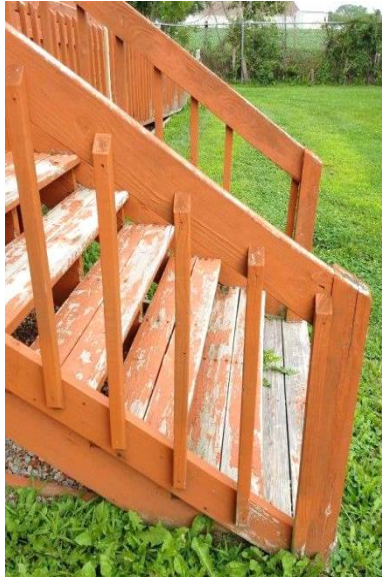
Non-Code Compliant Wood Stair Deteriorating, Paint Flaking Off

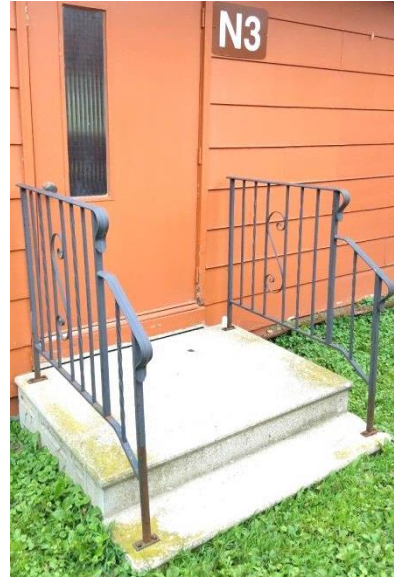
Non-Code Compliant Entrance/Exit at N3

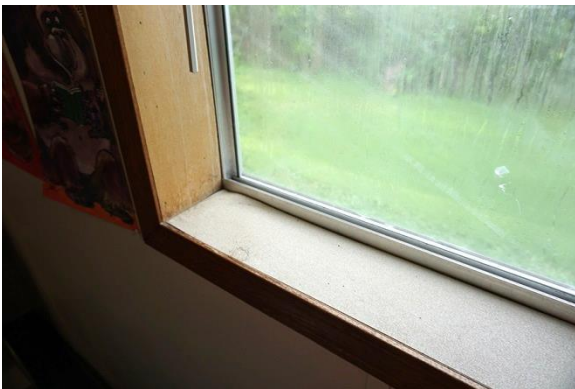
Single Pane Glazing at Original Building Classrooms

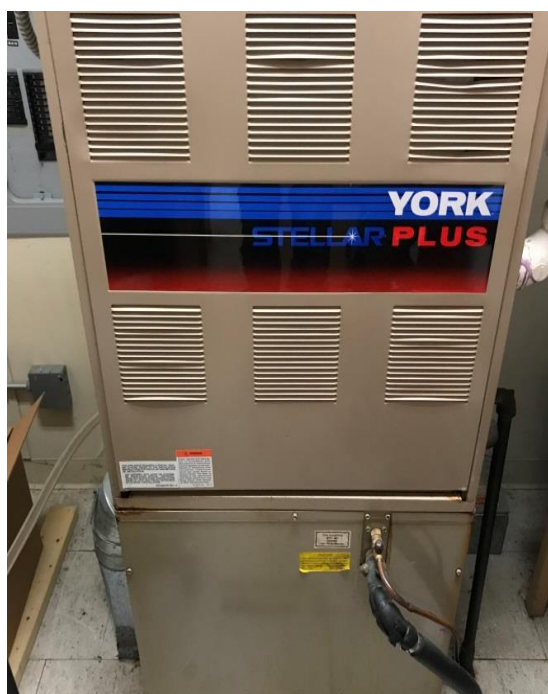
The primary heating system is a steam boiler located in the mechanical room. While this boiler was replaced 2013 and have an average life of 30 years, the overall condition of the piping and insulation is in poor condition. Recommend replacement of existing system to a new hot water system.

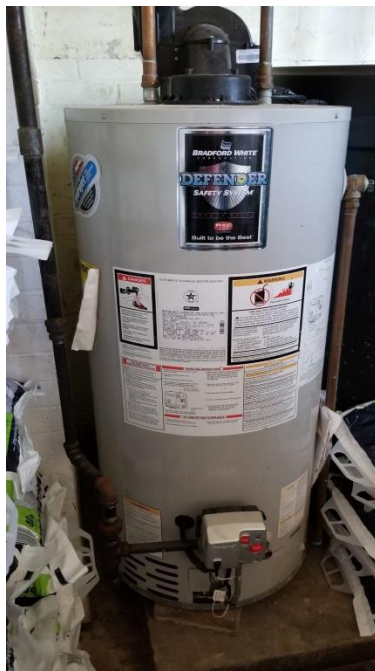
The majority of the domestic hot water is heated by a 40 gal power vent water heater located in the mechanical. A booster heater is located in the mechanical room that serves the kitchen/cafeteria serving area.

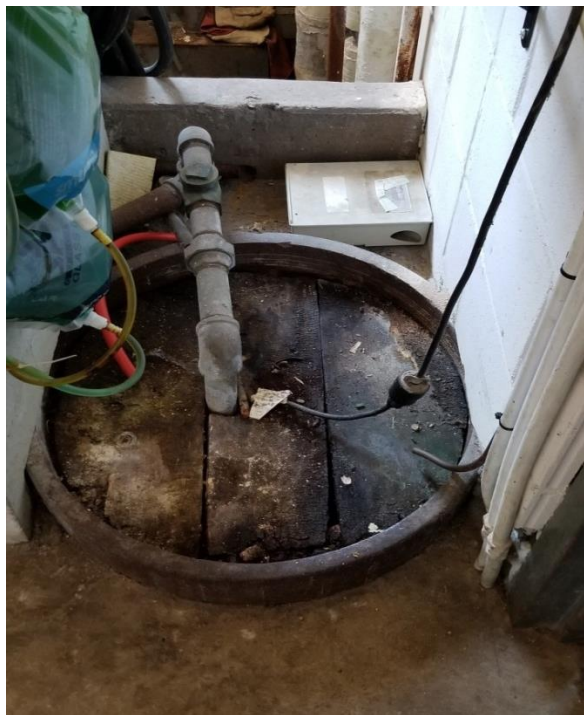
The sanitary drainage system serves the building plumbing fixtures and floor drains. The sanitary drainage system drains by gravity to a private sewage system. A sewage ejector is located in the mechanical room. Piping is typically original to the building and constructed of cast iron hub & spigot 3" and under with galvanized waste and vent 2" and less. PVC piping has been used in areas of renovation and repair. The piping appears to be in fair to poor condition for the age of the building. There are apparent signs of leaks on some of the waste piping joints.

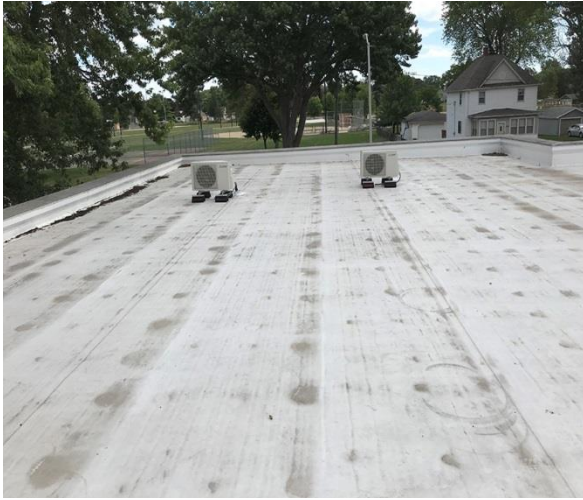
TPO Roofing with Scrim Showing

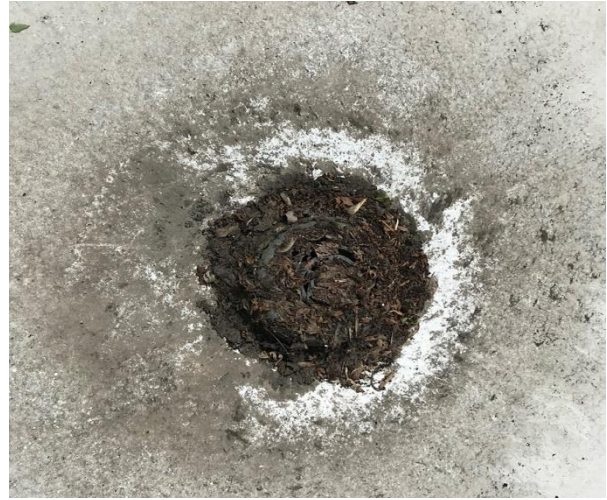
Deteriorated/Plugged Roof Drain

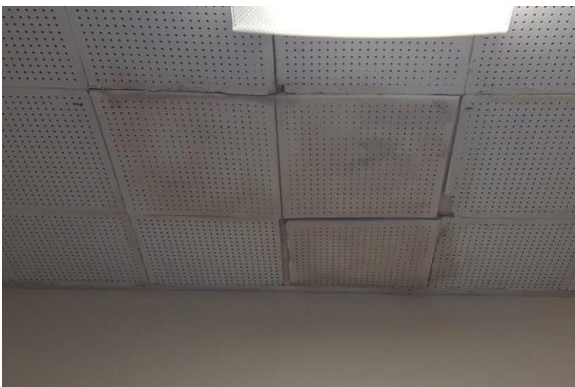
Ceiling Tile Staining, Sagging, and Deteriorating at Classroom 207

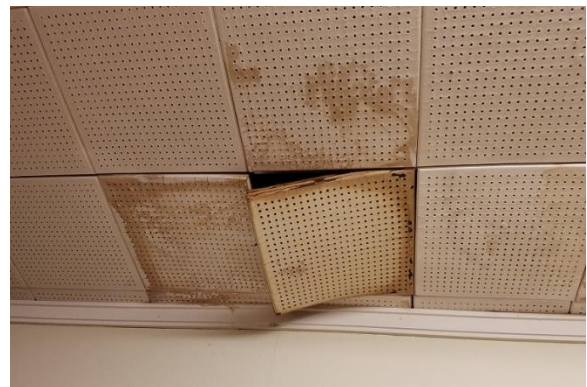
Ceiling Tile Deterioration and Staining at Classroom 302

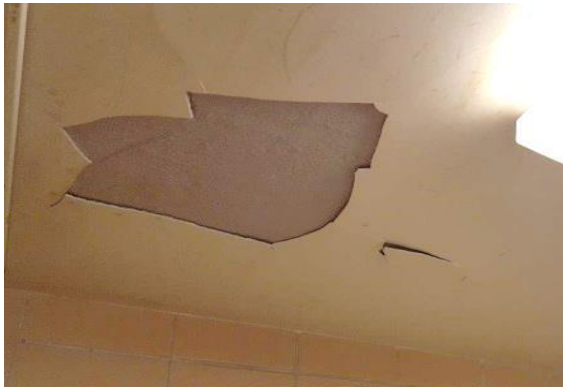
Deteriorated Plaster Ceiling at Restroom

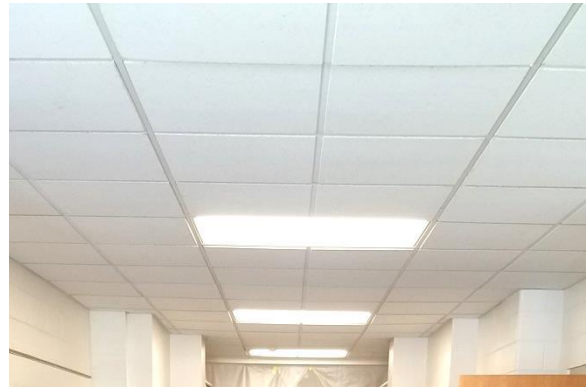
Newer Ceiling Tile System at Corridor

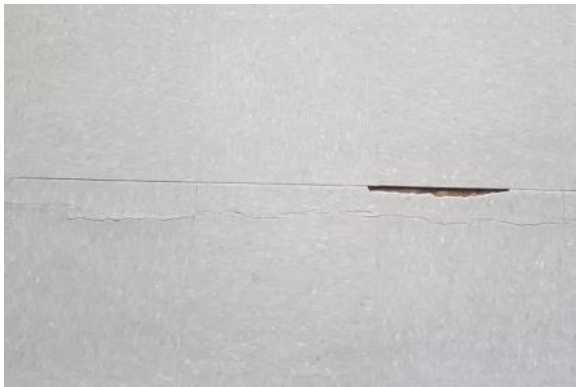
Cracked and Chipped Vinyl Tile at

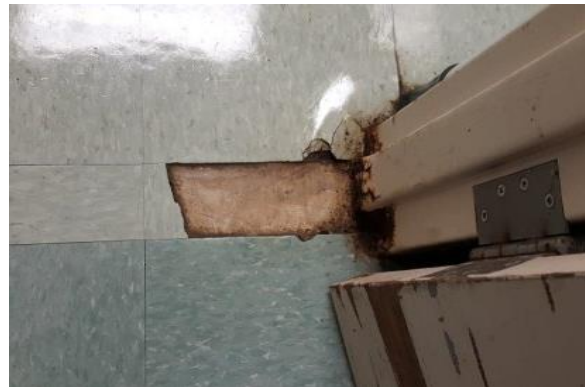
Damaged Vinyl Tile and Rusted Metal Door Frame

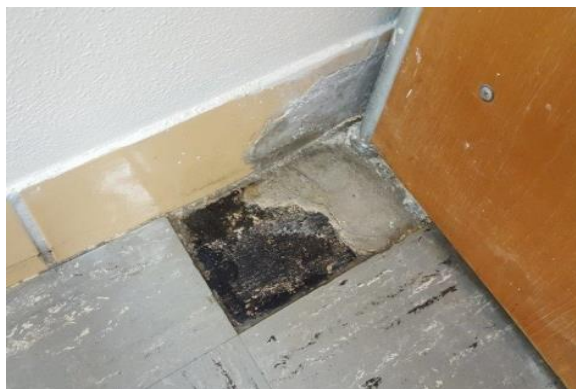
Missing Flooring & Baseboard at Corridor

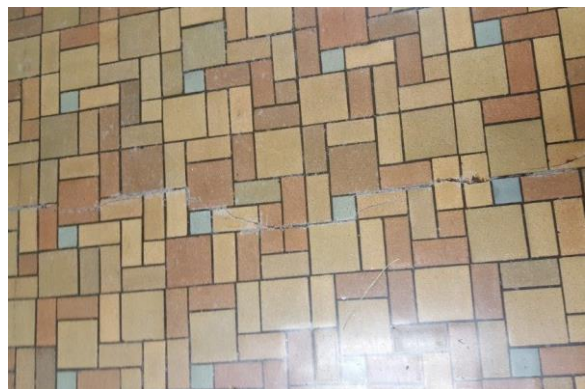
Cracks on Ceramic Tile Flooring

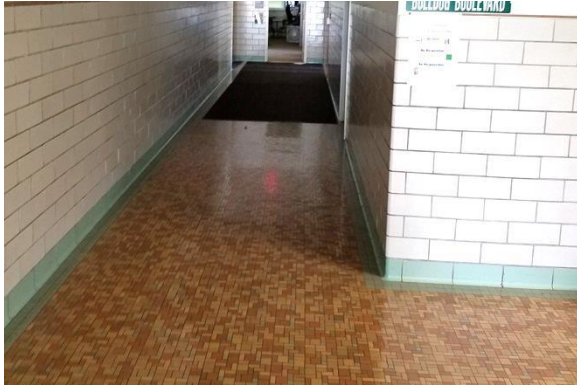
Typical Corridor with Ceramic Tile

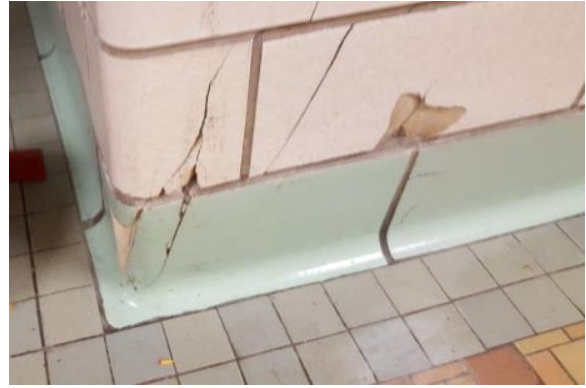
Damaged & Cracked Glazed CMU and Wall Base at Corridor

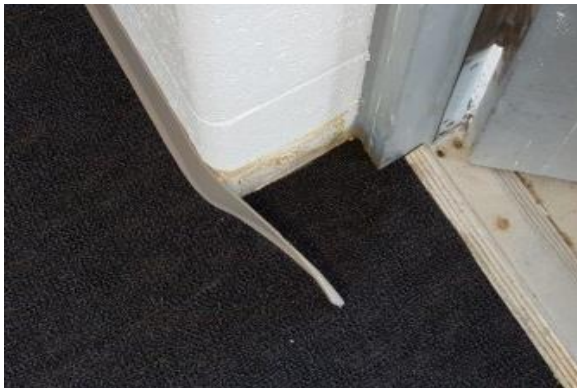
Lifting Wall Base at E2 Main Entrance

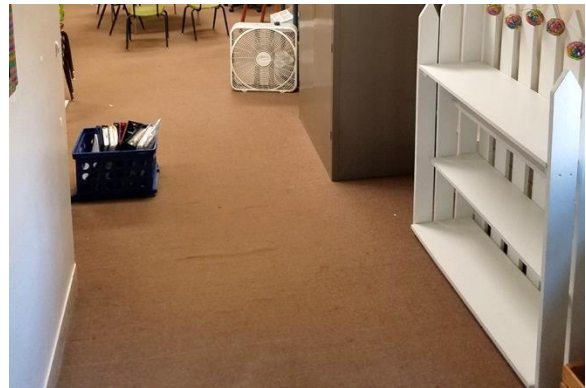
Carpet Stained and Delaminating at Classroom 204

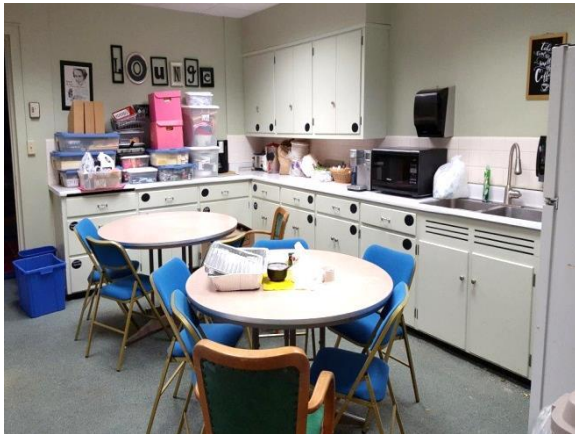
Non-ADA Compliant Casework/Sink at Break Room

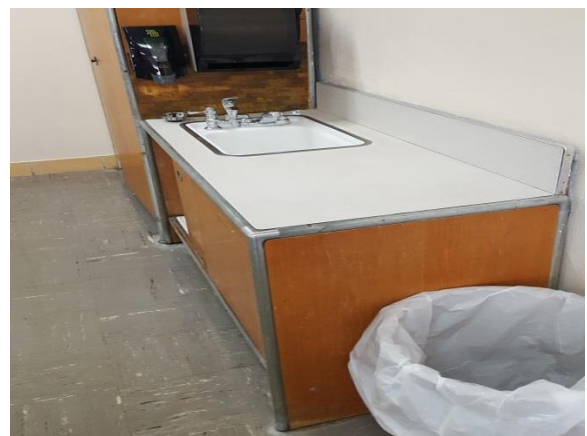
Damaged Non-ADA Compliant Casework at Classroom

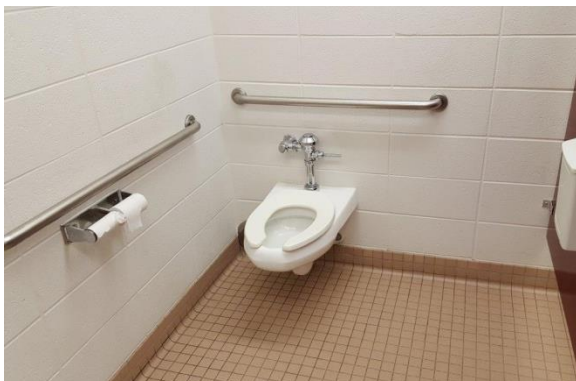
Missing Vertical Grab Bar at Men's Restroom

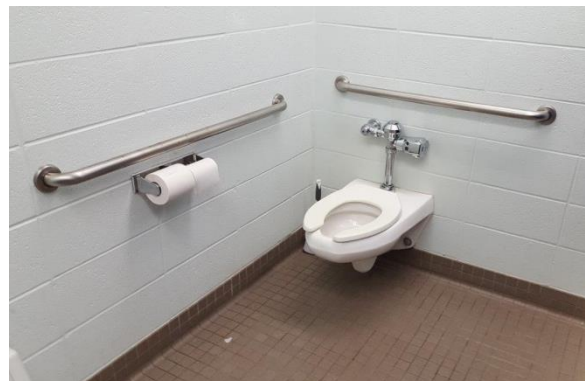
Missing Vertical Bar at Women's Restroom

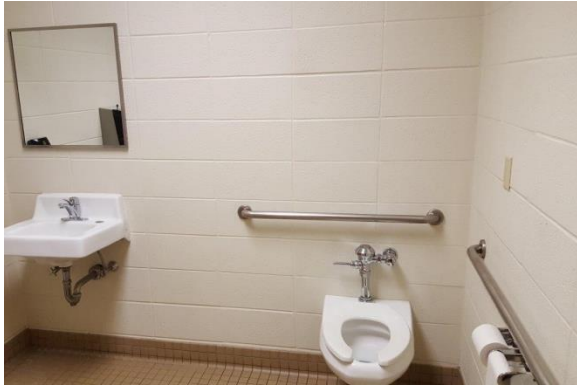
Lack of Vertical Bar at ADA Restroom

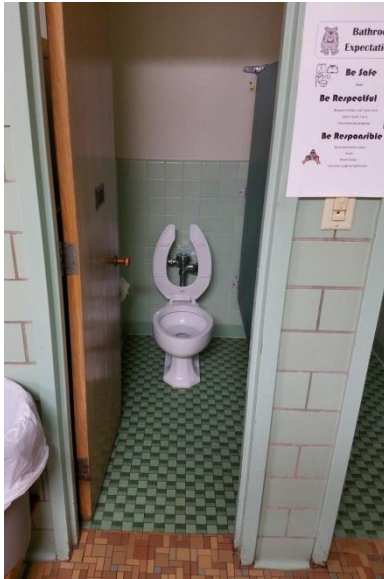
24" Door at Women Restroom – Office

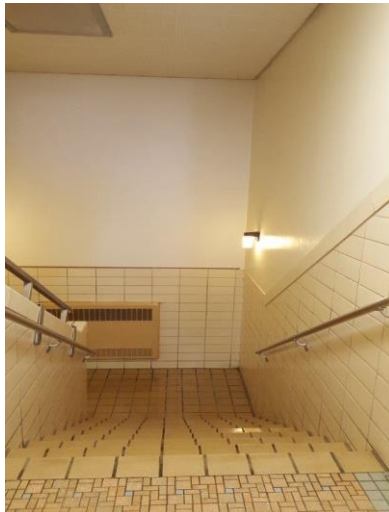
Ceramic Stair Treads; Missing Code-Required Rail Extensions

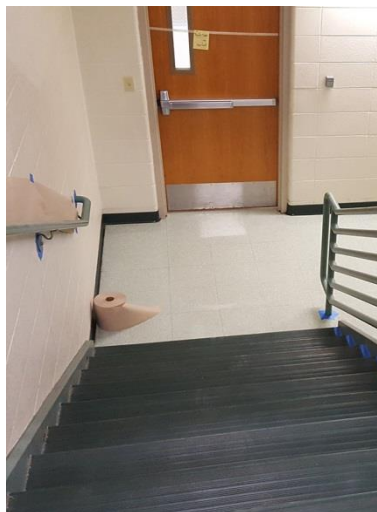
Maintenance at Stairs

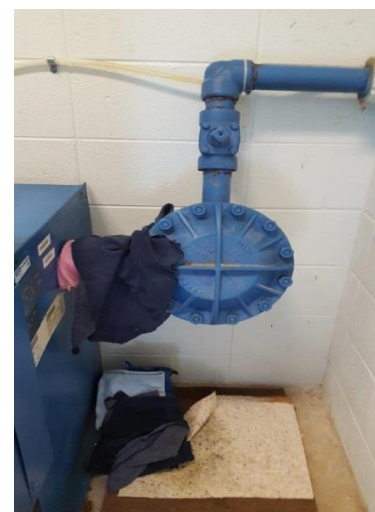
Leaking Elevator Equipment Piping

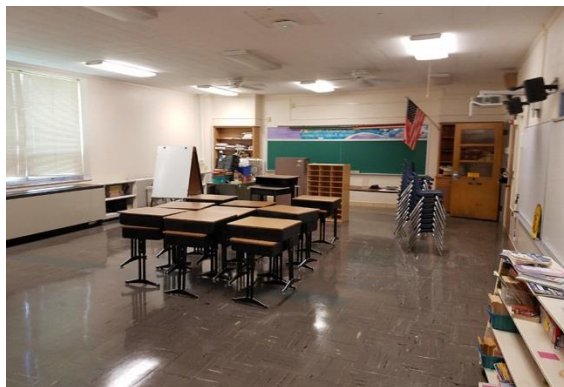
Typical Classroom Layout - Original Building

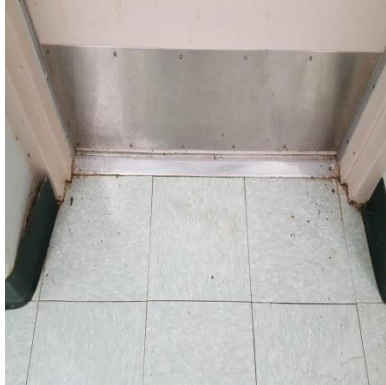
Rusted Metal Door/Frame

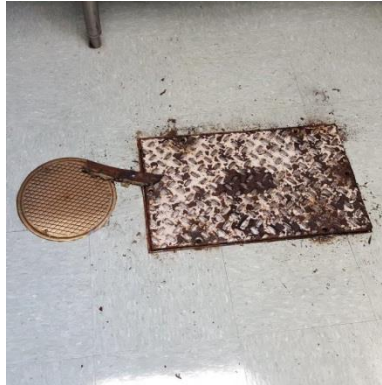
Rusted Kitchen Metal Floor Plate

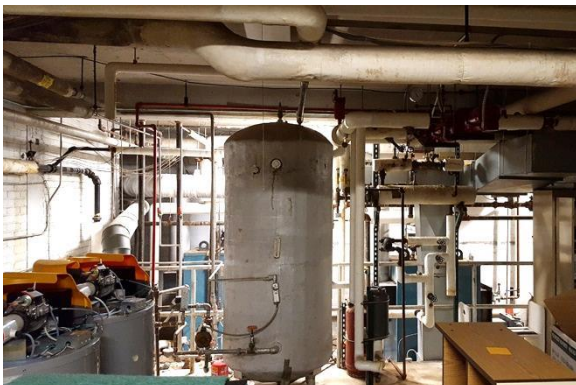
Boiler Room with Abandoned and New Equipment/Piping

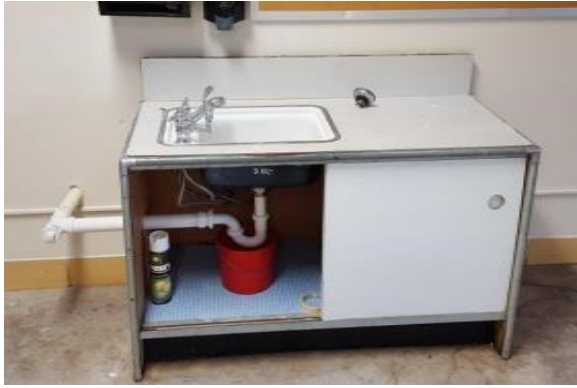
Exposed Plumbing, Damaged Millwork at Classroom 302

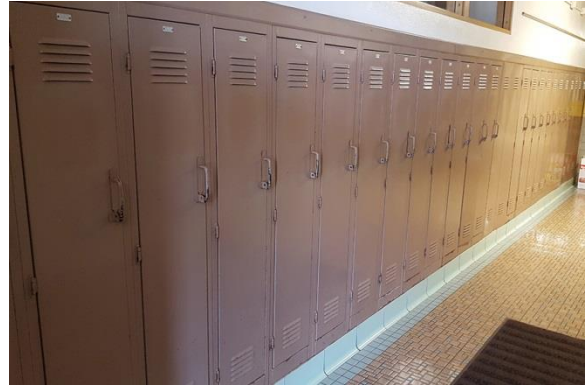
Rusting, Dented, and Scratched Metal Lockers

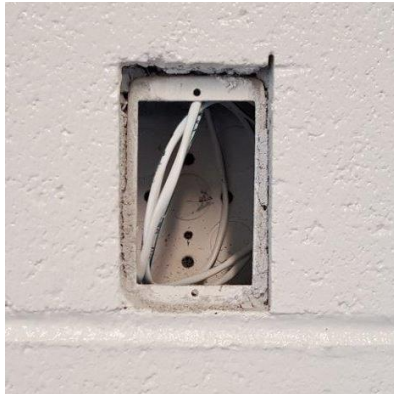
Missing Outlet Cover/Exposed Wires

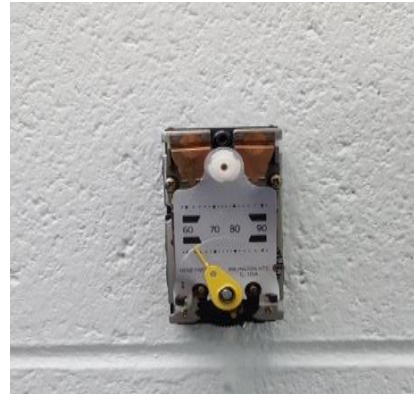
Missing Thermostat Cover

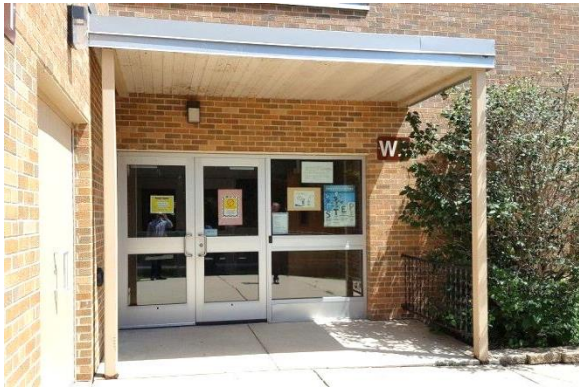
Resting at Base of Columns at W-2 Entrance; Heaving Concrete Walk

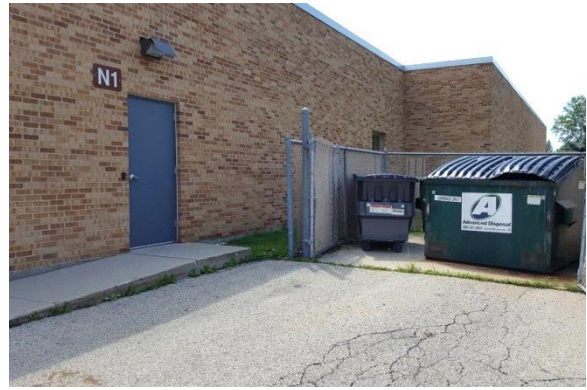
Ramp Not ADA Compliant; Deteriorated Dumpster Enclosure

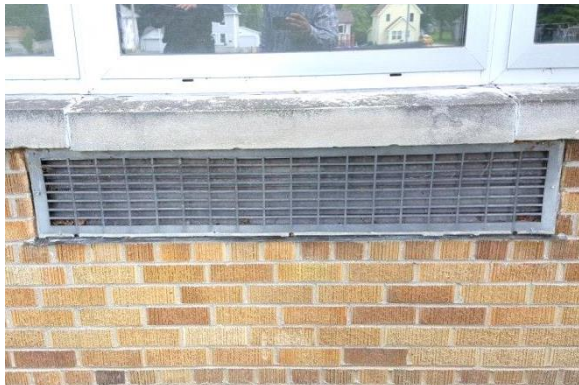
Rusted and Damaged Exterior Unit Vent Louver

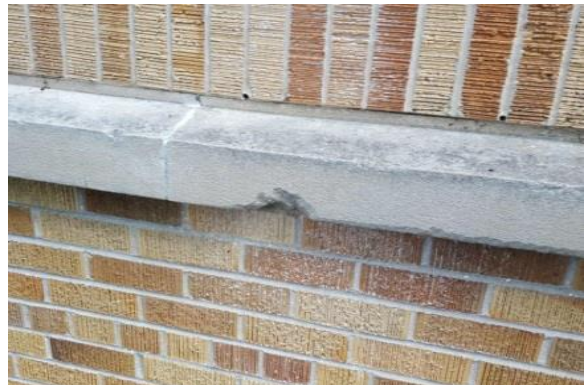
No Weeps Installed at Concrete Sill

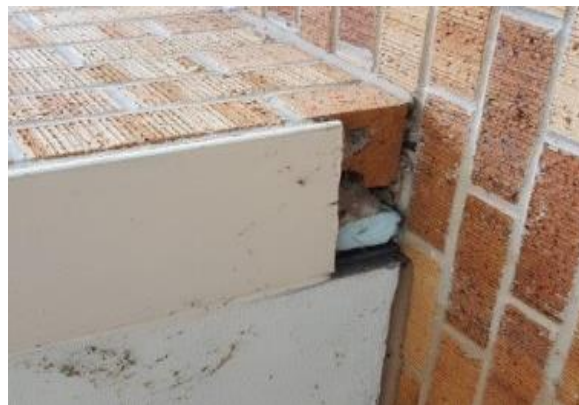
Exposed Cavity Wall/Deficient Lintel

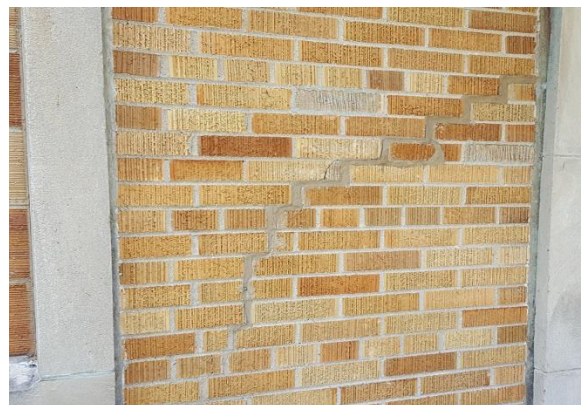
Previous Masonry Repairs

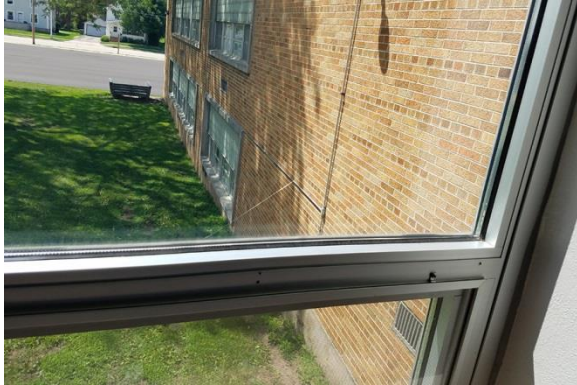
Insulated Glazing at Addition Classrooms

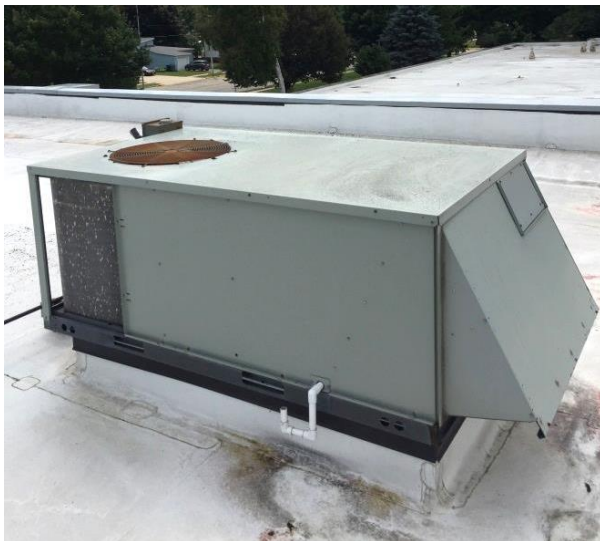
The primary cooling system consists of four (4) Trane rooftop units that were installed in 1997 and have an anticipated life expectancy of 15 years. It is recommended that all of these units should be replaced within the next 1-3 years. Various unit ventilators that serve the classrooms were replaced in the last few years and others will require replacement soon.

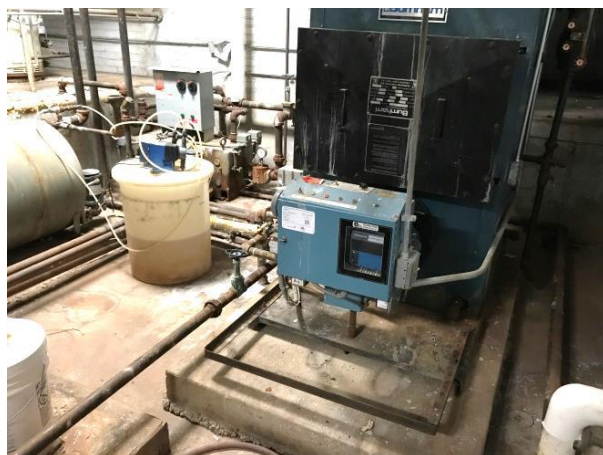
Burnham Fire Tube Boiler

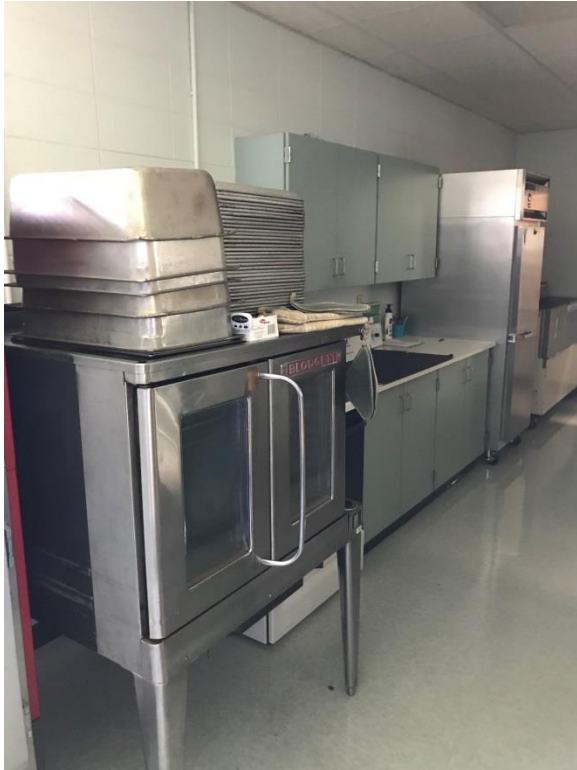
In the kitchen no ventilation exhaust hoods were present. This is a “gray” area of the current International Mechanical Code (IMC) and falls upon the local code inspector’s interpretation. According to the IMC 2015, Type II kitchen hoods must be installed above cooking or dishwashing appliances that produce heat and moisture and/or products of combustion.” This kitchen may require a type II commercial hood over equipment that produces heat or moisture.

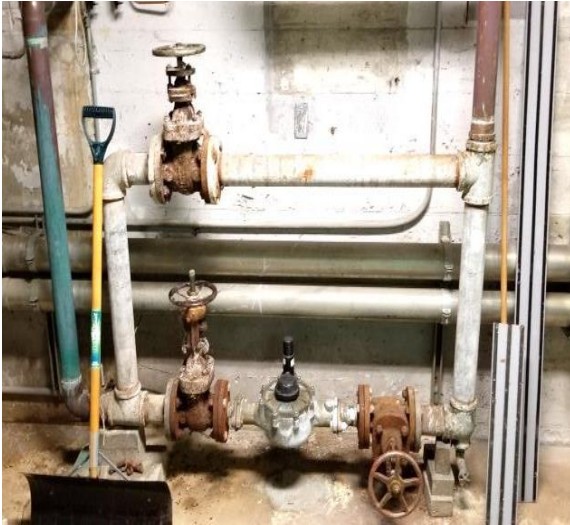
The domestic hot water system is heated with a gas fired draft hot water heater with a circulated storage tank and a tube bundle from the hydronic heating system. System appears to be in the process of being replaced with 2 high efficacy cyclone HWH's. See photos below.

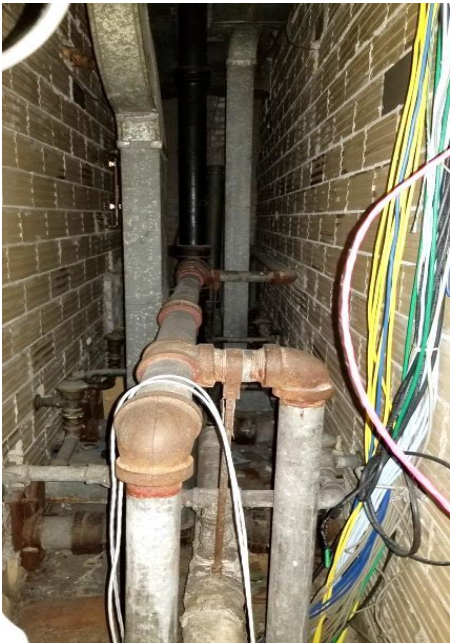
Plumbing Chase at Toilet Rooms

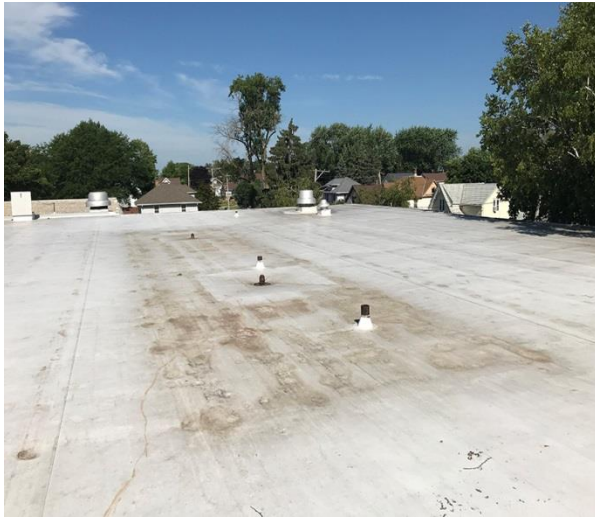
TPO Roofing with Scrim Showing

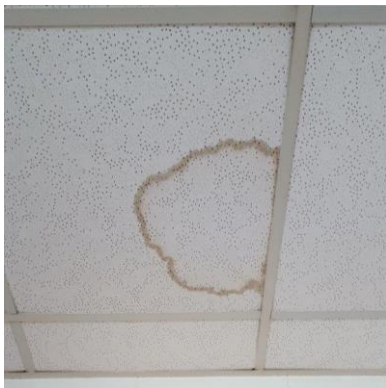
Ceiling Tile Staining at Kindergarten Room 100

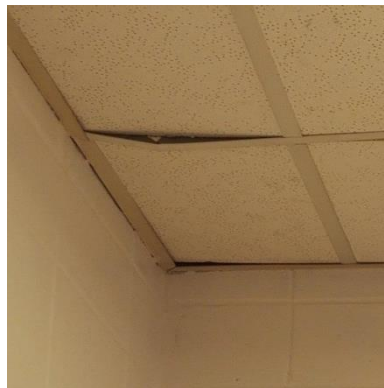
Ceiling Tile Sagging at Music Room

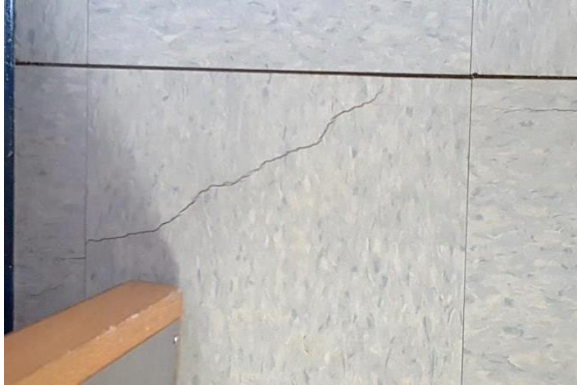
Cracked Vinyl Tile at Media Center - 207

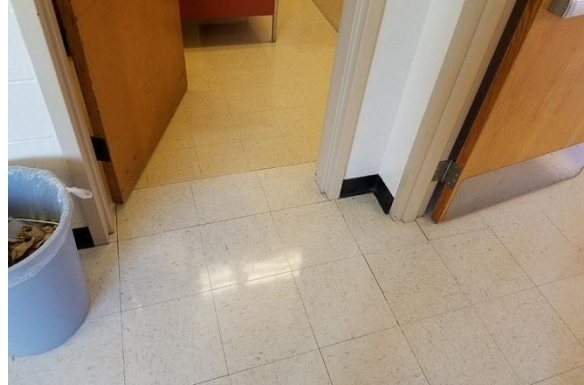
Vinyl Tile Delamination; No Transition

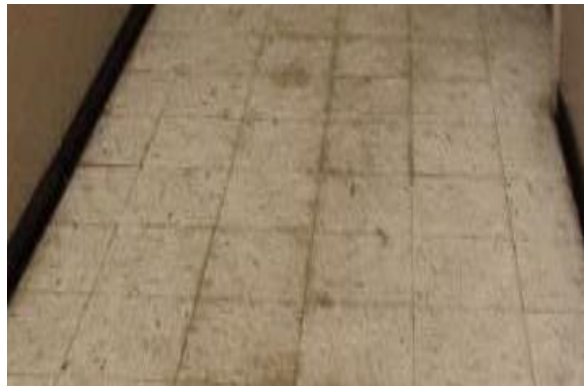
Damaged Tiles at Boiler Room Corridor

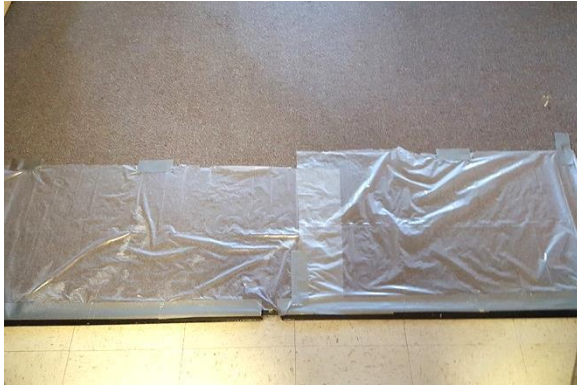
Damaged/Taped Carpet Transition at Classroom 100

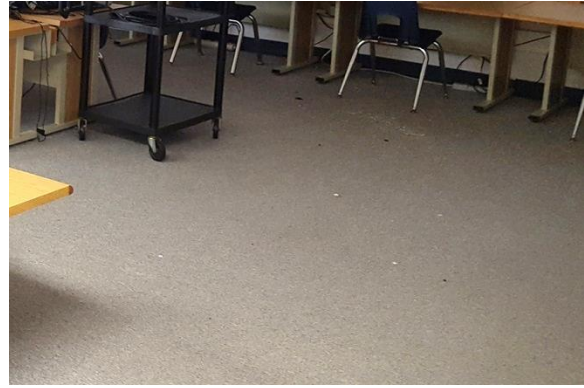
Stained/Worn Carper at Computer Lab

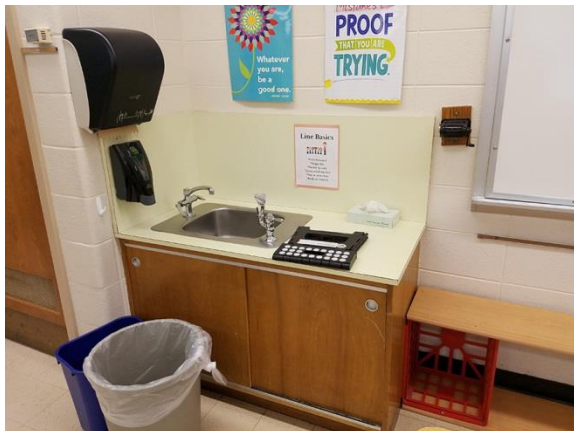
Non-ADA Compliant Casework/Sink at Class Rooms

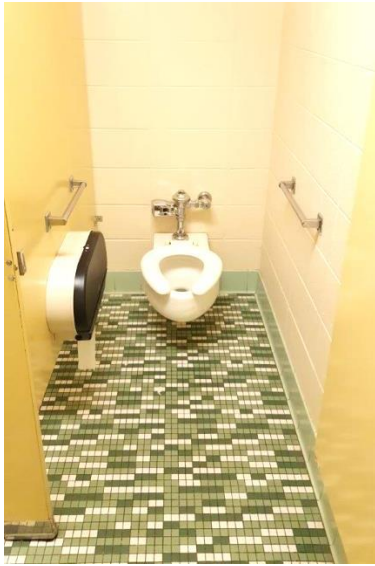
*Missing Grab Bars; Non-ADA
Compliant Clearances*

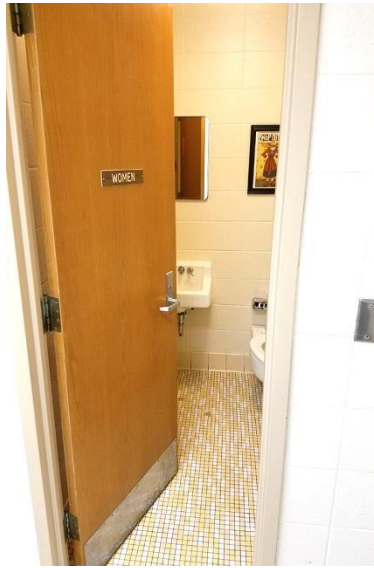
*Non-ADA Compliant Toilet Room at
Administration*

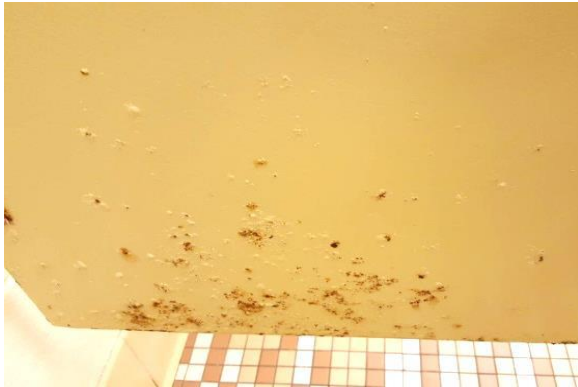
Rusting Toilet Partition

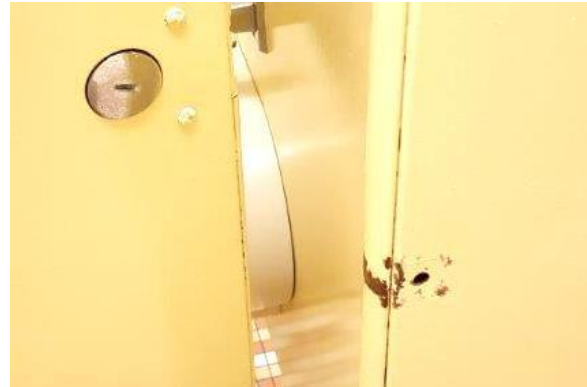
*Missing/Damaged Privacy Locks on Toilet Partition
Door at Staff Toilet Room*

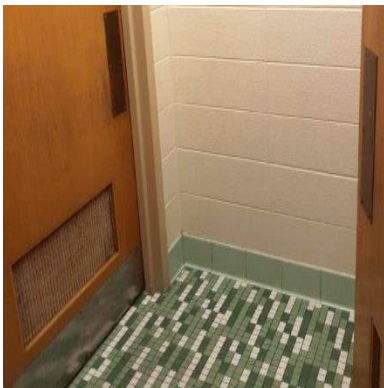
*Toilet Room Vestibules Non-ADA
Compliant*

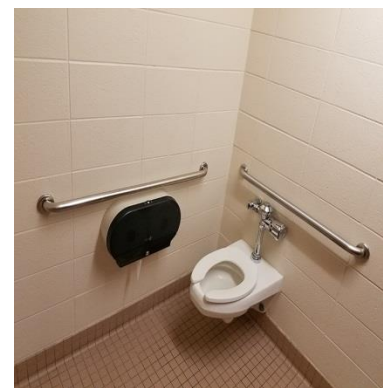
Missing Grab Bars at ADA Toilet Room

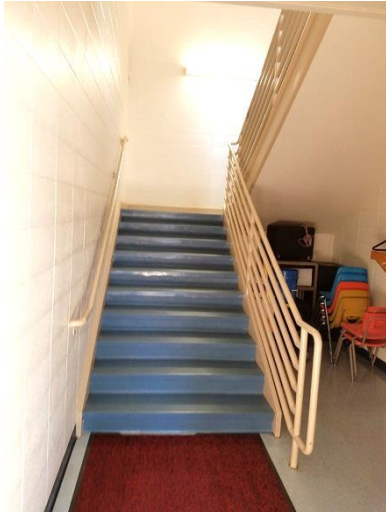
Code Compliant Stairs

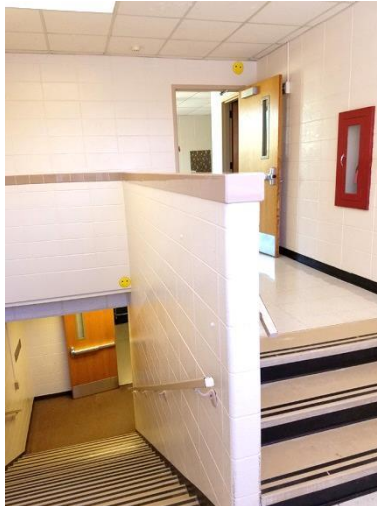
Missing Code-Required Rail Extensions at Stairs

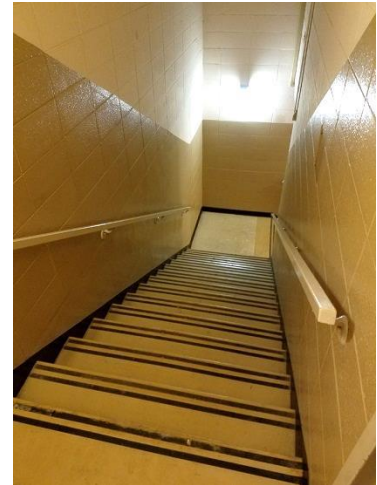
Stairs Leading to Boiler/Locker Room

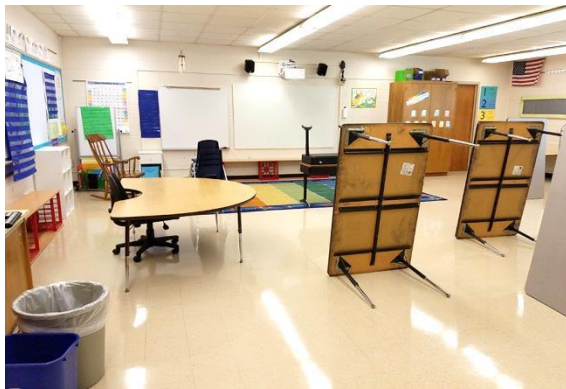
Typical Classroom Layout

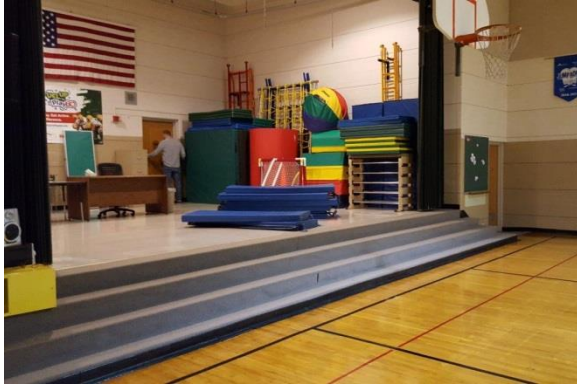
There was no observed ADA access to the stage adjacent to the gym. Depending on the use in this area – ADA accessibility may not be required. Overall, the gymnasium space appeared to be in good condition. Recommend addressing maintenance issues in this space only.

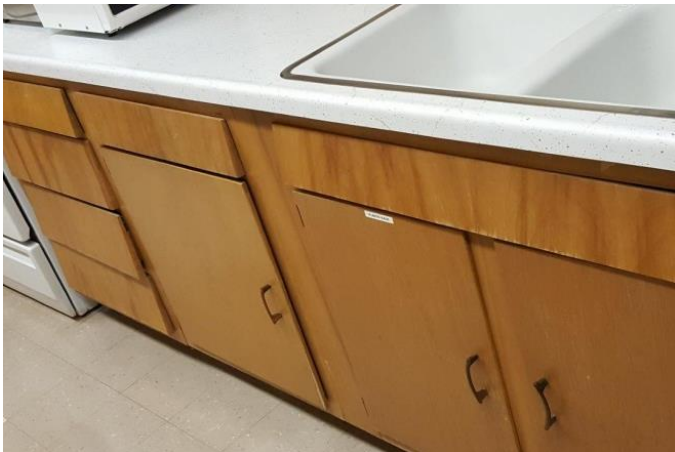
Old and Worn Non-ADA Compliant Casework

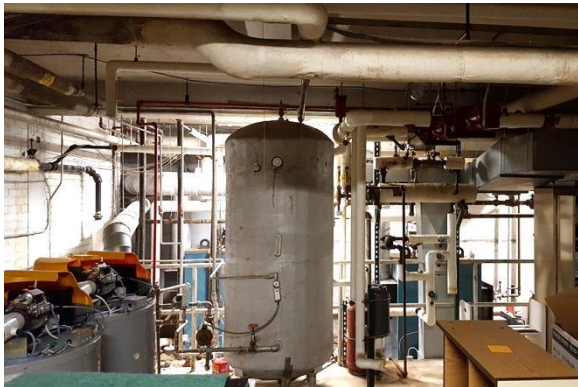
Boiler Room with Abandoned and New Equipment/Piping

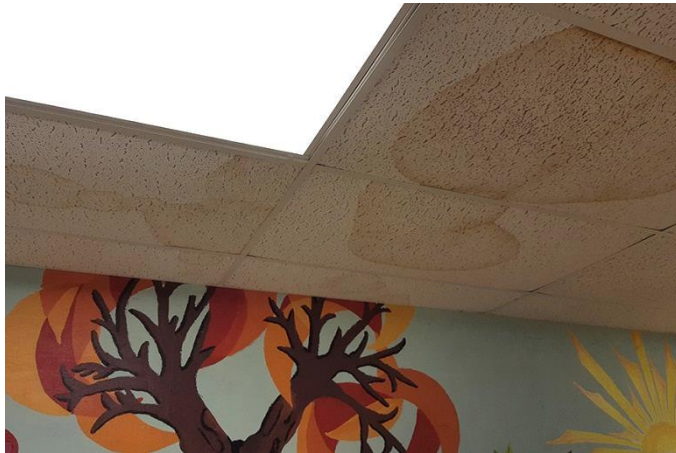
Water Damaged Ceiling Tiles

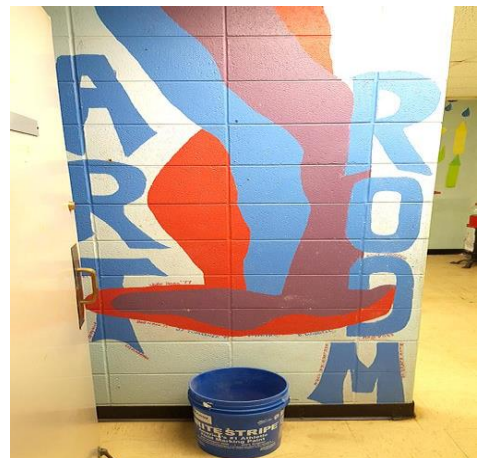
Art Room in Basement

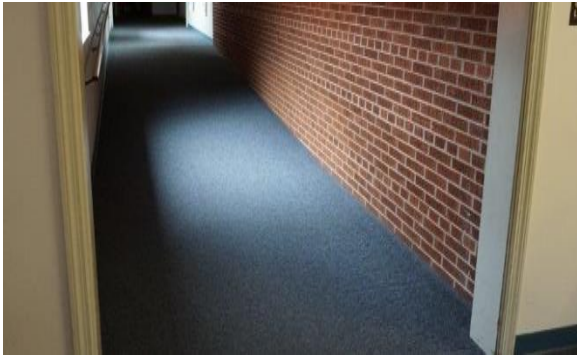
Non-Ada Compliant Ramp at Shed Module

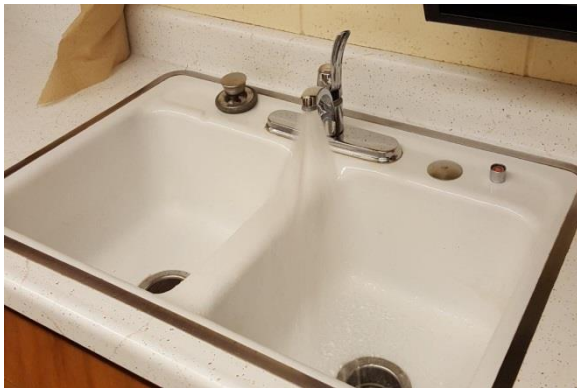
Faucet Working Incorrectly

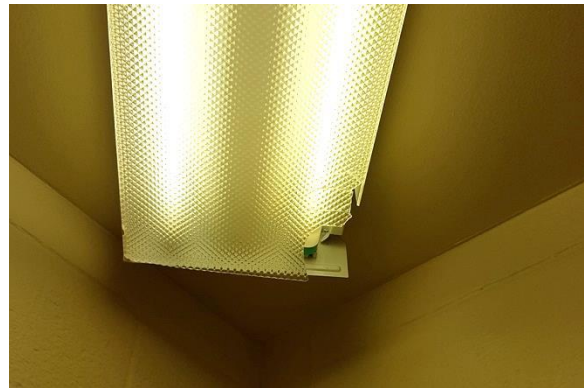
Damaged Light Fixture

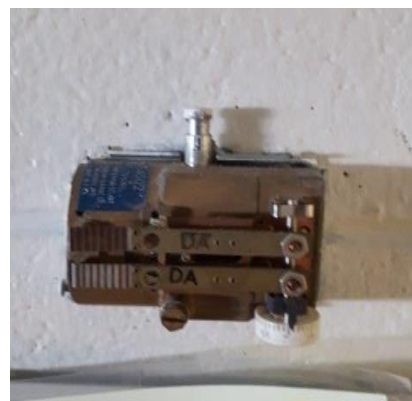
Missing Thermostat Cover

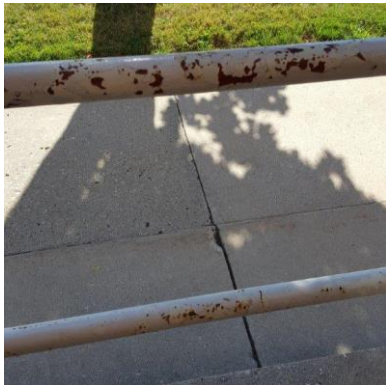
ADA accessibility has not been accommodated at the primary entrances, and due to slab settlement, many of the walks leading to entrances have cracked and heaved leaving non-ADA compliant elevation changes. All exterior slabs, stoops, and walks should be re-leveled to conform to ADA requirements and, if necessary replaced completely. Column bases show signs of rust and should be refinished and protected. The exterior louvers at the through-wall unit vents should be removed and replaced due to damage and reports of water infiltration from heavy rain events. New unit vent louvers should be designed to resist direct water infiltration from the exterior. Also, many of the steel lintels were showing signs of rust. Rusted lintels should be refinished, re-flashed, or re-caulked based on the condition of the lintel. Many exterior doors/frames were observed to be rusted and should be replaced.

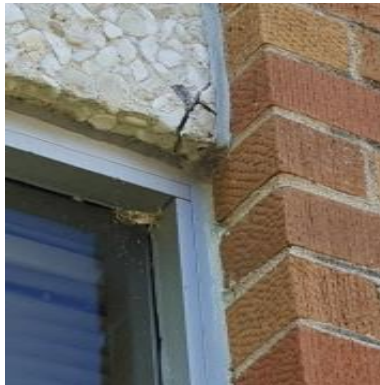
Cracked Masonry at Window Edge

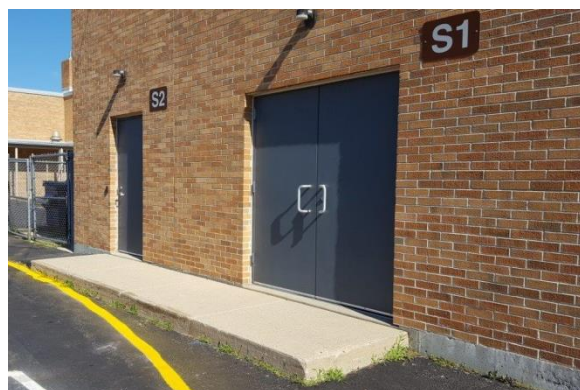
W-1 Not ADA Compliant - Missing ramp and handrails

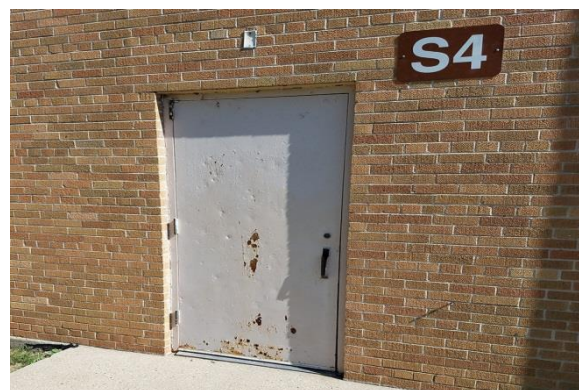
Rusted Exterior Door at Exit S4 handrails

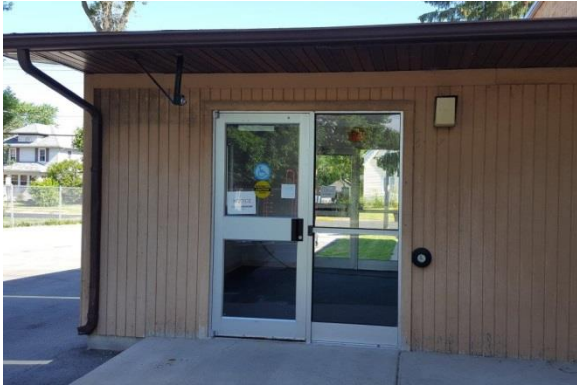
Vestibule Addition at W-1 Entrance

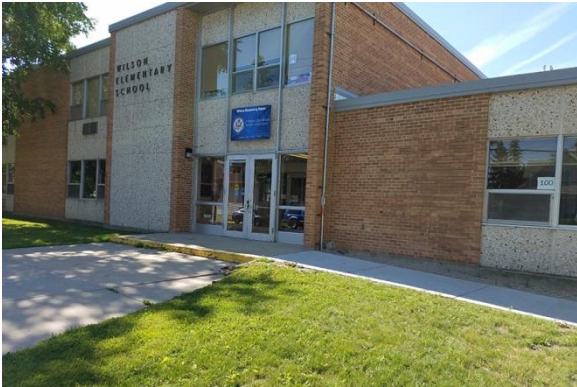
Non-ADA Compliant Main Entry

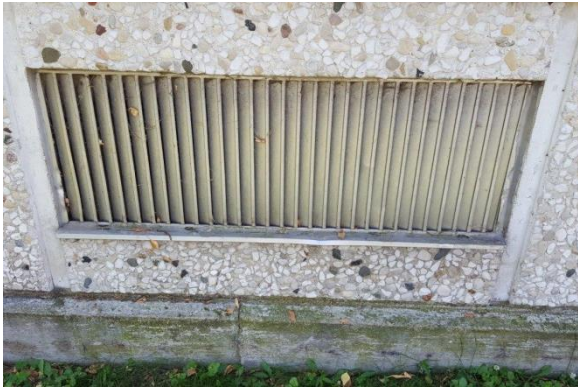
Deteriorated Louver at Unit Vent at S-3 Entrance

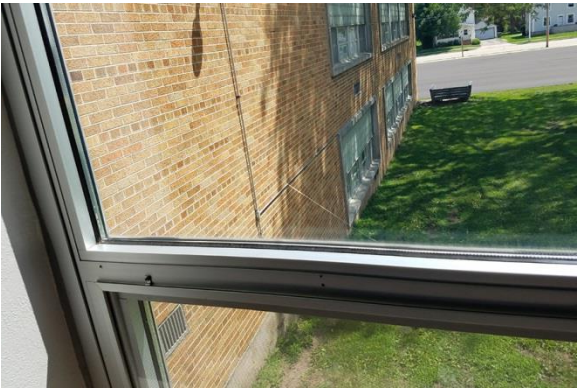
Insulated Glazing at Addition Classrooms

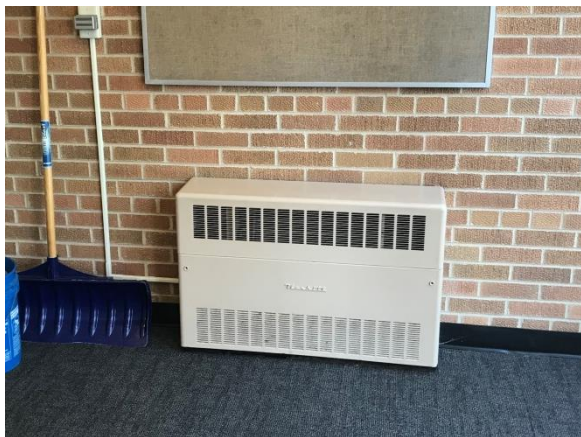
The heating for this building is supplied by two Thermal Solutions gas-fired boilers that were replaced in 2014. These boilers are in good condition and have an average life of 25 years. The associated boiler circulator pumps are in good condition and have an expected life of 10 years. For the base mounted hot water pumps, these have an average life of 20 years are in good condition. There is an old cabinet unit heater that we do recommend replacing to help reduce infiltration during the winter.

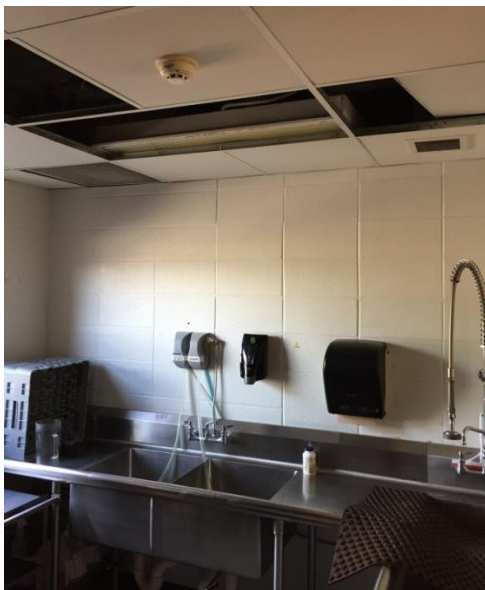
In the kitchen no ventilation exhaust hoods were present. This is a “gray” area of the current International Mechanical Code (IMC) and falls upon the local code inspector’s interpretation. According to the IMC 2015, Type II kitchen hoods must be installed above cooking or dishwashing appliances that produce heat and moisture and/or products of combustion.” This kitchen may require a type II commercial hood over equipment that produces heat or moisture.
