2018 Facility Assessment Plan

Prepared by:

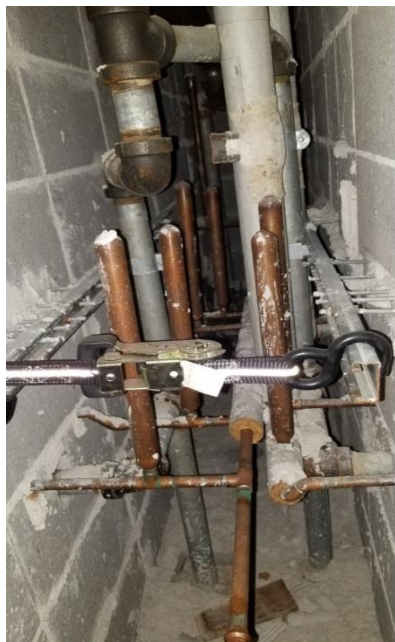
Plumbing Chase at Toilet Rooms

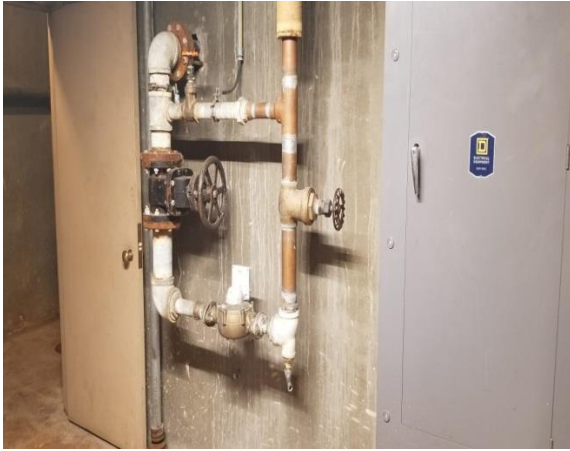
The sanitary drainage system serves the building plumbing fixtures and floor drains. The sanitary drainage systems drains by gravity to the municipal sewer – no sewage ejectors are present. Piping is typically original to the building and constructed of cast iron hub and spigot. PVC piping has been used in areas of renovation and repair. The piping appears to be in good condition for the age of the building with no apparent signs or reports of issues.
