Facilities Master Planning

Beaver Dam School District

Beaver Dam, WI

Existing Facilities Survey

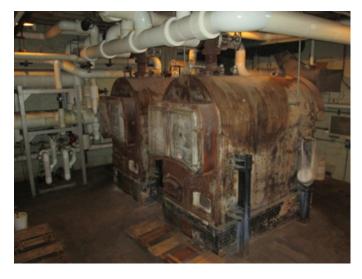
The main boiler areas and electrical service are located in this lower level. Within the boiler area, the old boilers were left in place when the new boilers were installed. Those boilers should be removed.
