facility survey

Beaver Dam Unified School District

Beaver Dam, WI PRA Project #114442

December 2011

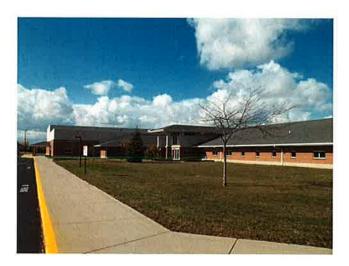
There is a parking and drop offs on the south and east side of the building. The parking on the east side of the building was recently seal coated. The other asphalt is in fair condition. The play equipment on the north side of the building is in good condition.

Due to the low roof eves, there is a concern over easy access to the roof of the building.

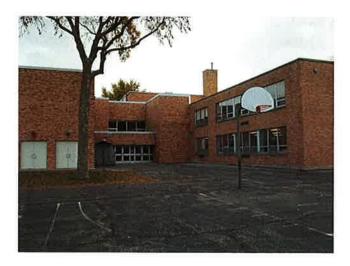
There is a wood storage shed at the west entrance which is in fair/poor condition and should be repaired. A building mounted light fixture on the west side of the building has exposed wiring which should be repaired. There is a crack in the exterior drywall at the east entrance to the building which should be repaired.

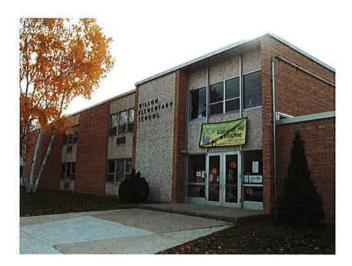
The asphalt play area on the south side of the building is in fair/good condition. It was stated that this playground is used by the adjacent church for parking.

Approximately 99% of the roof is 20 years old or older and should be replaced.

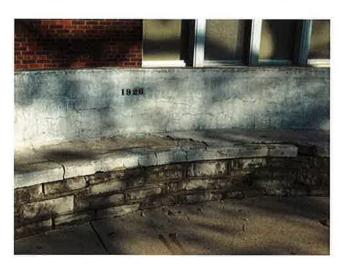
Student drop-off and school bus drop-off occurs along the adjacent city streets. Half of the asphalt is in poor/fair condition and should be replaced, the other half is in fair condition. The older site stairrails (those not leading to the main entry) are in fair/poor condition and should be repaired or replaced. The masonry walls that adjoin the stairs to the older section of the building (two of them) are in poor condition and should be replaced or repaired. The seating bench at the south side of the site is in poor condition and should be repaired.

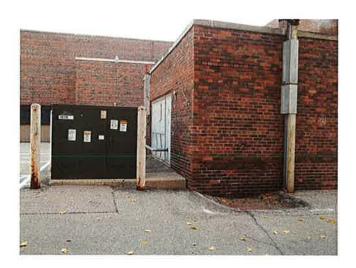
There is a combined hard play area and grassy area to the east of the school on a separate lot accessible by crossing North Spring Street. The asphalt green space and track are in fair/good condition. The fence surrounding this area is in good condition. Overall, the site is too small for a middle school. The building entry systems are in good condition. The building façade is in generally good repair with the exception of the boiler room area to the northwest of the main building. This area requires tuckpointing and façade replacement/repair. The paved areas over the rooms below should be evaluated for structural integrity and water infiltration. The existing smokestack is inactive and should be reviewed for removal.

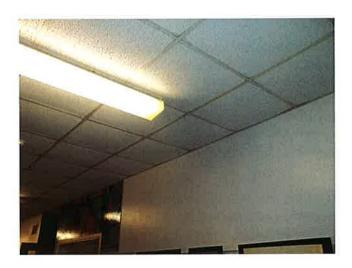
The main corridors are adequately sized. Student storage is accomplished with lockers. The corridor floors are terrazzo, VCT or carpet. The terrazzo and VCT are in good condition, most of the carpet is old (there are some smaller newer sections of carpet in the locker pull -out areas on each east/west wing which are in good condition) and most of the older carpet is in bad condition and should be replaced. The entrance to the north by the new gym has carpet squares which are worn, and should be replaced. The stair treads/nosings in the entry vestibule next to the new gym are damaged and should be replaced. The ceilings are 2x2 acoustical ceiling tile, all are in fair condition however some of the grids are old and are yellowing (approximately 15%). There are areas of the ceiling that are damaged and should be replaced (approximately 5%). The stairwells should be painted. Some of the casework that is located in the corridor break-out areas has delaminated and should be replaced (approximately 50%).

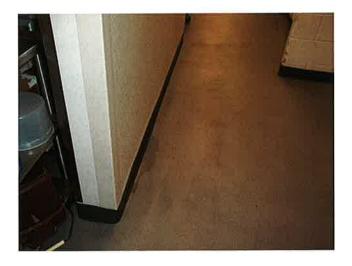
The kitchen has a poured topping floor which is in good condition. The base is a 4" vinyl cove base which will allow water to seep underneath it affecting the adjacent walls and allowing water to pond. The base should be replaced with a ceramic base. The ceiling is a 2x2 vinyl wrapped gypsum lay-in ceiling in good condition.

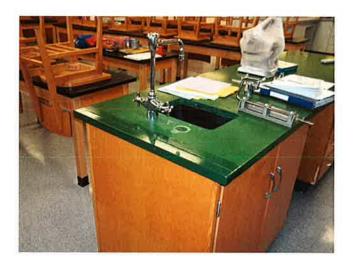
The science classrooms have VCT flooring, which is in good condition. The first floor casework is in fair/good condition. The second floor casework is in fair/good condition, but the countertops are in fair/poor condition

and should be repaired or replaced. The third floor science casework and countertops are in fair/poor condition and some should be replaced (approximately 50%). There is a section of wall that requires repair within the third floor science prep area. There are no dedicated ADA compliant science stations in any of the science classrooms.

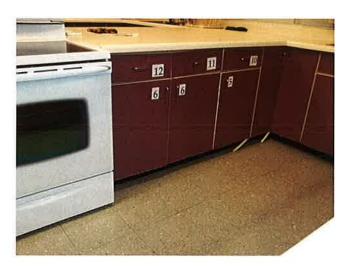
The family and consumer education room has VCT flooring and carpet which are in good condition. The 2x2 acoustical lay-in ceiling is also in good condition. The casework is in fair/poor condition and should be replaced. There is no dedicated ADA compliant work-station.

The newer gym has a wood floor which is in good condition. There is a section of roof drainage piping with wrapped insulation that should receive a PVC protective sleeve. The exit doors to the north are rusted through and should be replaced. The adjacent locker rooms have poured floors, some of which should be repaired (approximately 25%). The ceilings are vinyl wrapped gypsum board lay-in and are in good/fair condition, approximately 10% of the ceiling panels are damaged and should be replaced. Within the boys team locker area approximately 20% of the lockers are damaged and should be replaced. The locker room restrooms are ADA compliant.

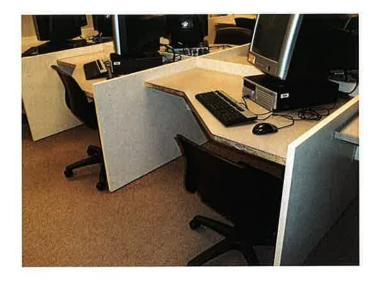
The IMC computer lab has worn carpet which should be replaced. The ceiling is a 2x2 lay-in acoustical ceiling which is in good condition. The casework is in fair condition with the exception of the work surface edges which are in poor condition and should be repaired. There are damaged column surfaces which should be repaired and repainted.

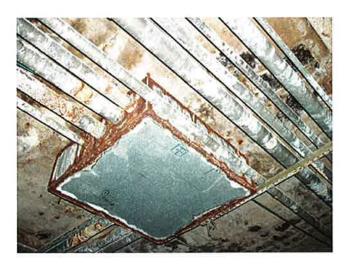
Electrical junction boxes and conduits in the adjacent room show significant rust due to water leakage in the space. This equipment needs to be replaced after the water infiltration problem is resolved. This condition has a high probability of creating an unscheduled outage that could leave a significant portion of the school without power for an extended period of time.

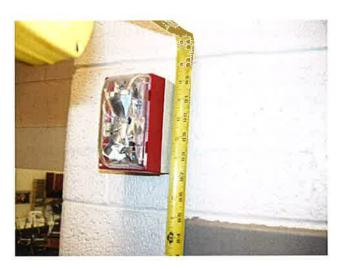
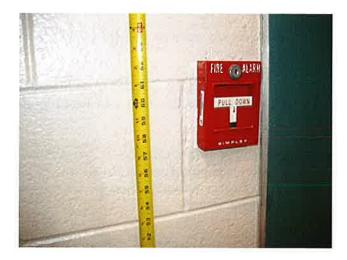
The building has a Simplex 4020 fire alarm system installed. The system consisted of corridor smoke detectors, manual pull stations and audible and visual devices. The installation does not appear to completely comply with current code requirements.

Fire alarm initiation devices and audible/visual devices are not all installed at spacing and mounting heights (pull stations are to be no higher than 48" and strobes are to be at 80" - see pictures) as required by current codes. Some areas (common use spaces) that should have visual device coverage are not covered.

The system is relatively close to end of useful life and should be considered for upgrade or replacement.

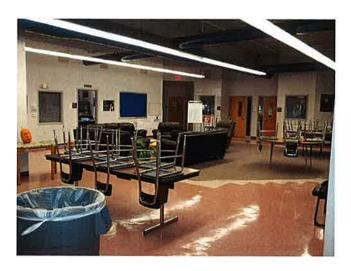
The classrooms have either vinyl composition tile, or carpet, all of which are in good condition. The casework is PLAM and is in good condition. The classrooms have 2x2 acoustical lay-in ceiling tile which is in generally good condition, however some of the ceiling tile is damaged by water from the roof (approximately 5%).

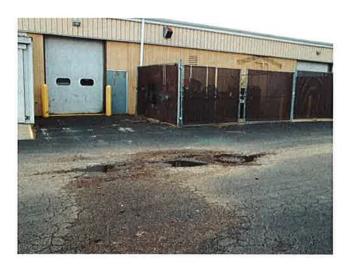
The bus drop off area and student drop off area and visitor parking are co-mingled, creating a potential pedestrian hazard. The asphalt in this area is in fair/poor condition and should be repaired or replaced. The student parking area appears to be adequately sized and the asphalt is in fair condition. The loading areas to the east of the building by tech education are in poor condition and should be repaired. The loading area for the school cafeteria has no turn-around or pull-out for delivery vehicles forcing the vehicles to back up from McKinley Street to the at-grade loading area, a distance of approximately 240 feet. The loading area asphalt is in poor condition and should be replaced and reconfigured if possible to allow vehicular turn-arounds.

The play fields are in good condition. The track and bleachers are in good condition. The tennis court surface is in good condition with the exception of some expansion cracks which should be filled in. There is an area of asphalt with some old basketball hoops, the asphalt is in poor condition and should be replaced. Adjacent to the basketball hoop area is a shed with some

rusty doors which should be repaired or replaced. There are also several wood storage sheds adjacent to the tech education area that have rotting doors and sagging roofs which should be repaired.

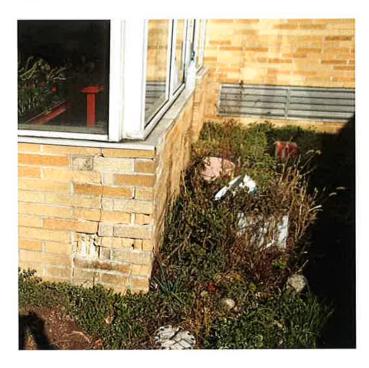
There is some loose fascia along the western façade that should be repaired. There is also a double-pane window section that has a failed seal which should be replaced. The interior courtyard, inclusive of the greenhouse contains single-glazed curtain wall which should be either infilled with a masonry wall and windows or replaced with a more energy efficient system. The greenhouse partial height wall shows extensive water staining and freeze/thaw damage. These walls should be replaced or repaired. The doors to the courtyard should receive new weatherstripping (BDUSD Update: repaired).

Approximately 25 percent of the glazing is single glazed and should be replaced.

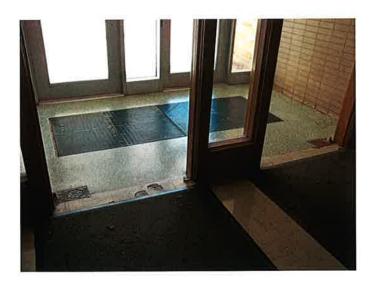
The entrance to the building faces south and has a lobby adjacent to the main office. There is no direct connection from the main vestibule to the office. Security is accomplished through the use of a remote magnetic lock and closed circuit cameras. The flooring in

the entry vestibule is terrazzo, which is in good condition. The flooring in the lobby is asbestos vinyl composition tile which is in fair condition. The recessed entry mats are in poor condition and should be replaced. Consideration should be given to moving the inner set of doors further inward to the lobby, thus allowing direct access from the entry vestibule into the main office for visitor security.

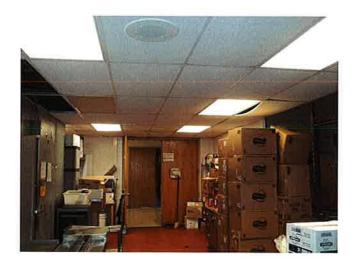
The loading area for the dining service also serves as a general loading area for the building. The exterior door/frame are severely rusted and should be replaced. If possible, the dining loading area and the general purpose area should not be the same. The flooring is sealed concrete.

The kitchen area is adjacent to the loading area across the hall. The high school kitchen prepares meals for the entire district. The kitchen and storage area are undersized for the size of the high school. The kitchen also prepares the meals for the rest of the district. The ceiling in the storage area is a 2x4 lay-in acoustical ceiling which is in poor condition. This ceiling should be washable, it is not. Some of the freezer/refrigerator panels are rusting and should be repaired. There are wall sections missing due to remodeling that should be The flooring throughout the storage and kitchen areas is quarry tile which is in good condition. There is inadequate storage. The entire loading/ unloading/storage/kitchen/serving/dish washing area should be redesigned and remodeled to the correct size and configuration to meet the building and district food service expectations.

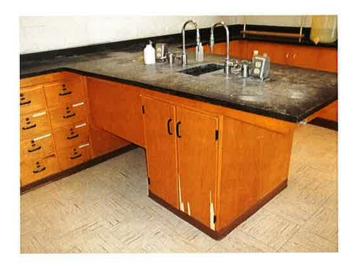
The science classrooms have either VCT or asbestos vinyl composition tile flooring, which is in good condition. The casework/countertops are in fair/poor condi-

tion. The countertops are in poor condition. Generally the science rooms are configured with the sinks and teaching stations facing toward the walls instead of facing toward an instructional area. The ceilings are either 2x4 lay-in acoustical or 1'x1' acoustical tile. Most of the science ceilings have water damaged tiles (approximately 10%) which should be replaced. Most of the science rooms are undersized to provide a pod type work area and lecture area. The science prep areas have damaged countertops and casework some of which are inappropriate to their current use, which should be reconfigured and replaced.

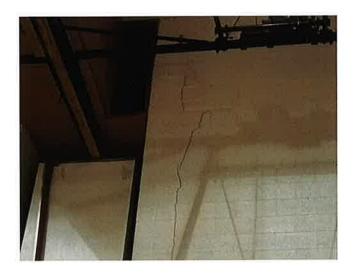
The south gym has a wood floor which is in good condition, however the entry vestibules to the gym from the west (main hallway) are vinyl asbestos composition tile and are in poor condition, with many of the tiles cracked or missing and should be replaced. There is an old fold-out divider for the gym which is in poor condition and reportedly there are no replacement parts available for the divider due to it's age. There are cracks in the masonry walls adjacent to the divider. The locker room to the north of this gym is used as a changing area only. There is an ADA compliant restroom within this locker room. The flooring is terrazzo which is in good condition. The lockers are old but serviceable. The ceiling is in good condition.

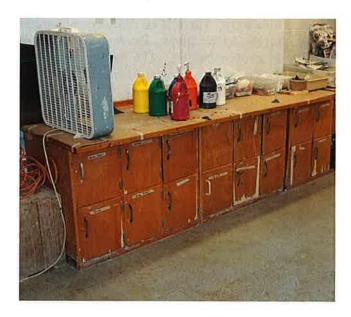
The art rooms have painted concrete floors some of which are worn and should be re-painted. The ceilings are exposed structure, 1'x1' acoustical tile or a 2x4 layin acoustical ceiling some of which should be replaced due to water damage. Most of the casework is damaged and should be replaced.

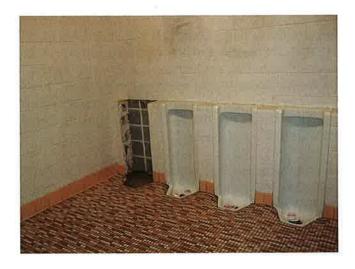
Most of the restrooms are in fair condition. All but the north gym restrooms should be repainted. There are rusty partitions which should be replaced and the existing piping is failing forcing the elimination of in-floor fixtures.
